REPORT ON GEOTECHNICAL SITE INVESTIGATION

PROPOSED NEW INCLINATOR

4 NOTTING LANE, COTTAGE POINT, NSW

Project No.: 2012-228.1

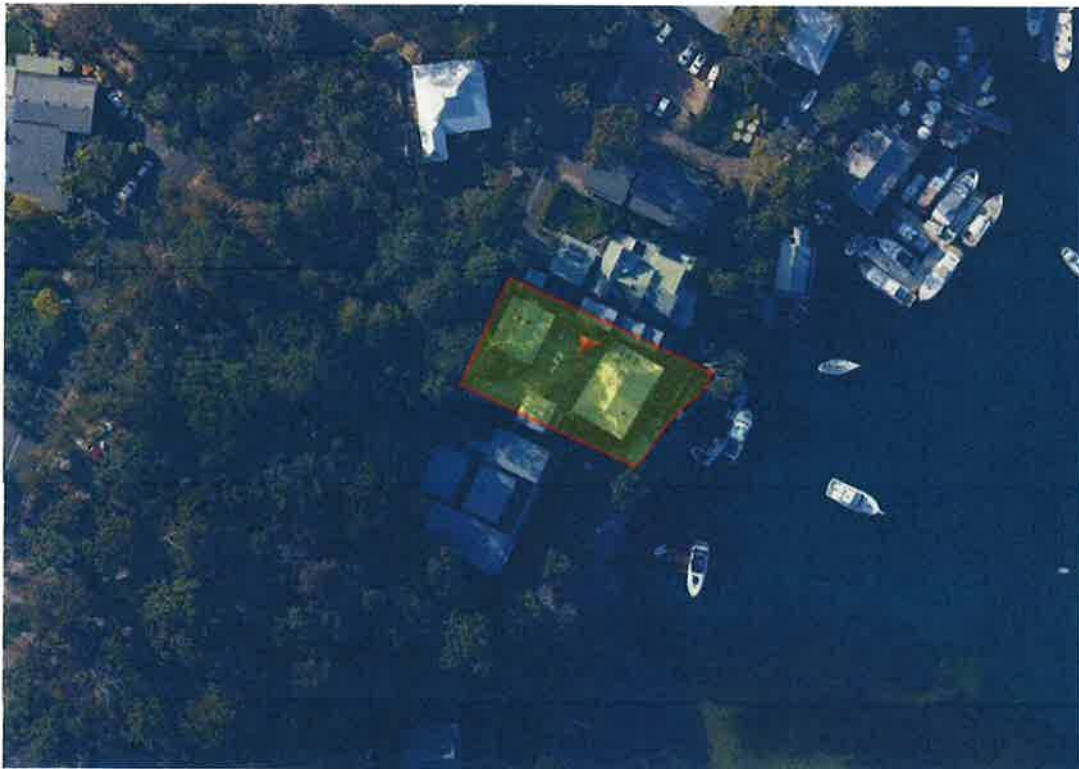
Photograph 1: Aerial photo of site and surrounds

The site is a trapezoidal shaped block within moderately south dipping topography. An aerial photograph of the site and its surrounds is provided below (Photograph 1), as sourced from NSW Government Six Map spatial data system. The site is located at the tip of a north-east striking ridge line that extends down to Cottage Point, Sydney NSW. It is located on the south-eastern side of the ridge, at the base of the slope adjacent to Coal & Candle Creek. The property is situated on the low eastern side of Notting Lane within moderate to steep east dipping topography down to the waterway.
