PRELIMINARY GEOTECHNICAL ASSESSMENT:

8 Bate Avenue, Allambie Heights

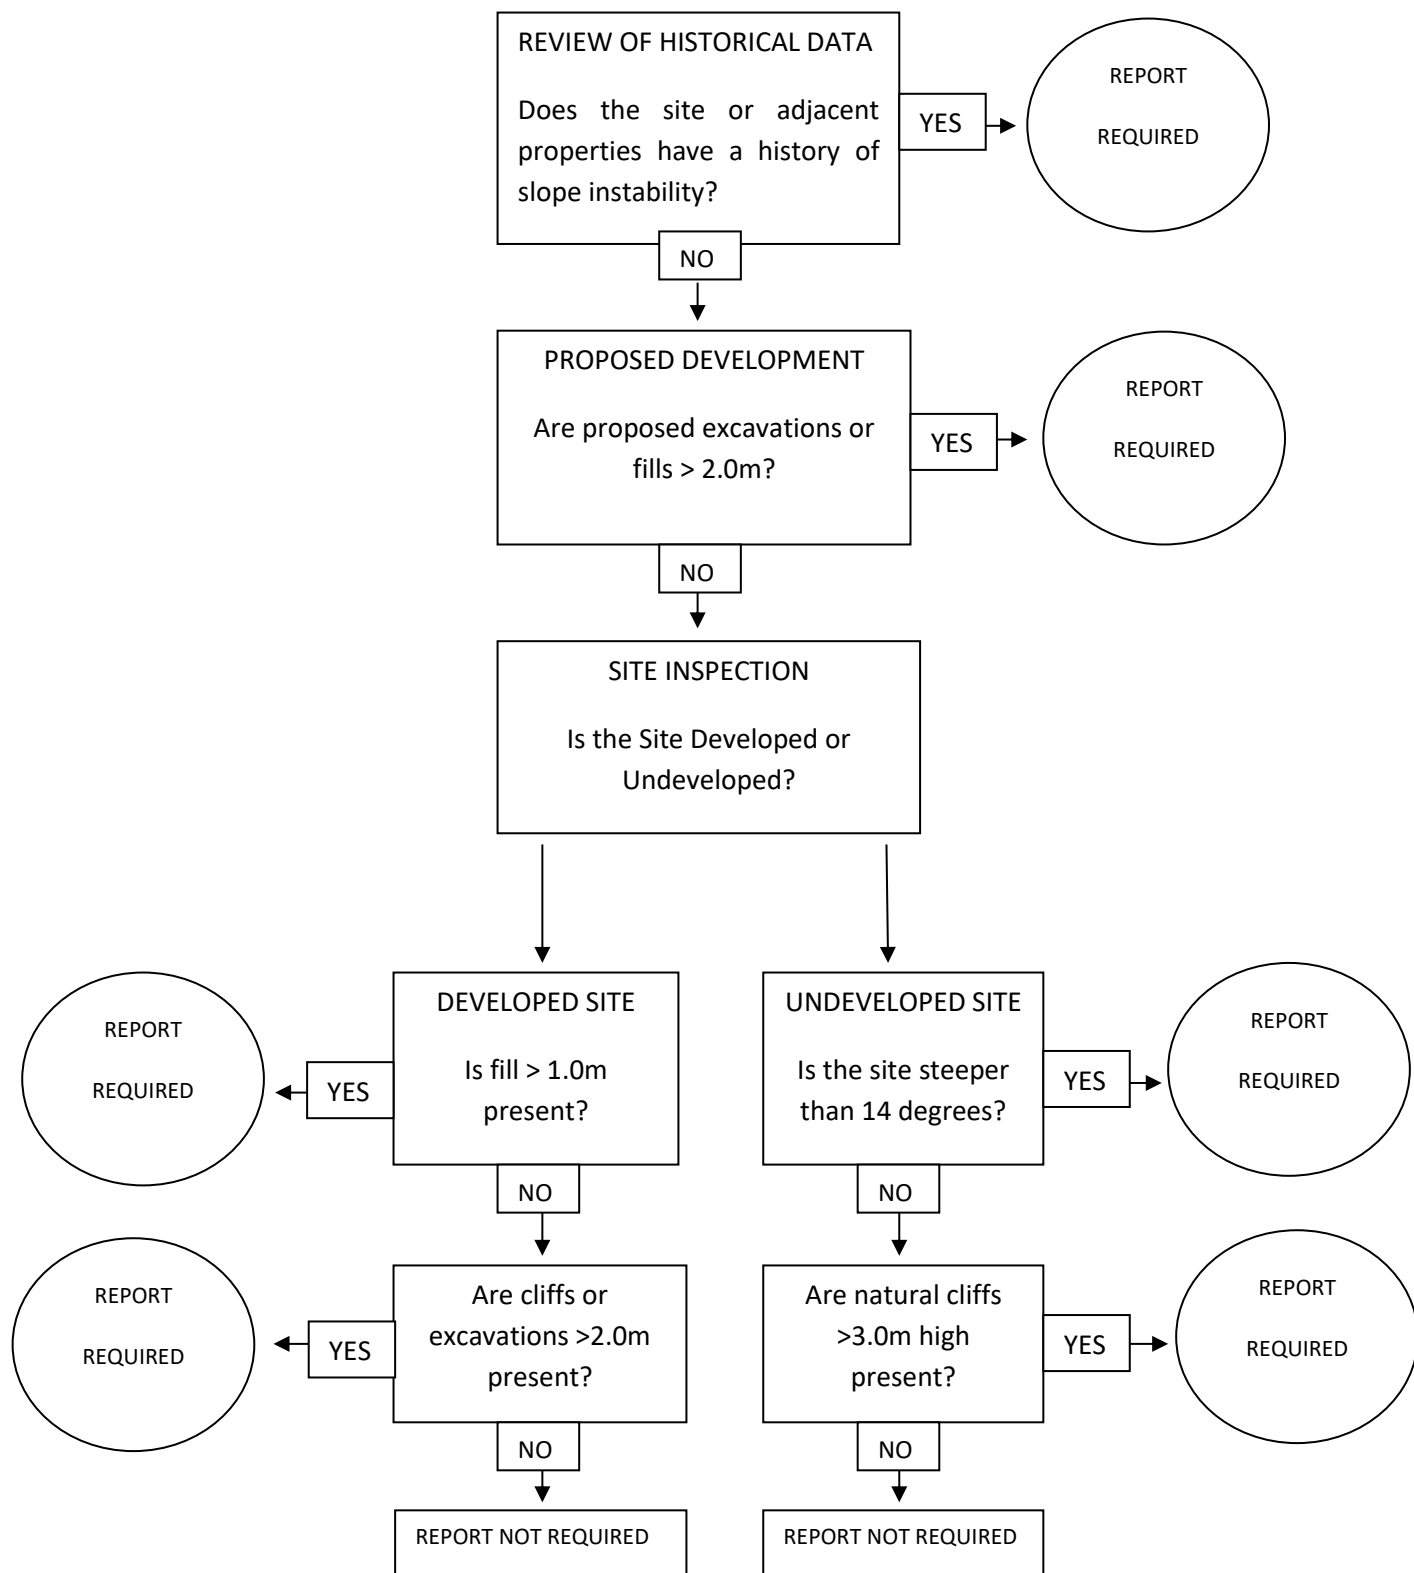
Preliminary Assessment Flow Chart – Northern Beaches Council (Warringah)

The proposed development and site conditions were considered and applied to the Council Flow Chart.
