PRELIMINARY GEOTECHNICAL ASSESSMENT:

21 Wedgewood Crescent, Beacon Hill

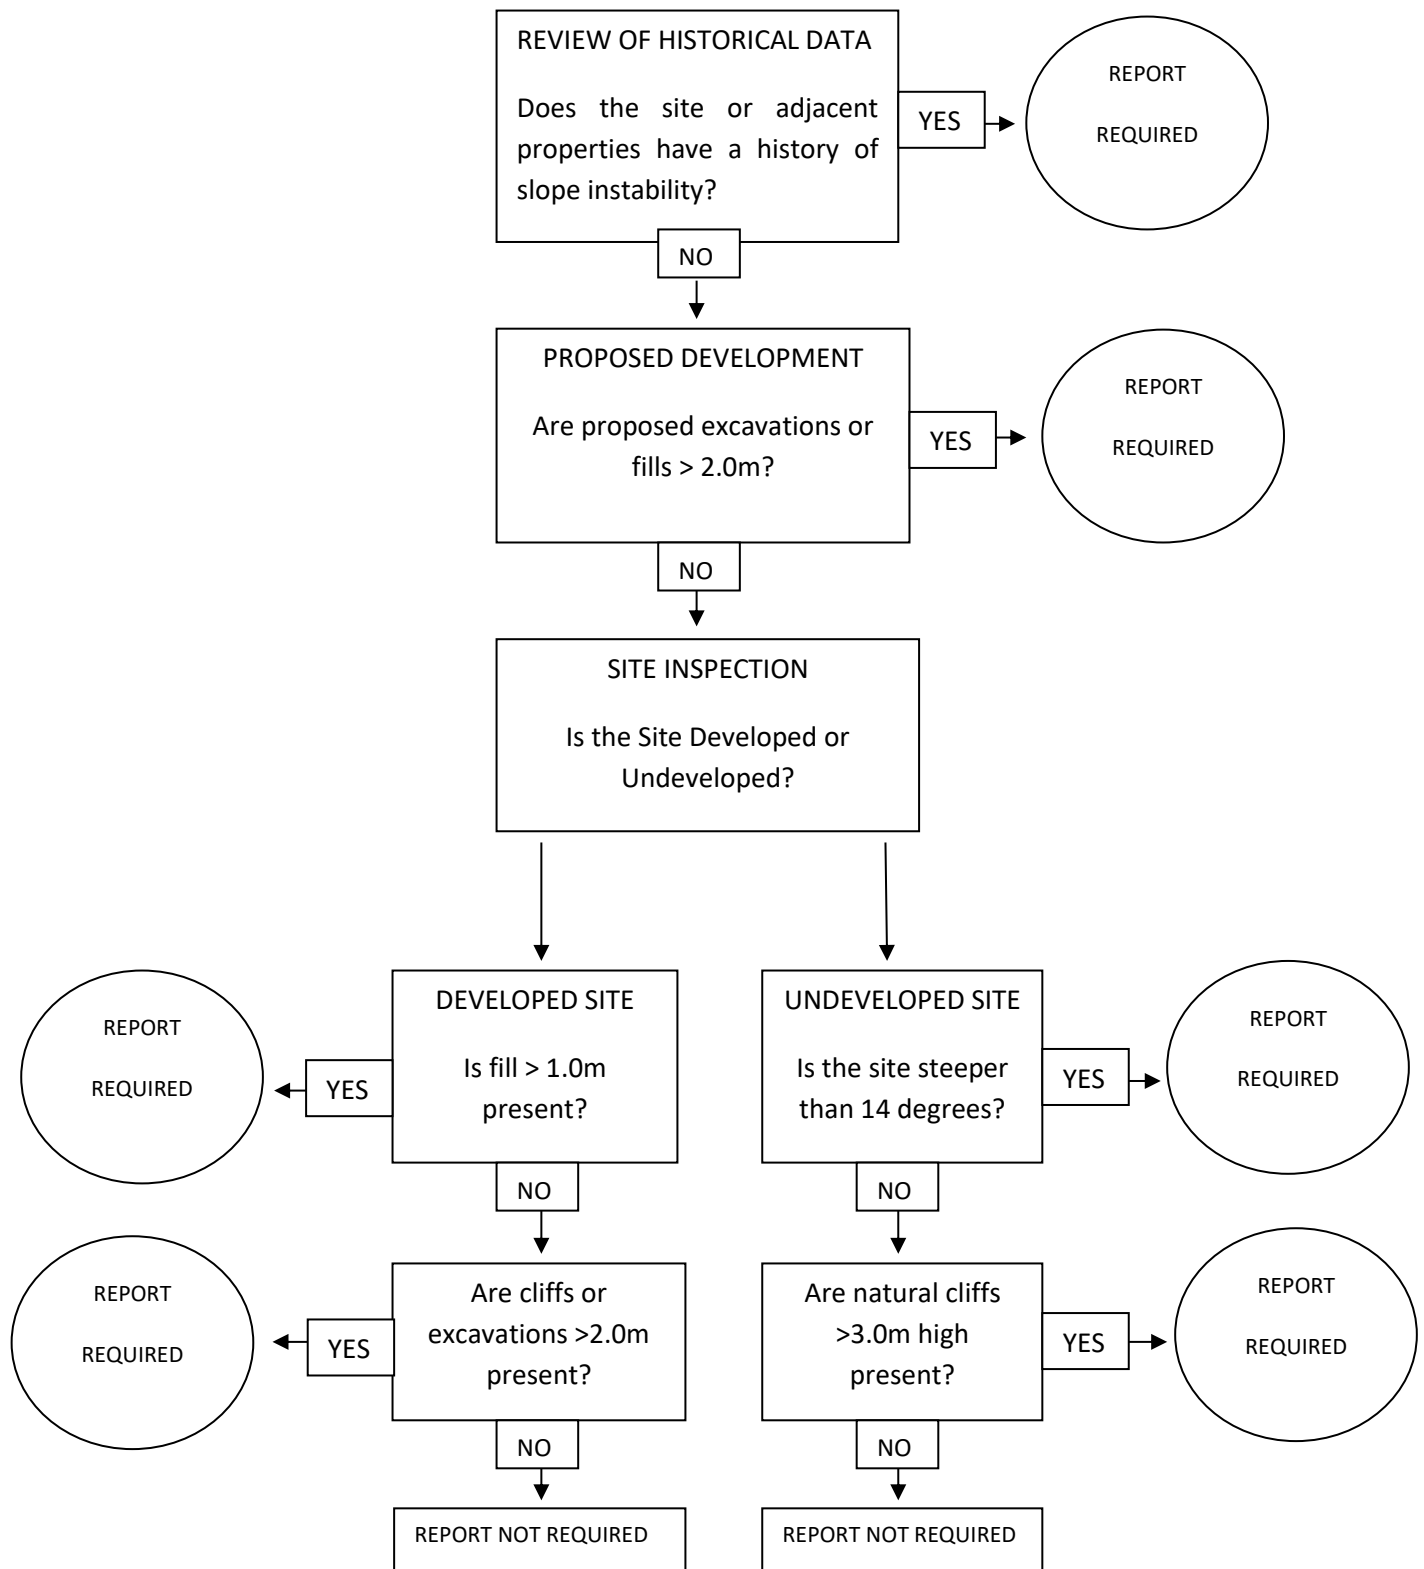
Preliminary Assessment Flow Chart – Northern Beaches Council (Warringah)

The proposed development and site conditions were considered and applied to the Council Flow Chart.
