## **PRELIMINARY GEOTECHNICAL ASSESSMENT:**

### **32 Badcoe Road, Cromer**

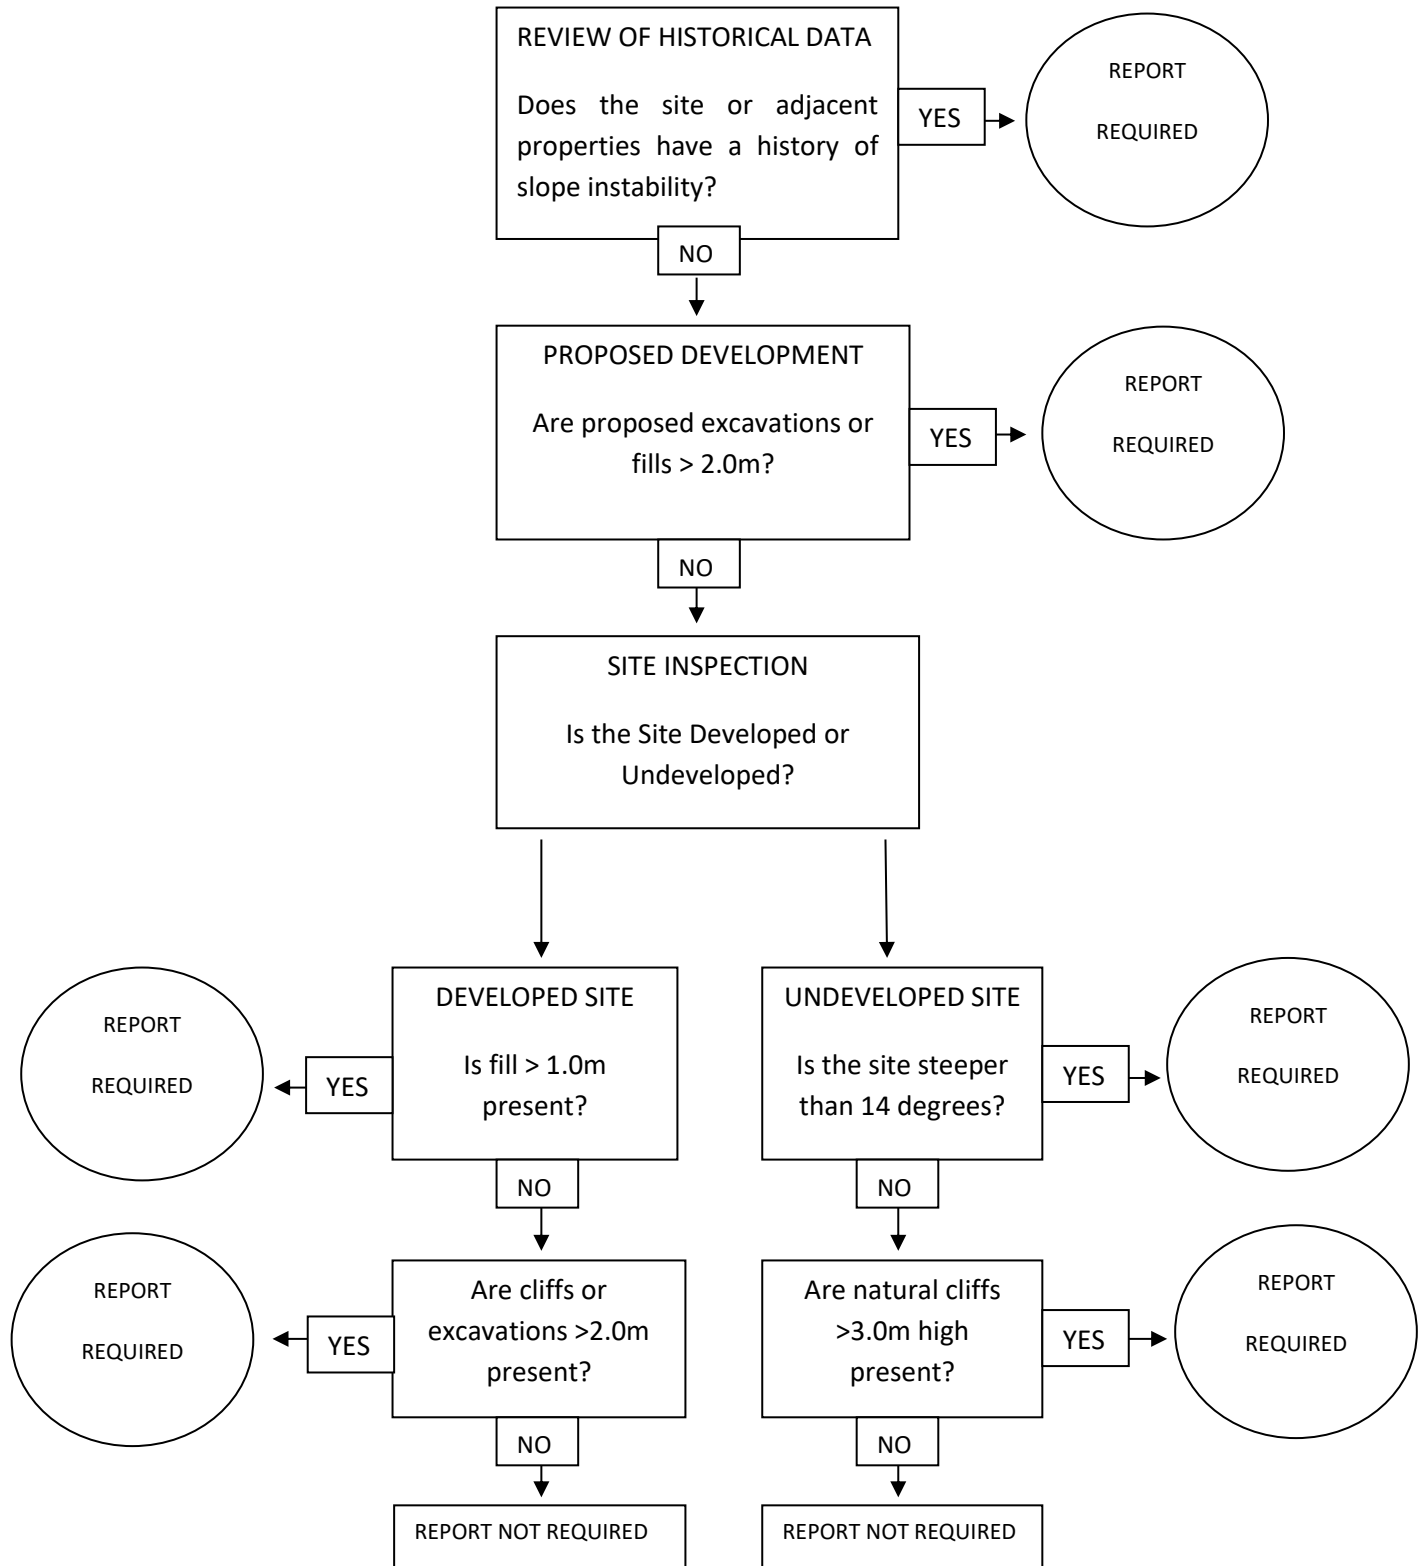
**Preliminary Assessment Flow Chart – Northern Beaches Council (Warringah)**

The proposed development and site conditions were considered and applied to the Council Flow Chart.
