FIRE ENGINEERING MEMO

TO: Phillip Rodrigues
FROM: Dan Kirk
SUBJECT: Fire Engineering Report(FER) – Members Services Fitout, Harbord Diggers
OUR REF: Harbord_Diggers_Member_Services_fitout FER rev. 2
DATE: 13 June 2019

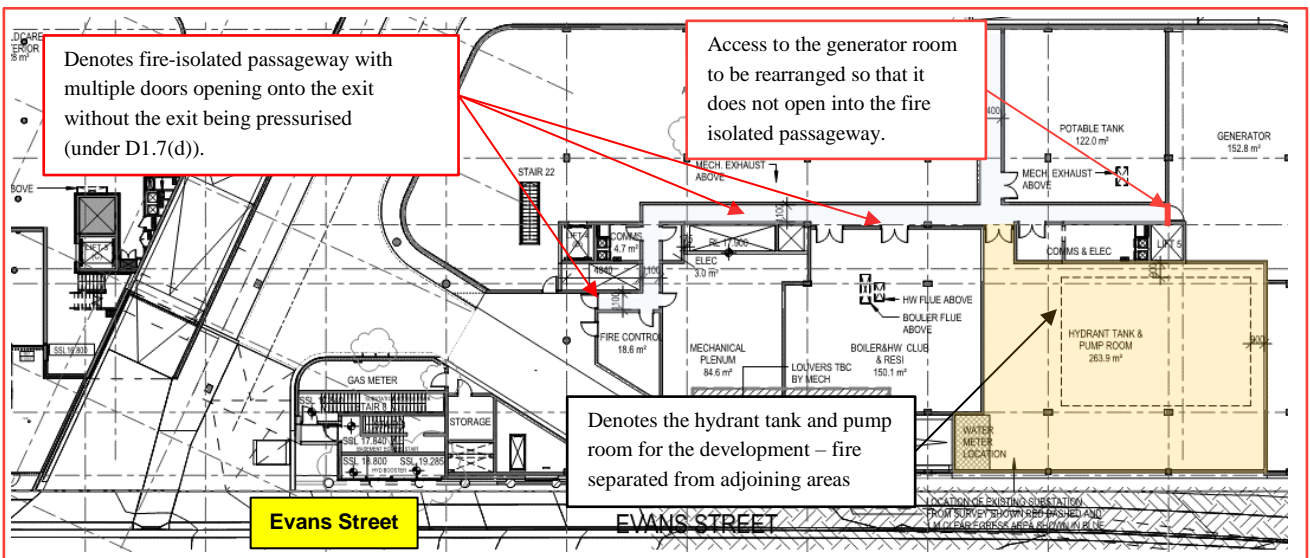
As per BCA Clause D1.7, if more than two access doorways open into a required fire isolated exit / corridor in the same storey, than either a smoke lobby in accordance with D2.6 or pressurisation of the exit in accordance with AS 1668.1-2015 must be provided. At the back of MS5 – MS8 of Harbord Diggers, a fire isolated corridor exists which has already been justified in the base-building FER as not having pressurisation despite having >2 doors opening into it. Figure 3 shows the number of doorways which were opening into this corridor upon completion of the works in this area in mid-2018 (ten doors in total).

Figure 3: Fire-isolated passageway to pump room (extract from base building FER)
