PRELIMINARY GEOTECHNICAL ASSESSMENT:

8 Townsend Avenue, Frenchs Forest

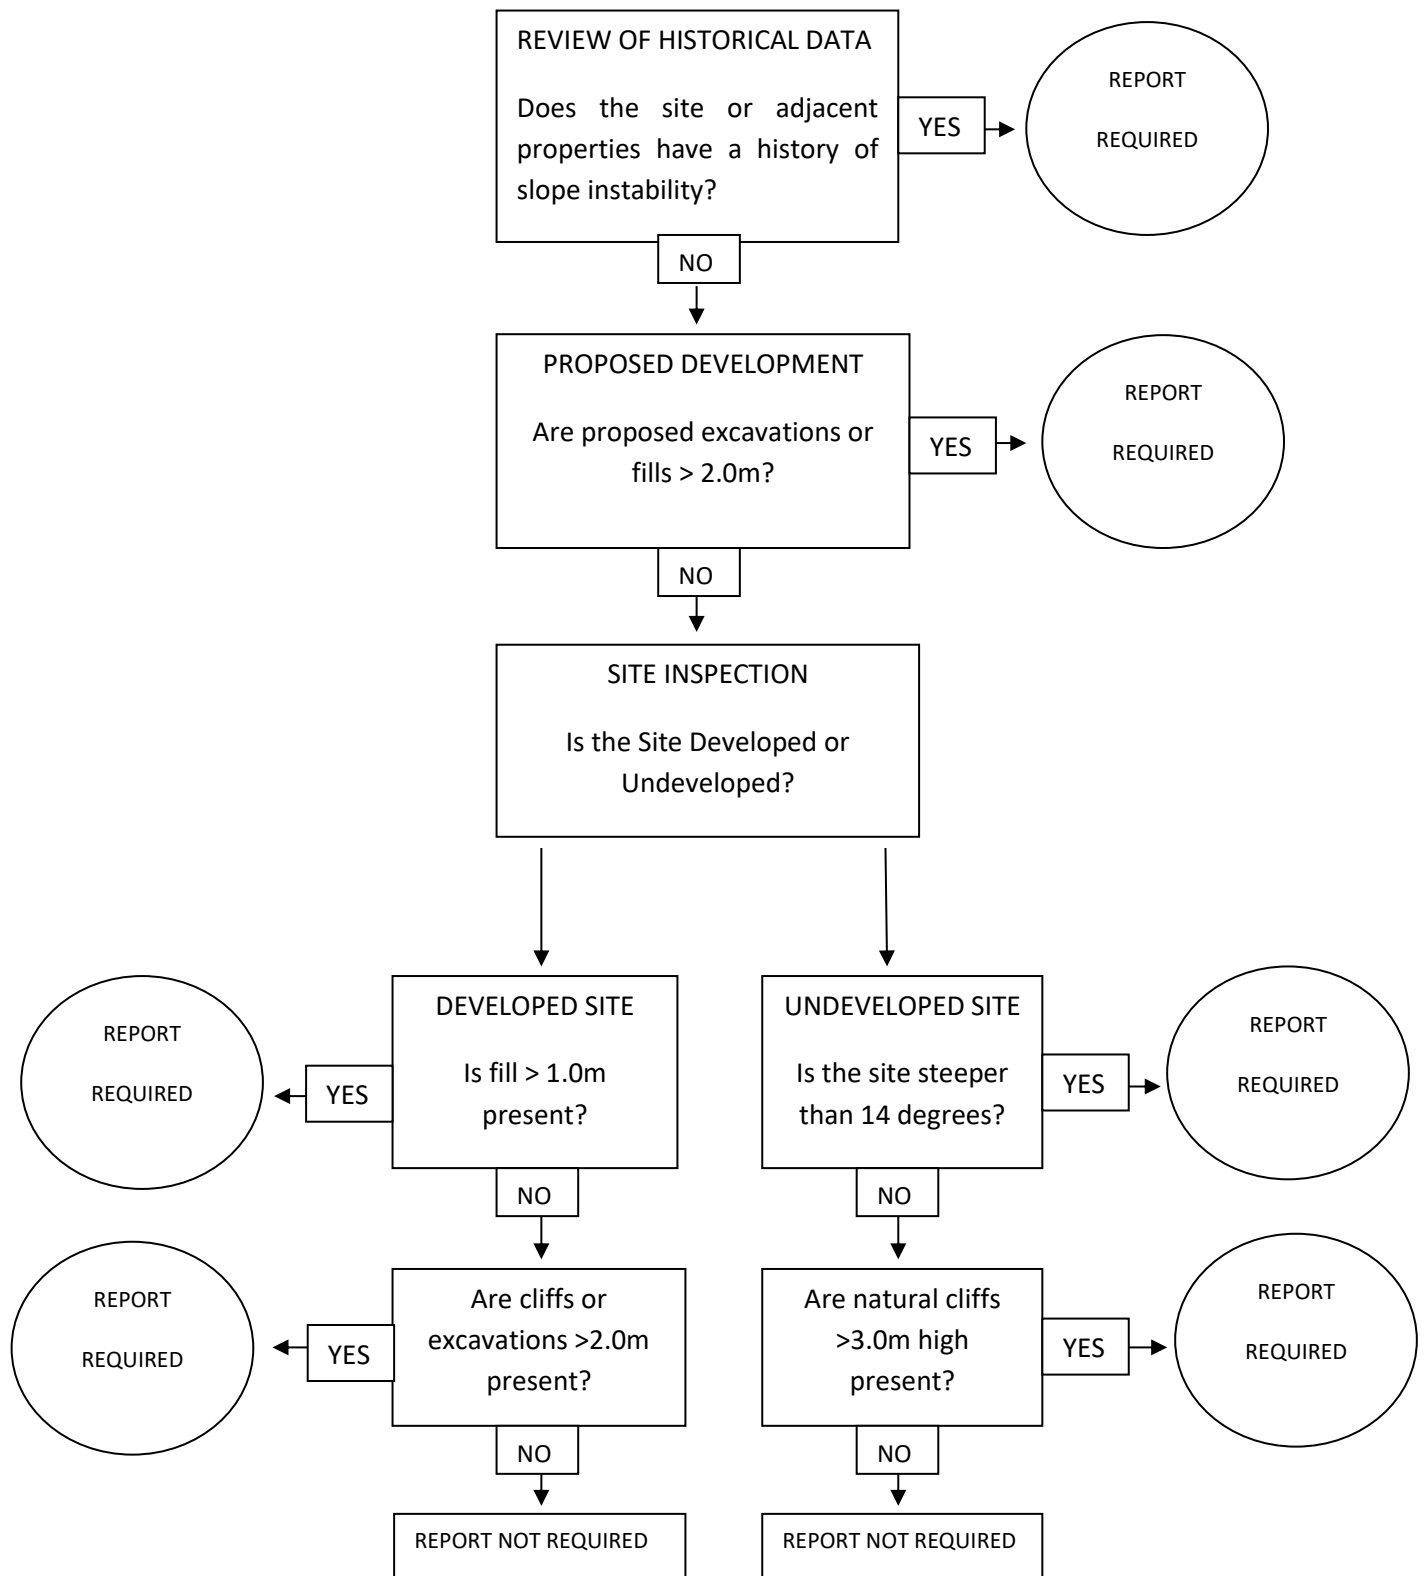
Preliminary Assessment Flow Chart – Northern Beaches Council (Warringah)

The proposed development and site conditions were considered and applied to the Council Flow Chart.
