## AS2870-2011 SITE CLASSIFICATION

**Lot 1, No 11 Veterans Parade  
Collaroy Plateau NSW**

AS2870 Site Classification
<b>Class P</b>

Estimated AS4055-2021 Wind Classification
<b>N2</b>

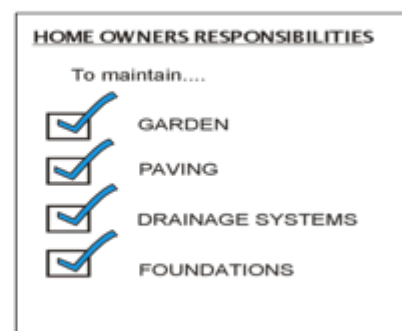
Fig.7

The home owner should read and become familiar with the Site Classification report provided prior to construction and the type of footing system used in the building. To comply with Australian Standard 2870 – "Residential slabs and footings", and achieve acceptable performance and safety during the design life of the house, the owners shall maintain the garden and foundation soil moistures, paving and drainage systems. (Fig. 7)

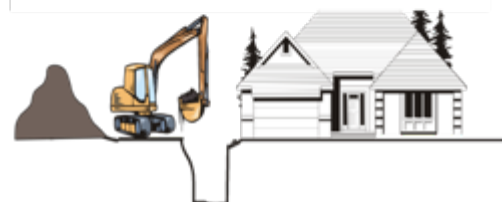
Fig. 11 De-stabilizing house foundations

- Ensuring that excavations are well supported or are dug to avoid collapses. (Fig. 11)
- Constructing well-compacted and retained 'soil aprons' around the building to stop erosion.

- Special considerations if any excavations are to be dug near adjoining structures. (Fig. 11)
- Sloping the soil and paths away from the building by the minimum amount required by the building regulations to prevent water flowing towards the building foundations. (Fig. 10 & 18)

- Running machinery over shallow drain pipes may break them causing leaks and subsequent foundation movements.
- Any excavations close to building footings can cause them to sink by disturbing the foundation material or by drying the foundation clay. (Fig 11)
