## **Preliminary Geotechnical Assessment**

**Project:** Alterations & Additions  
9 Hyde Avenue, Killarney Heights NSW

**Ref:** AG 22539  
14 December 2022

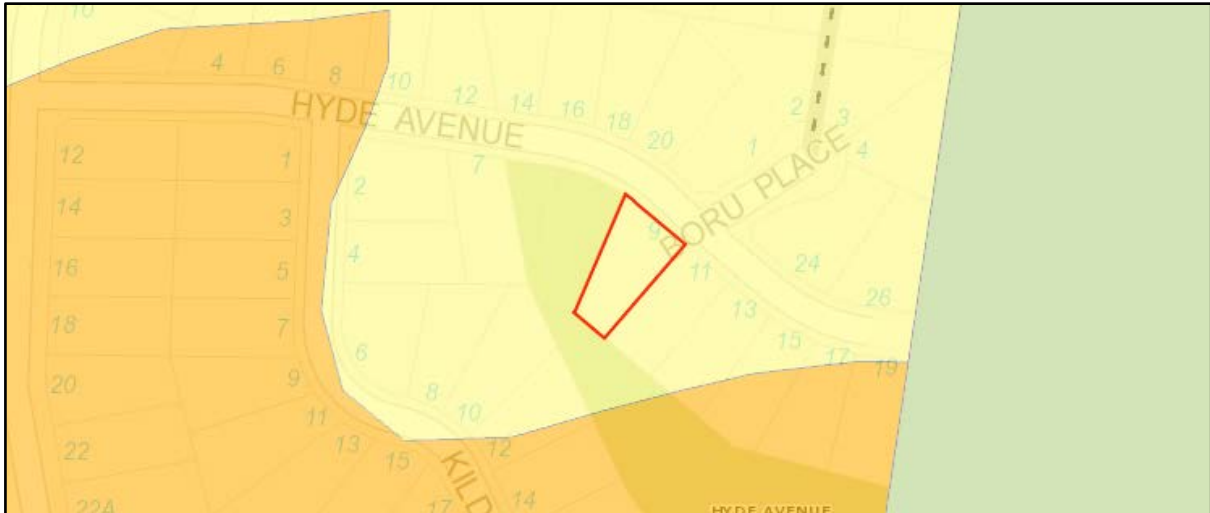
**Image 1.** Warringah Landslip Risk Map:  
9 Hyde Avenue, Killarney Heights NSW (© NBC Maps)

The site is mapped as **Area A** subject to specific landslip risk/geotechnical hazard mapping with reference to the Warringah (WLEP) Landslip Risk Map, Northern Beaches Council (**Image 1**).

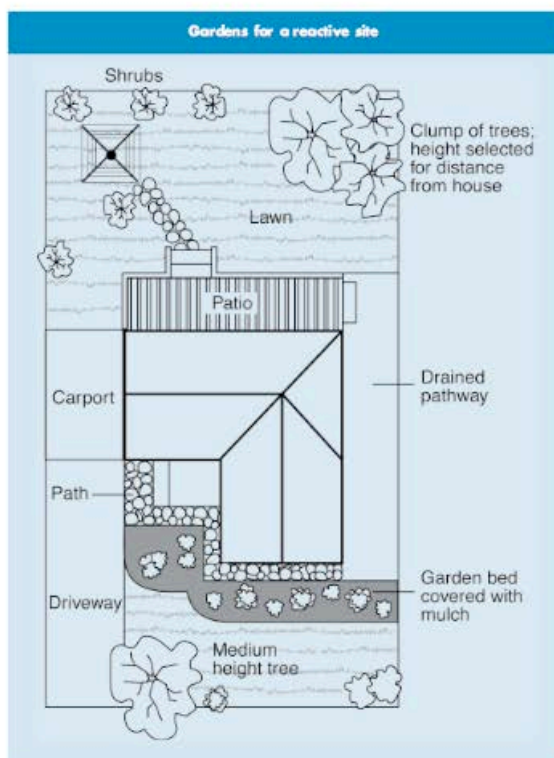
should extend outwards a minimum of 900 mm (more in highly reactive soil) and should have a minimum fall away from the building of 1:60. The finished paving should be no less than 100 mm below brick vent bases.
