**REPORT TO
30 FAIRLIGHT PTY LTD**

**ON
GEOTECHNICAL SLOPE STABILITY RISK
ASSESSMENT**

**FOR
PROPOSED RESIDENTIAL DEVELOPMENT**

**AT
30 FAIRLIGHT STREET, FAIRLIGHT, NSW**

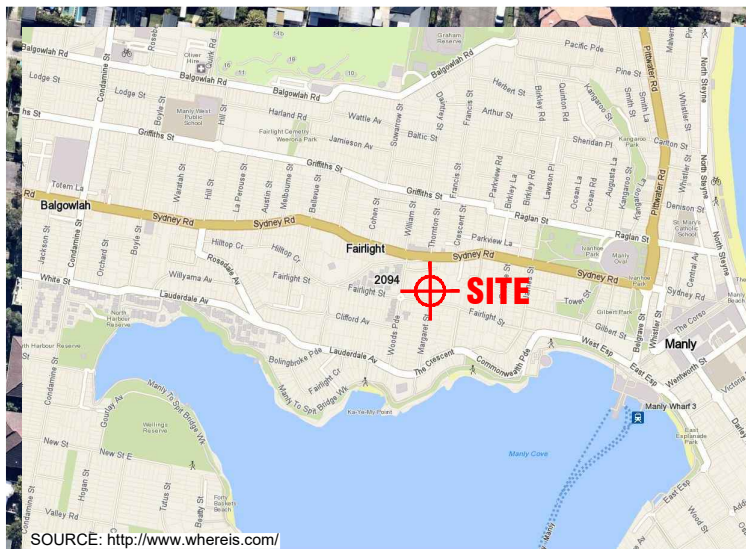
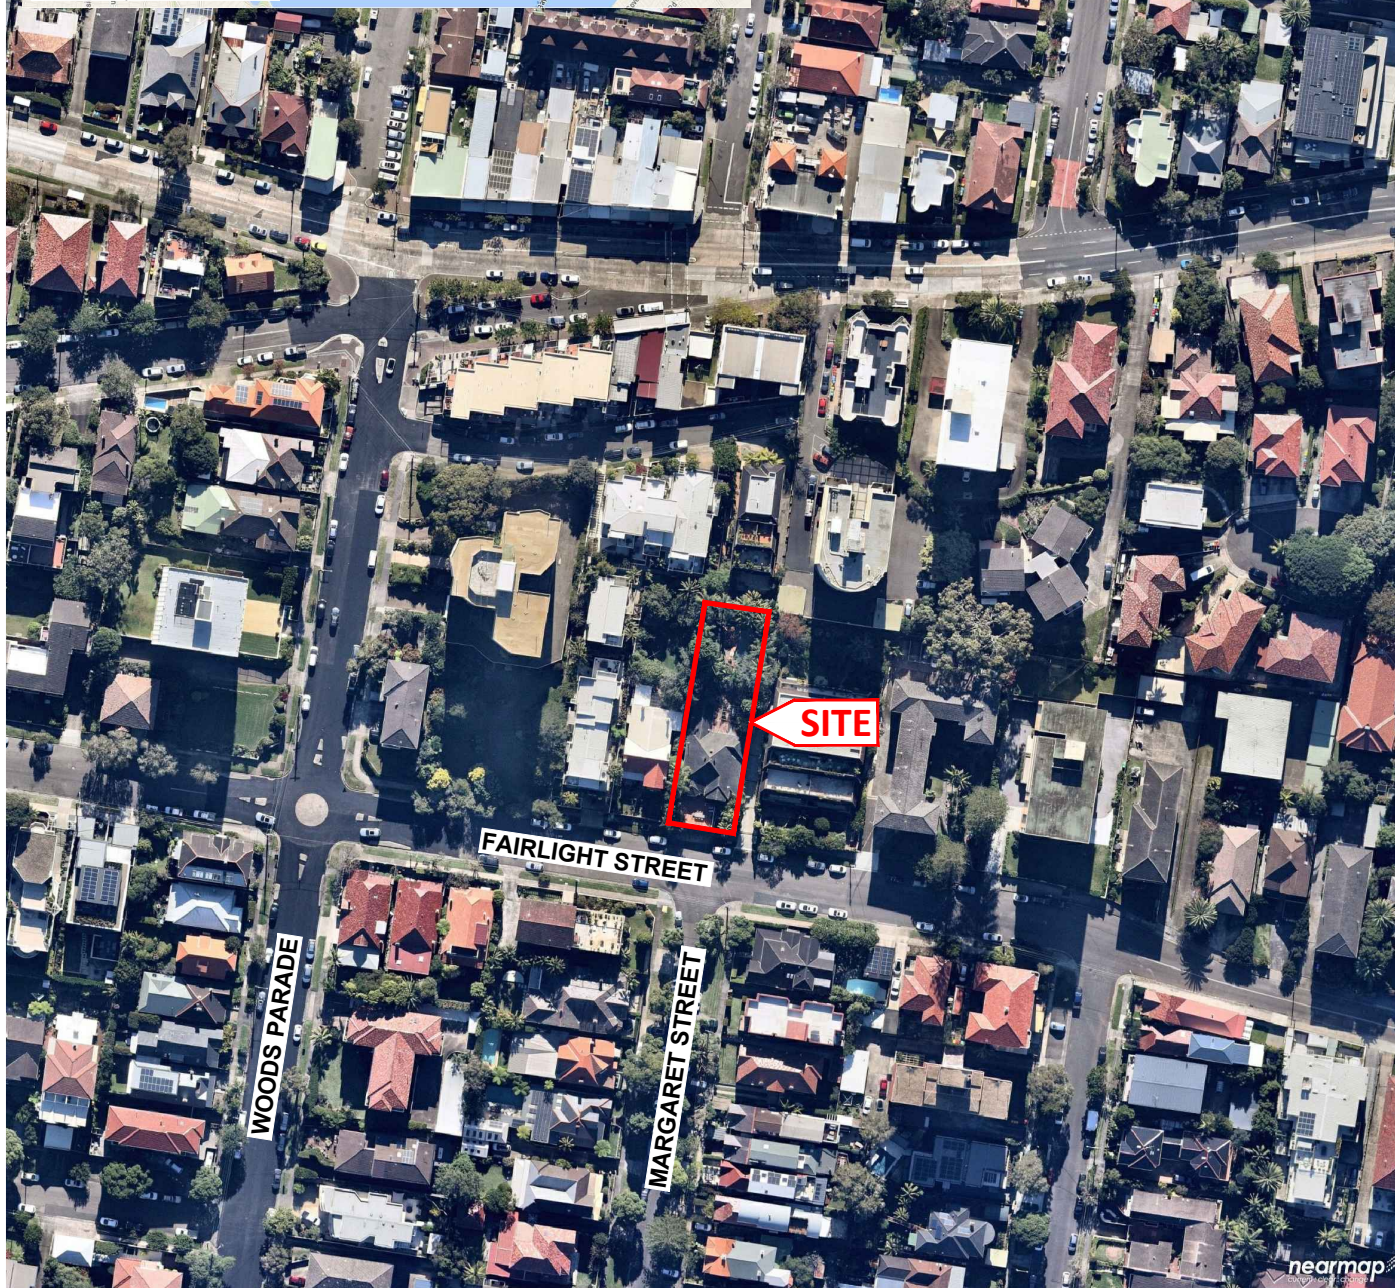
Title: SITE LOCATION PLAN	
Location: 30 FAIRLIGHT STREET, FAIRLIGHT, NSW	
Report No: 34216B	Figure No: 1
JKGeotechnics

AERIAL IMAGE SOURCE: MAPS.AU.NEARMAP.COM

This report presents the results of a geotechnical slope stability risk assessment for the proposed residential development at 30 Fairlight Street, Fairlight, NSW. The location of the site is shown in Figure 1. The assessment was commissioned by Aaron Hatch of 30 Fairlight Pty Ltd and was carried out in accordance with our proposal dated 25 May 2021, Ref: P54225B.

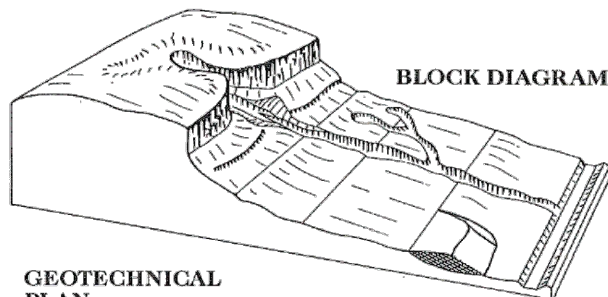
GEOTECHNICAL PLAN

EXAMPLE OF USE OF TOPOGRAPHIC SYMBOLS:

A walkover inspection of the site was completed by our Principal Geotechnical Engineer, Mr Daniel Bliss, on 25 June 2021. The attached Figure 2 presents a geotechnical sketch plan showing the principal geotechnical features present at the site. Figure 2 is based on the survey plan by Usher & Company (Ref: 6348-DET, dated 31/3/21). Additional features on Figure 2 have been measured by hand held inclinometer and tape measurement techniques and hence are only approximate. Should any of the features be critical to the proposed development, we recommend they be located more accurately using instrumental survey techniques. Figure 3 defines the mapping symbols used.

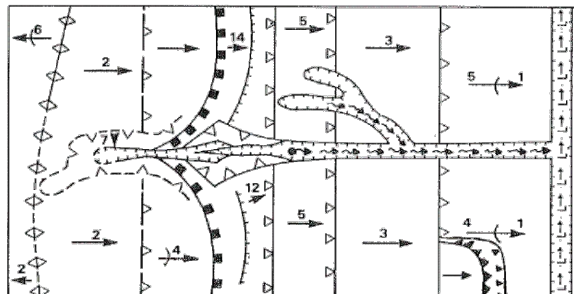
Title:	GEOTECHNICAL MAPPING SYMBOLS	
Location:	30 FAIRLIGHT STREET, FAIRLIGHT, NSW	
Report No:	34216B	Figure No: 3
JKGeotechnics

(After Gardiner, V & Dackombe, R. V.
(1983), Geomorphological Field Manual;
George Allen & Unwin).

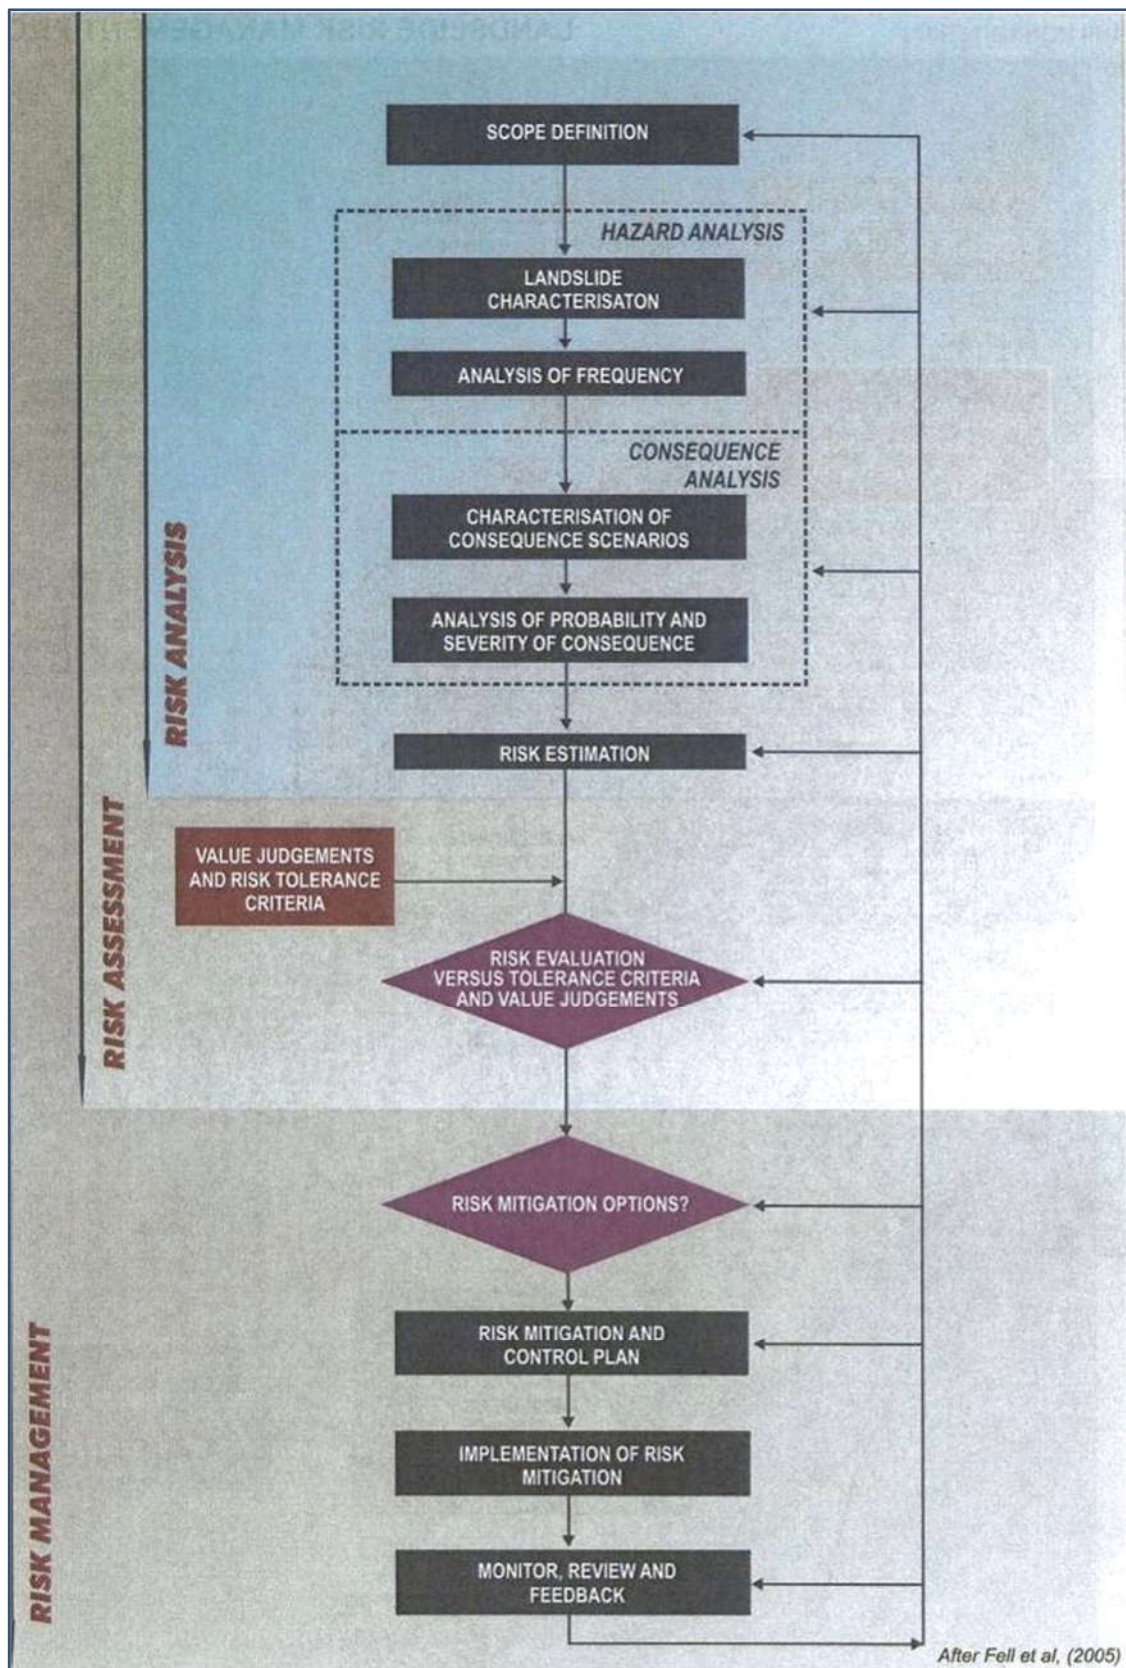
FIGURE A1: Flowchart for Landslide Risk Management.

This figure is an extract from GUIDELINE FOR LANDSLIDE SUSCEPTIBILITY, HAZARD AND RISK ZONING FOR LAND USE PLANNING, as presented in Australian Geomechanics Vol 42, No 1, March 2007, which discusses the matter more fully.

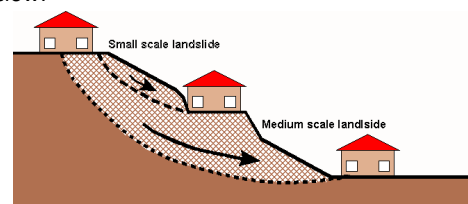
Figure 1

Rotational or circular slip failures (Figure 1) - can occur on moderate to very steep soil and weathered rock slopes (Table 1). The sliding surface of the moving mass tends to be deep seated. Tension cracks may open at the top of the slope and bulging may occur at the toe. The ground may move in discrete "steps" separated by long periods without movement. More rapid movement may occur after heavy rain.

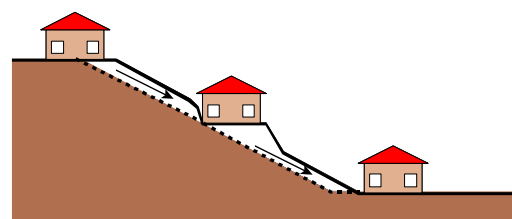
Figure 2

Translational slip failures (Figure 2) - tend to occur on moderate to very steep slopes (Table 1) where soil, or weak rock, overlies stronger strata. The sliding mass is often relatively shallow. It can move, or deform slowly (creep) over long periods of time. Extensive linear cracks and hummocks sometimes form along the contours. The sliding mass may accelerate after heavy rain.

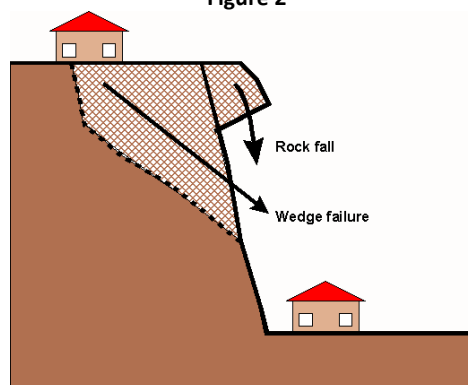
Figure 3

Wedge failures (Figure 3) - normally only occur on extreme slopes, or cliffs (Table 1), where discontinuities in the rock are inclined steeply downwards out of the face.

Rock falls (Figure 3) - tend to occur from cliffs and overhangs (Table 1).

Cliffs may remain, apparently unchanged, for hundreds of years. Collections of boulders at the foot of a cliff may indicate that rock falls are ongoing. Wedge failures and rock falls do not "creep". Familiarity with a particular local situation can instil a false sense of security since failure, when it occurs, is usually sudden and catastrophic.

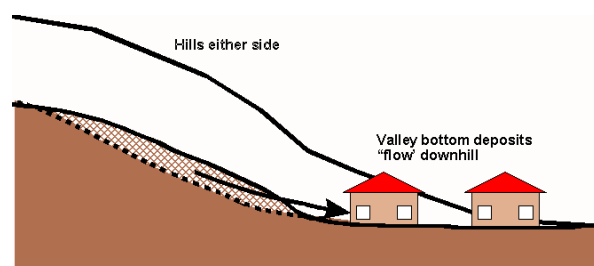
Figure 4

Debris flows and mud slides (Figure 4) - may occur in the foothills of ranges, where erosion has formed valleys which slope down to the plains below. The valley bottoms are often lined with loose eroded material (debris) which can "flow" if it becomes saturated during and after heavy rain. Debris flows are likely to occur with little warning; they travel a long way and often involve large volumes of soil. The consequences can be devastating.

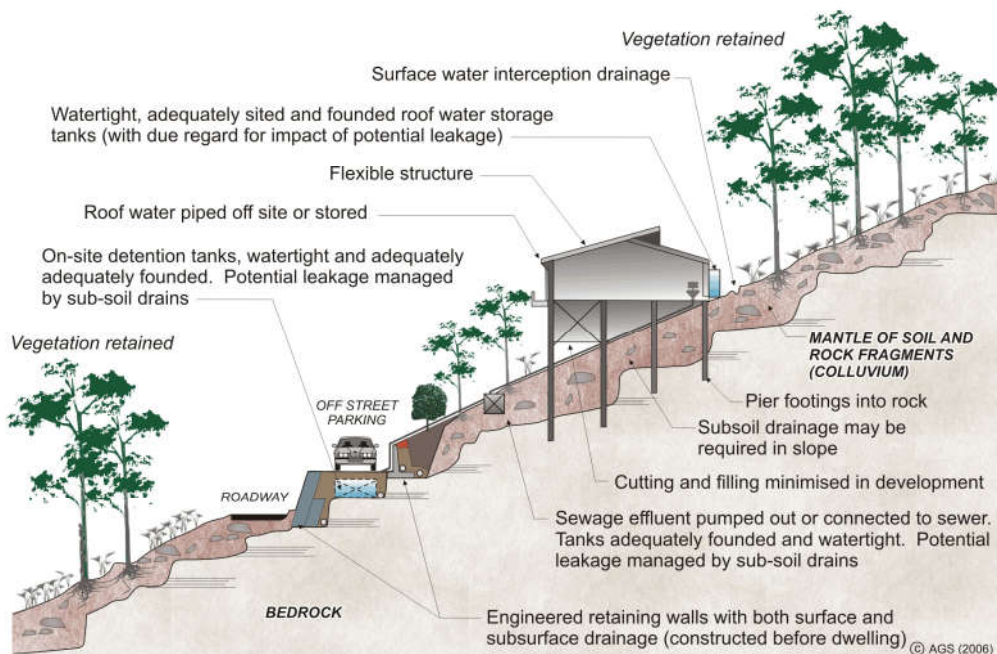
EXAMPLES FOR **GOOD** HILLSIDE CONSTRUCTION PRACTICE

WHY ARE THESE PRACTICES GOOD?

Roadways and parking areas - are paved and incorporate kerbs which prevent water discharging straight into the hillside (GeoGuide LR5).

Sensible development practices are required when building on hillsides, particularly if the hillside has more than a low risk of instability (GeoGuide LR7). Only building techniques intended to maintain, or reduce, the overall level of landslide risk should be considered. Examples of good hillside construction practice are illustrated below.

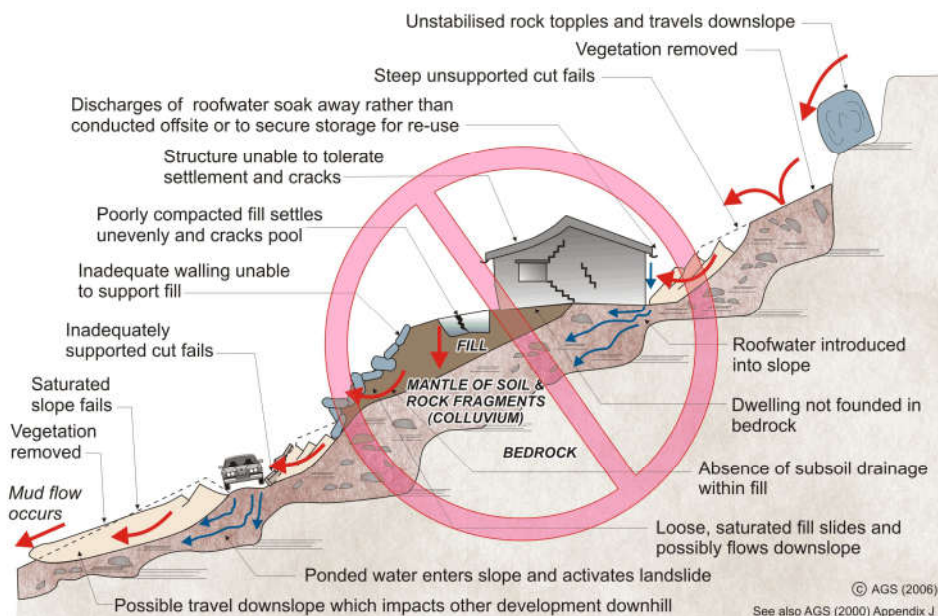
EXAMPLES FOR **POOR** HILLSIDE CONSTRUCTION PRACTICE

WHY ARE THESE PRACTICES POOR?

Roadways and parking areas - are unsurfaced and lack proper table drains (gutters) causing surface water to pond and soaks into the ground.
