Report on
Desktop Groundwater Assessment

Proposed Industrial Development
100 South Creek Road, Cromer

Prepared for
EG Funds Management Pty Ltd

Project 86951.00
October 2019

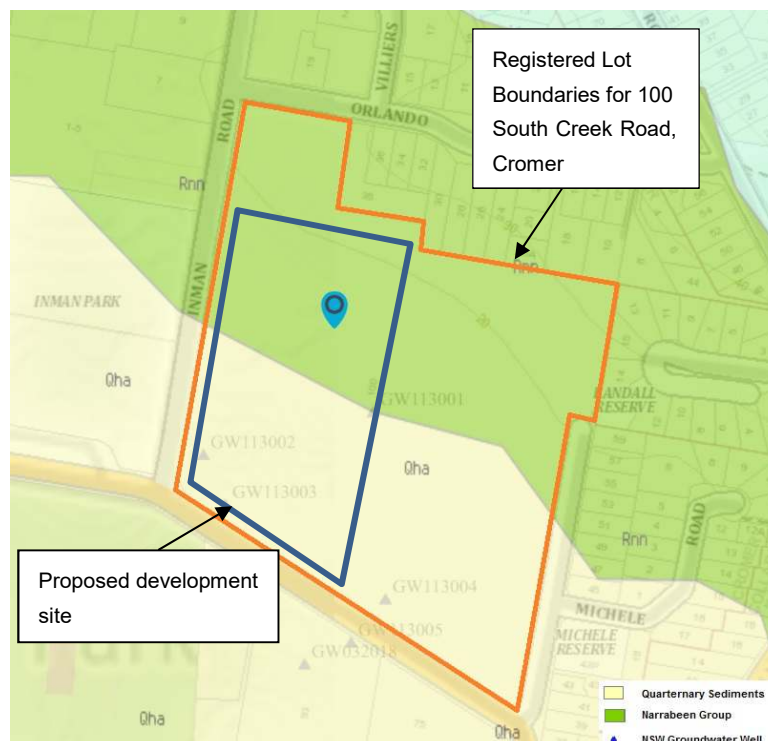
Figure 1. Excerpt from geological map sheet 9130 for Sydney.

Reference to the Sydney 1:100 000 Series Geological Map Sheet (9130) indicates that the site is on or near a geological boundary. The upper portion of the site, over the northern half of the broader site, is shown to be underlain by Narrabeen Group rocks of Triassic age (comprising interbedded laminite, shale, quartz and sandstone) and the southern portion is underlain by alluvial stream deposits of Quaternary age (comprising silty to peaty quartz sand, silt and clay). An excerpt from the geological map is given in Figure 1.

The location of registered groundwater wells is also shown in Figure 1. For the four registered wells located on the site and drilled in 2010, no measurement of the standing water level is recorded on the records held by Water NSW. All boreholes (i.e. wells) were drilled to a depth of 7.5 m.

Borehole and core penetration testing (CPT) investigations carried out at the site suggest that the geological boundary between areas underlain by bedrock and alluvium is located further to the north than shown on the geological map (and Figure 1), with relatively deep soils encountered over most of the proposed building footprint.

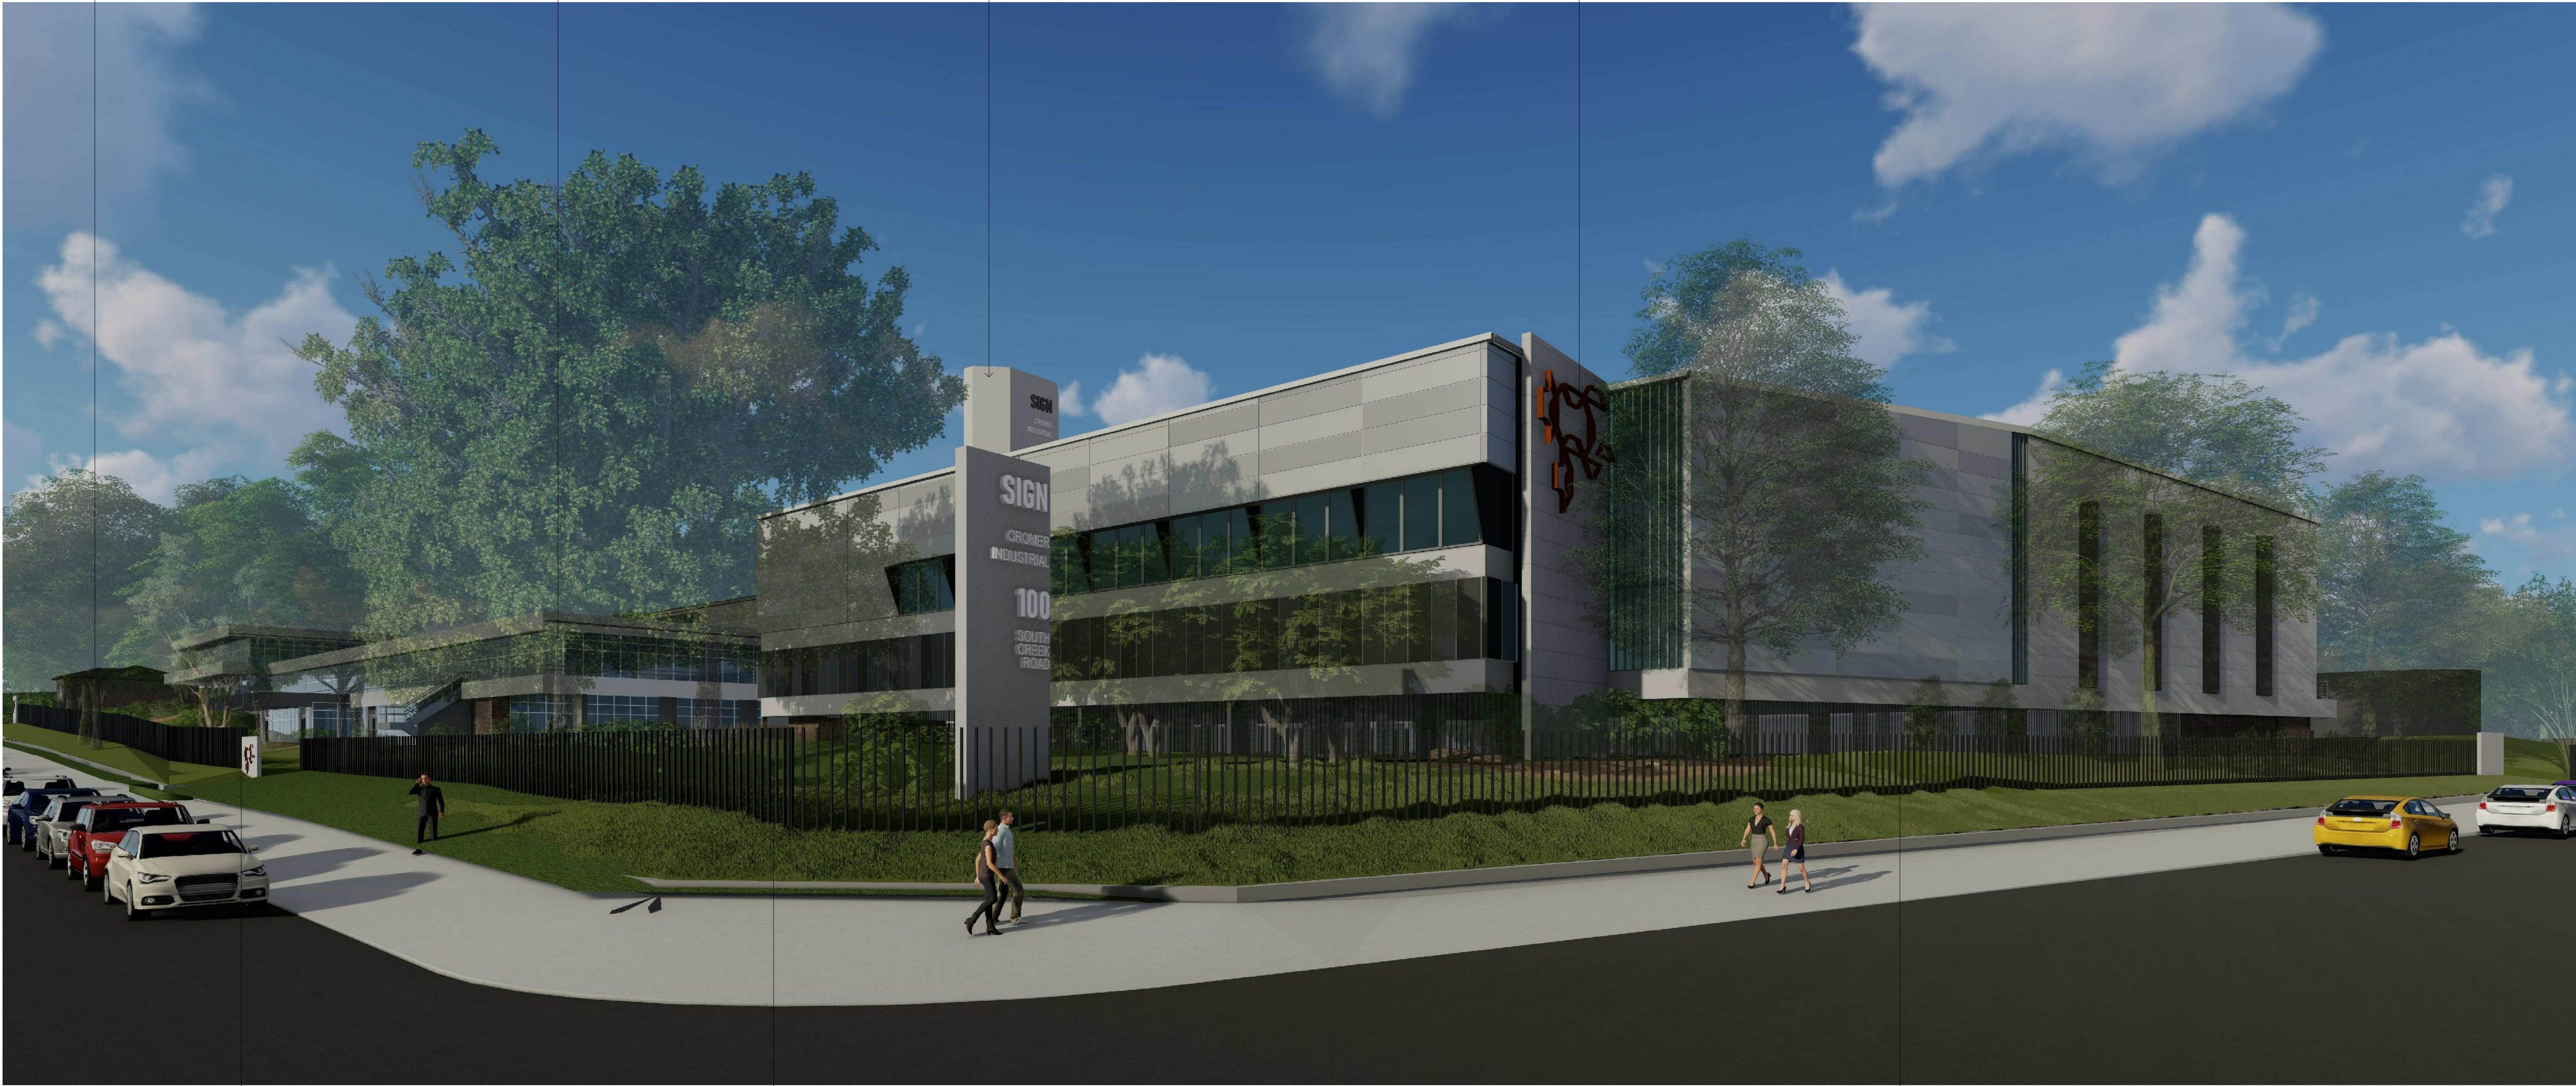
IMAGE 01 - NOTES

EXISTING HEXAGONAL TOWER ELEMENT. POTENTIAL FOR ADAPTIVE RE-USE AT BASE OF TOWER, I.e. WAREHOUSE OFFICES, SUBJECT TO FURTHER INVESTIGATION.

POTENTIAL INTERPRETATIVE FACADE TREATMENT + ARTWORK, SUBJECT TO FURTHER INVESTIGATION.

POSSIBLE LOCATION FOR PERMANENT CULTURAL HERITAGE INTERPRETATIVE DISPLAY AND ARTWORK

RETENTION, CONSERVATION AND SYMPATHETIC EMBELLISHMENT OF EXISTING LANDSCAPE SETTING ALONG INMAN ROAD FRONTAGE

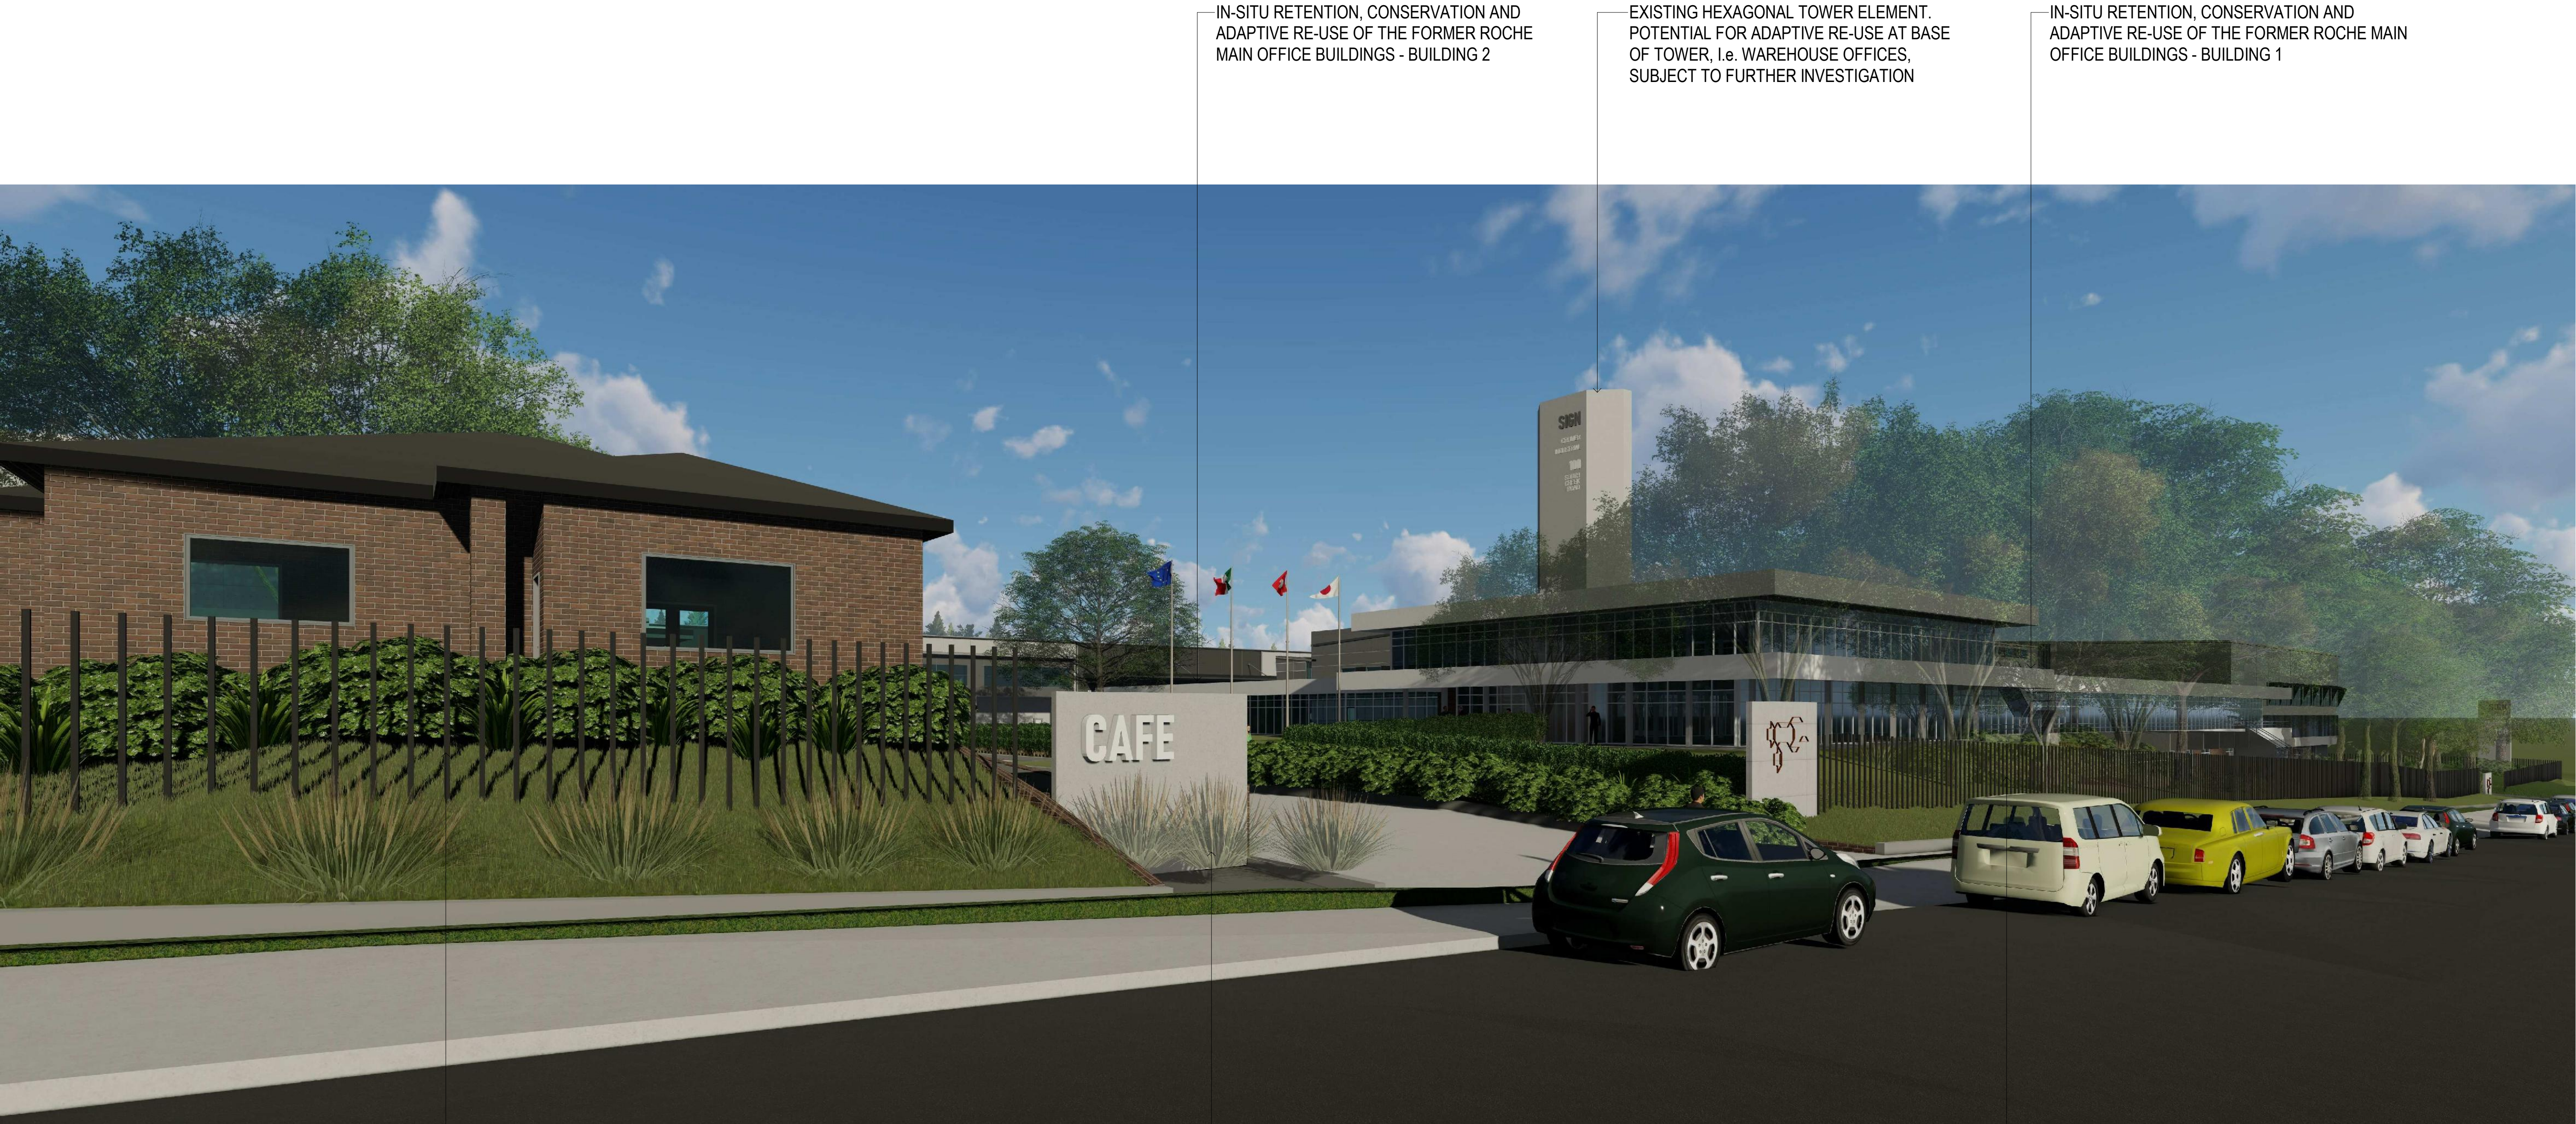
IN-SITU RETENTION, CONSERVATION AND ADAPTIVE RE-USE OF THE FORMER ROCHE MAIN OFFICE BUILDINGS - BUILDING 2

EXISTING HEXAGONAL TOWER ELEMENT. POTENTIAL FOR ADAPTIVE RE-USE AT BASE OF TOWER, I.e. WAREHOUSE OFFICES, SUBJECT TO FURTHER INVESTIGATION

EXISTING BUILDING OUTLINE SHOWN
DOTTED IN RED. IT IS APROX. 4m IN
FRONT OF THE PROPOSED BUILDING

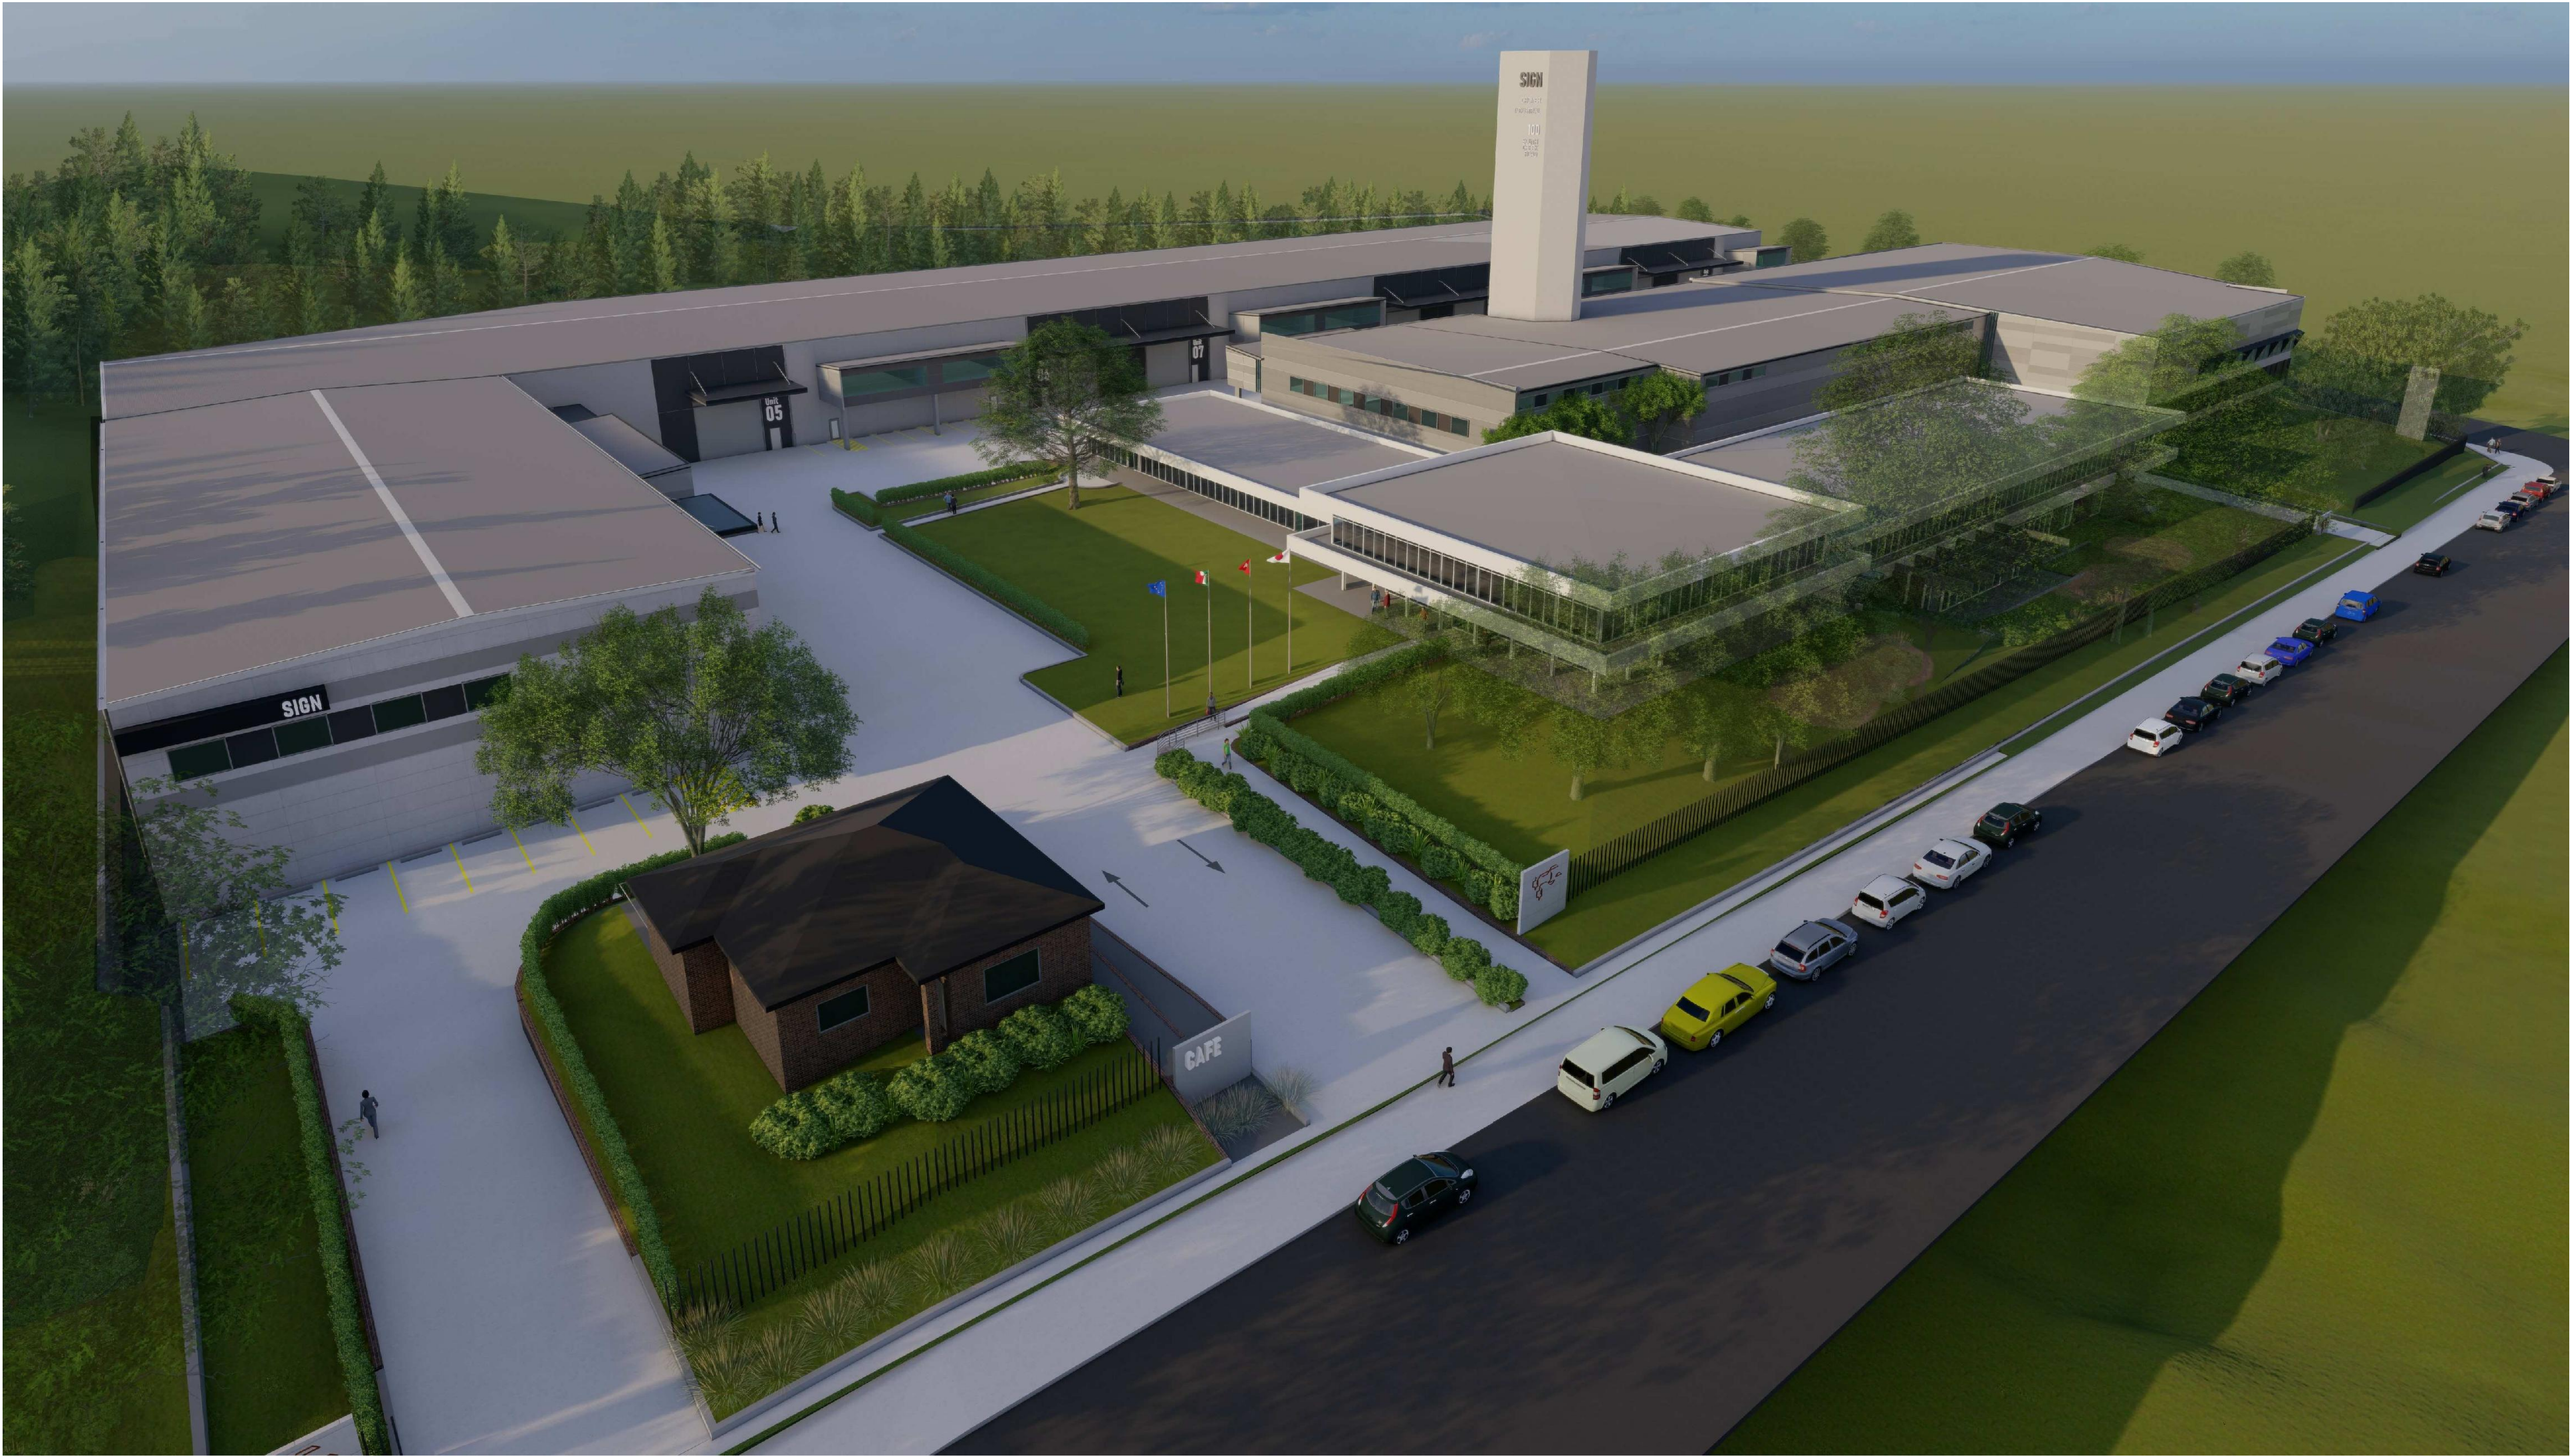
IMAGE 07

- AREA BETWEEN 0
AND 1 mt ABOVE
11 MTS HEIGHT
- AREA BETWEEN 1
AND 2 mts ABOVE
11 MTS HEIGHT
- AREA BETWEEN 2
AND 3 mts ABOVE
11 MTS HEIGHT
