### **Preliminary Geotechnical Assessment**

For Alterations and Additions at 90 Birkley Road, Manly NSW

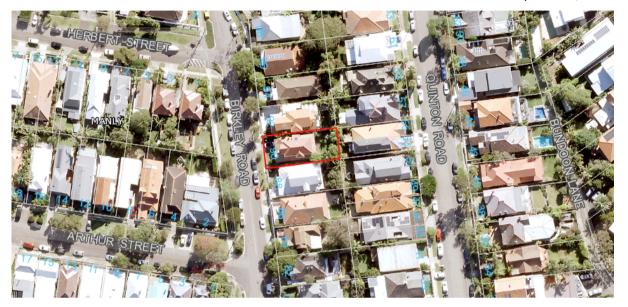
### Manly Landslide Risk Map

The site is not subject to specific landslip risk/geotechnical hazard mapping with reference to the Manly Landslip Risk Map (Image 1, below).
