**Hamptons by Rose Pty Ltd ATF Northern Beaches Trust  
15-23 Fisher Road, Dee Why - Geotechnical Investigation Report  
SYDGE271604AA**

# 15-23 Fisher Road, Dee Why - Geotechnical Investigation Report

Prepared for  
Hamptons by Rose Pty Ltd ATF Northern Beaches Trust

SYDGE271604AA

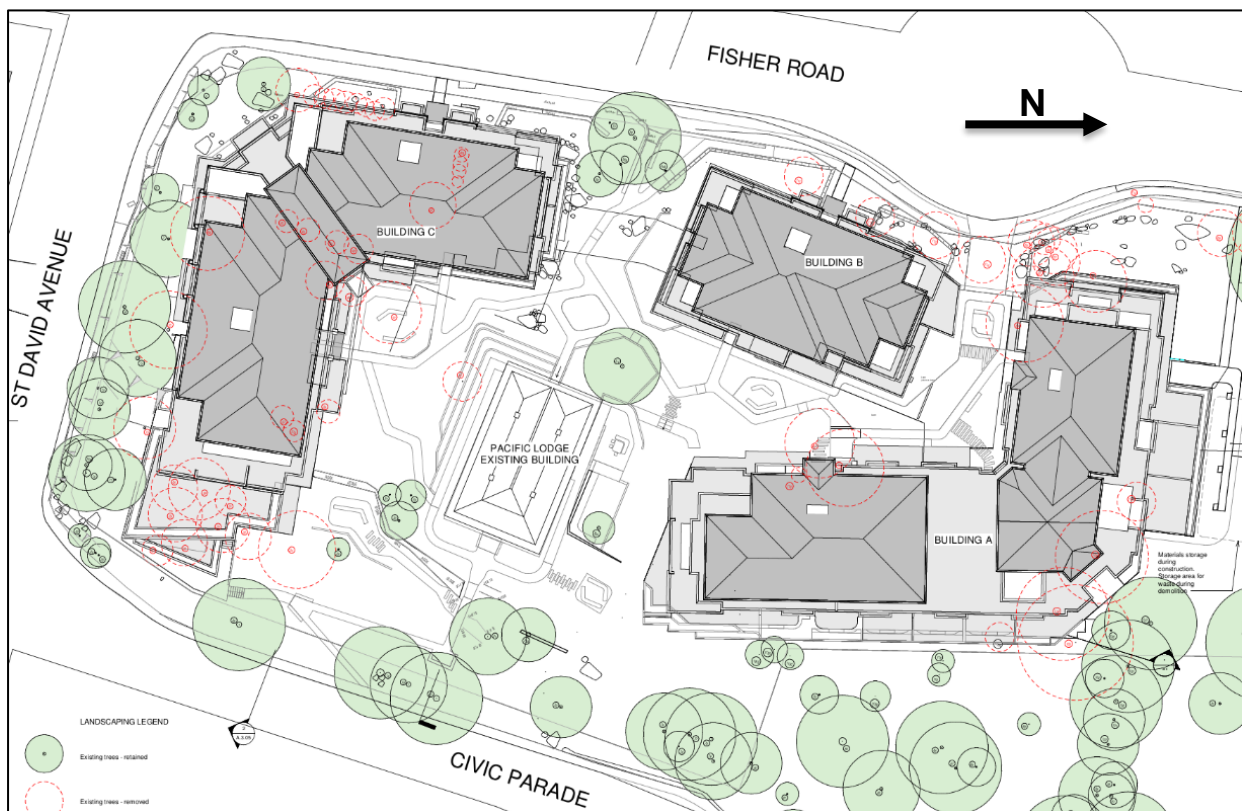
Figure 1 Proposed Development Plan

The three buildings, Buildings A, B and C comprise four to five storeys. A basement carpark will connect each of the three buildings, up to two levels below ground. The finished surface level (FSL)

Based on the supplied plans by Rose attached in Appendix A, Coffey understands that the proposed development includes the demolition of existing residential structures and construction of three multi-storey buildings with two levels of basement carparking. A historical building, the Pacific Lodge, located within the centre of site, will be retained as part of the development. Figure 1 is an extract from the DA approved architectural plans provided by Rose, illustrating the proposed development.

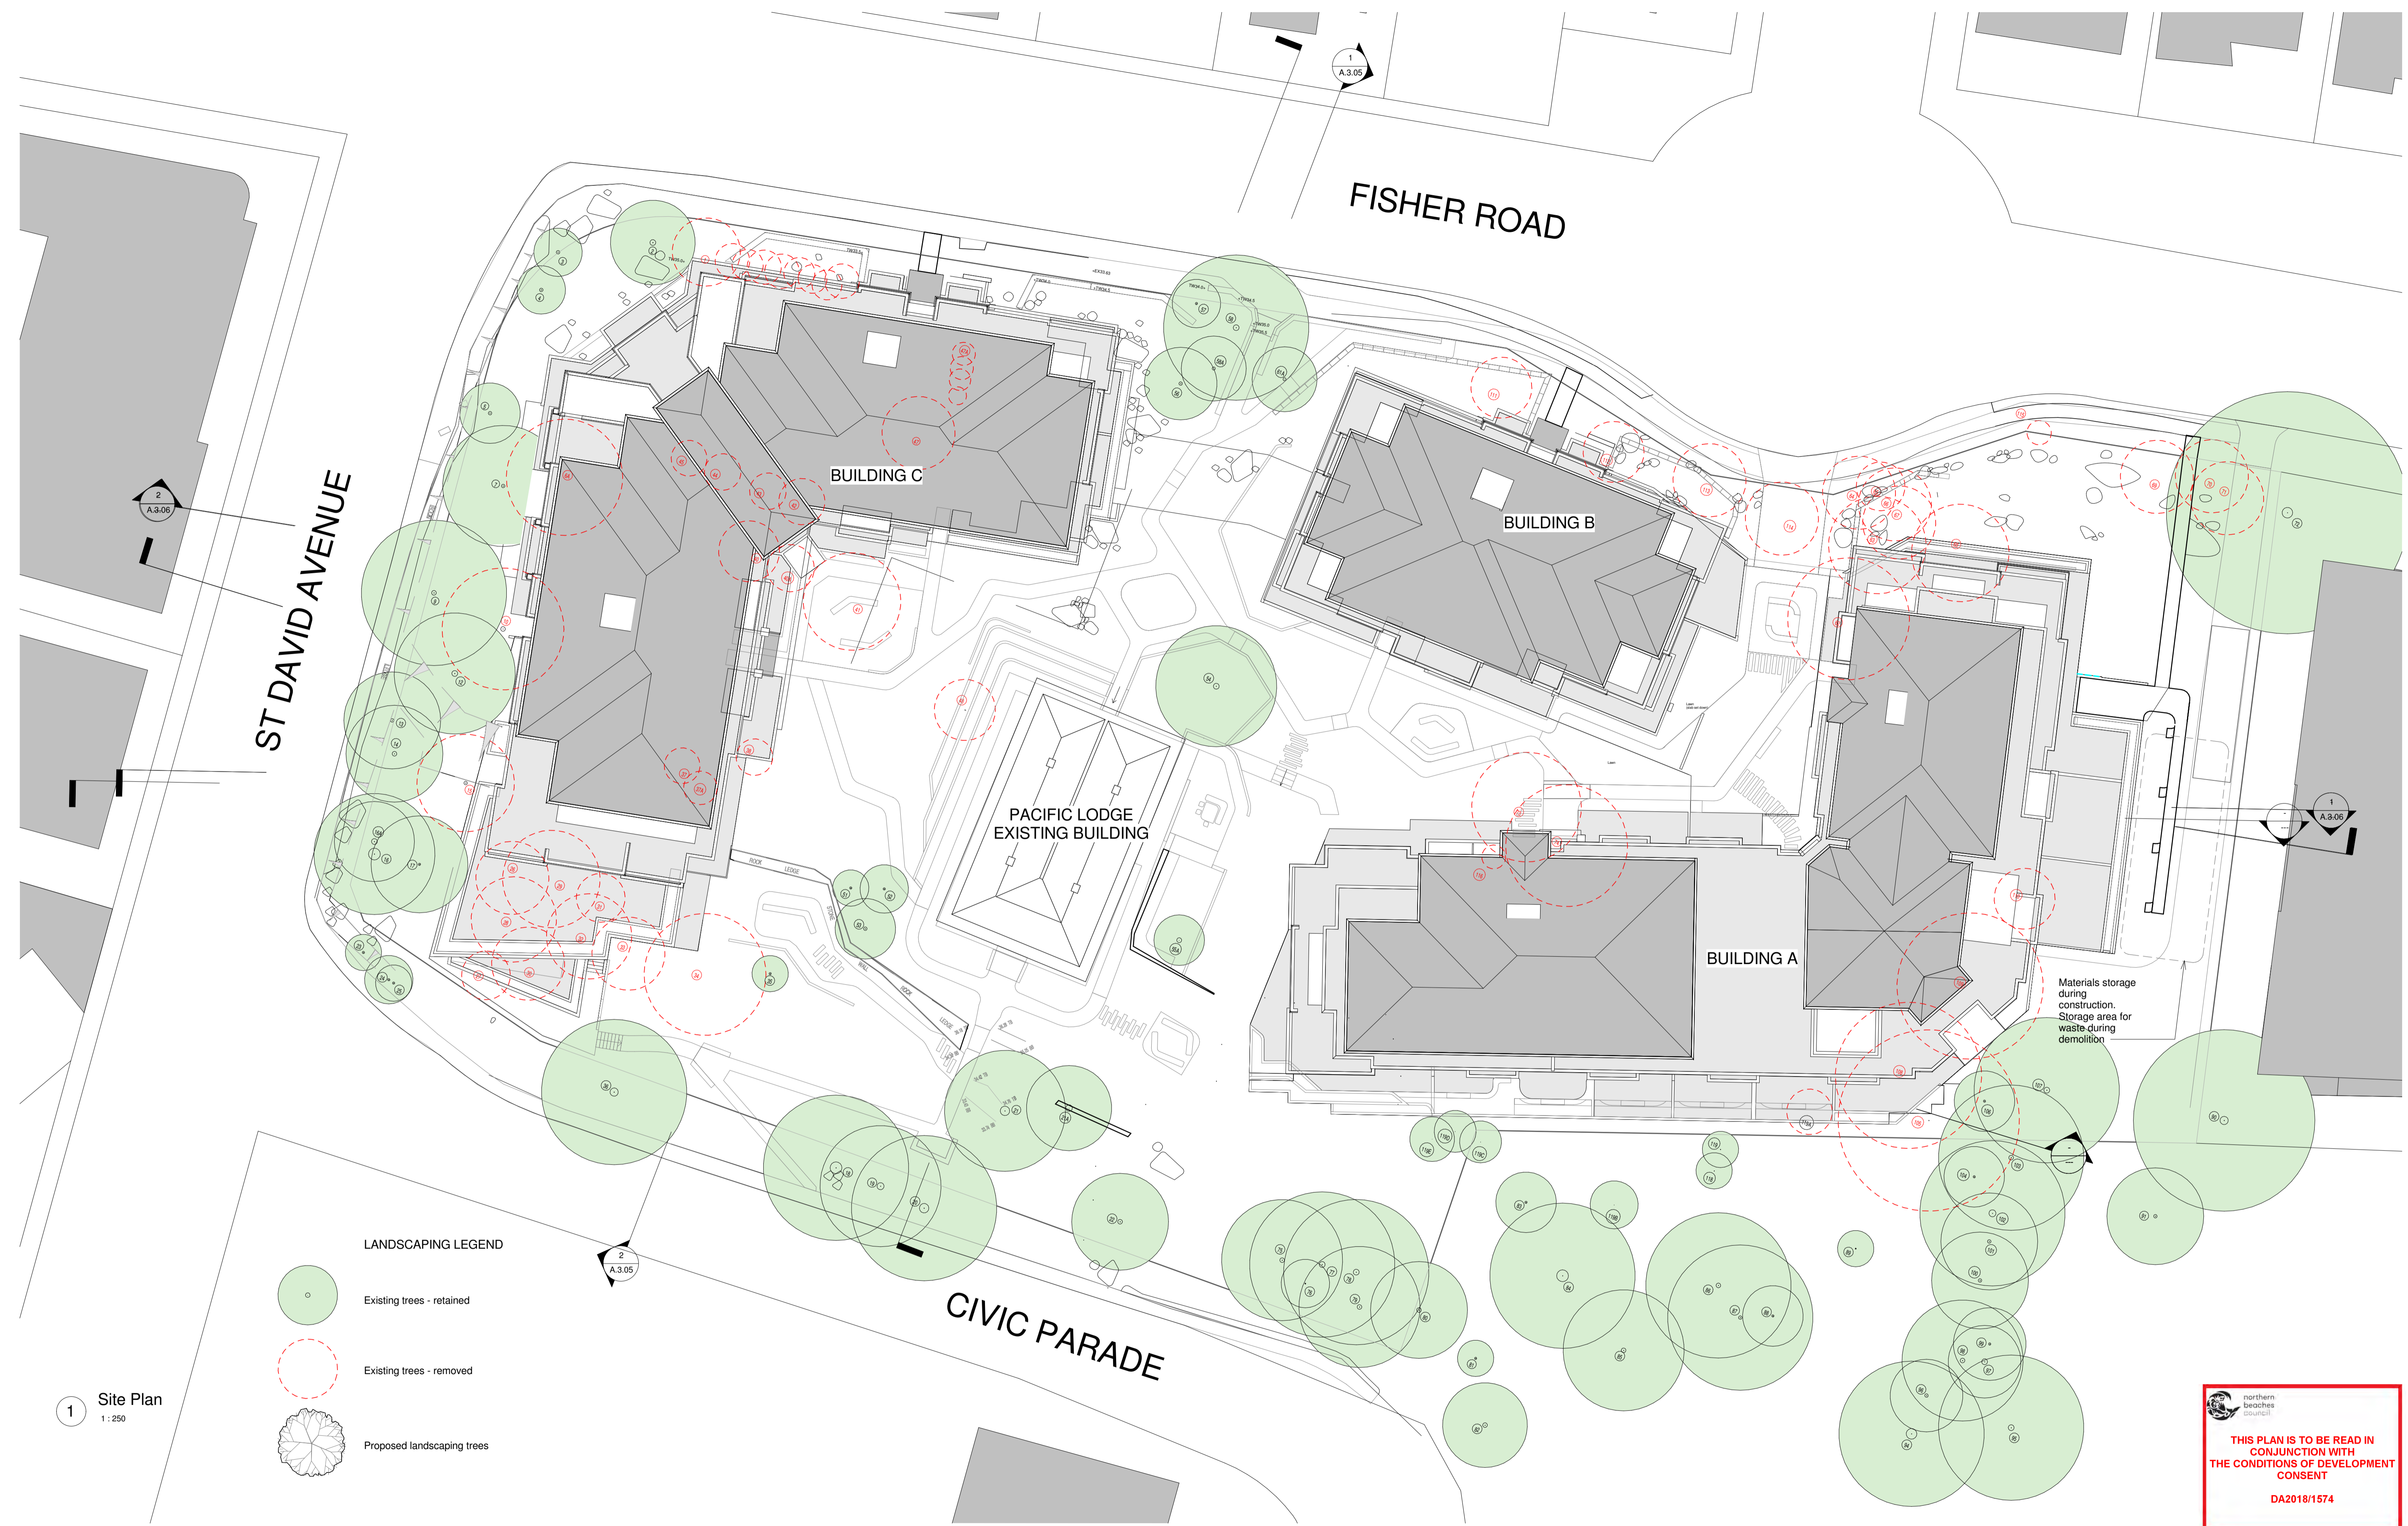
1 Site Plan  
1:250

Project	PROPOSED MIXED USE DEVELOPMENT	Drawing title	<b>SITE PLAN</b>	Status	DEVELOPMENT APPLICATION
Address	23 Fisher Road, Dee Why LOT 11 D.P.577062	Scale	1:250	Date	APRIL 2019
Client	Hamptons By Rose Pty Ltd	Drawn	RAD	Reviewed	Checked AO
Project No.	1607	Drawing No.	<b>A 1.01</b>	Revision	<b>C</b>

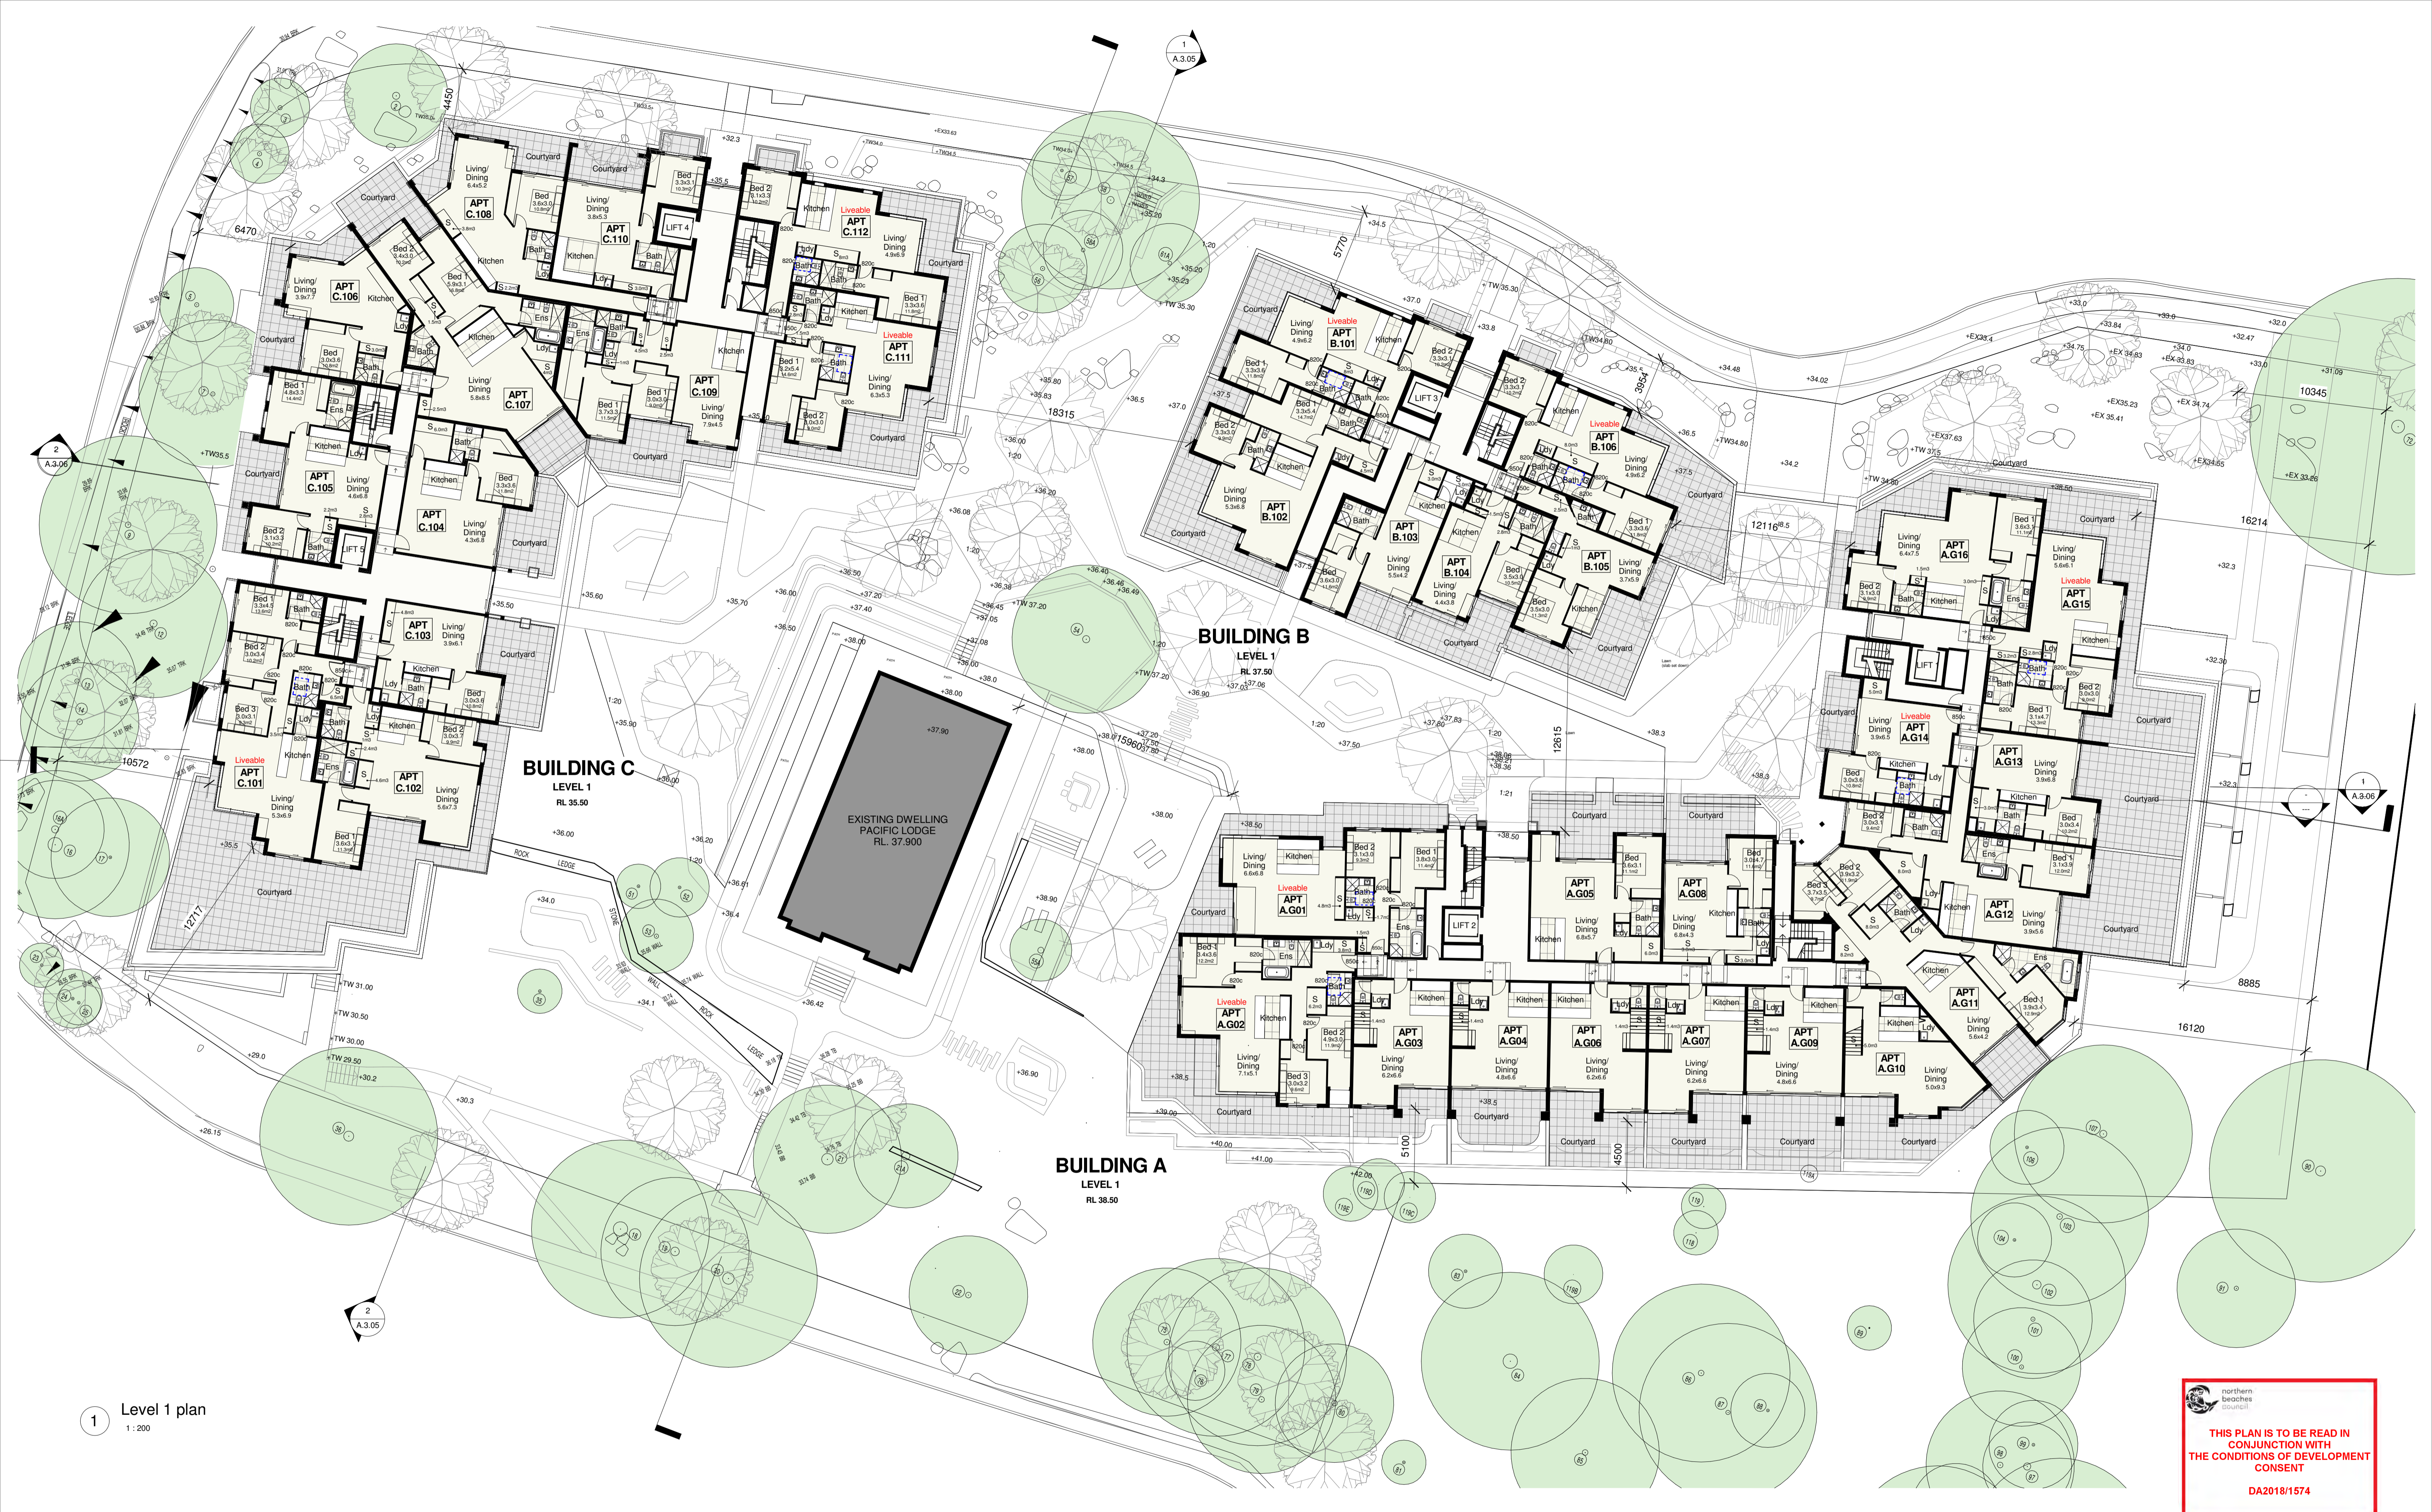
1 Level 1 plan  
1:200

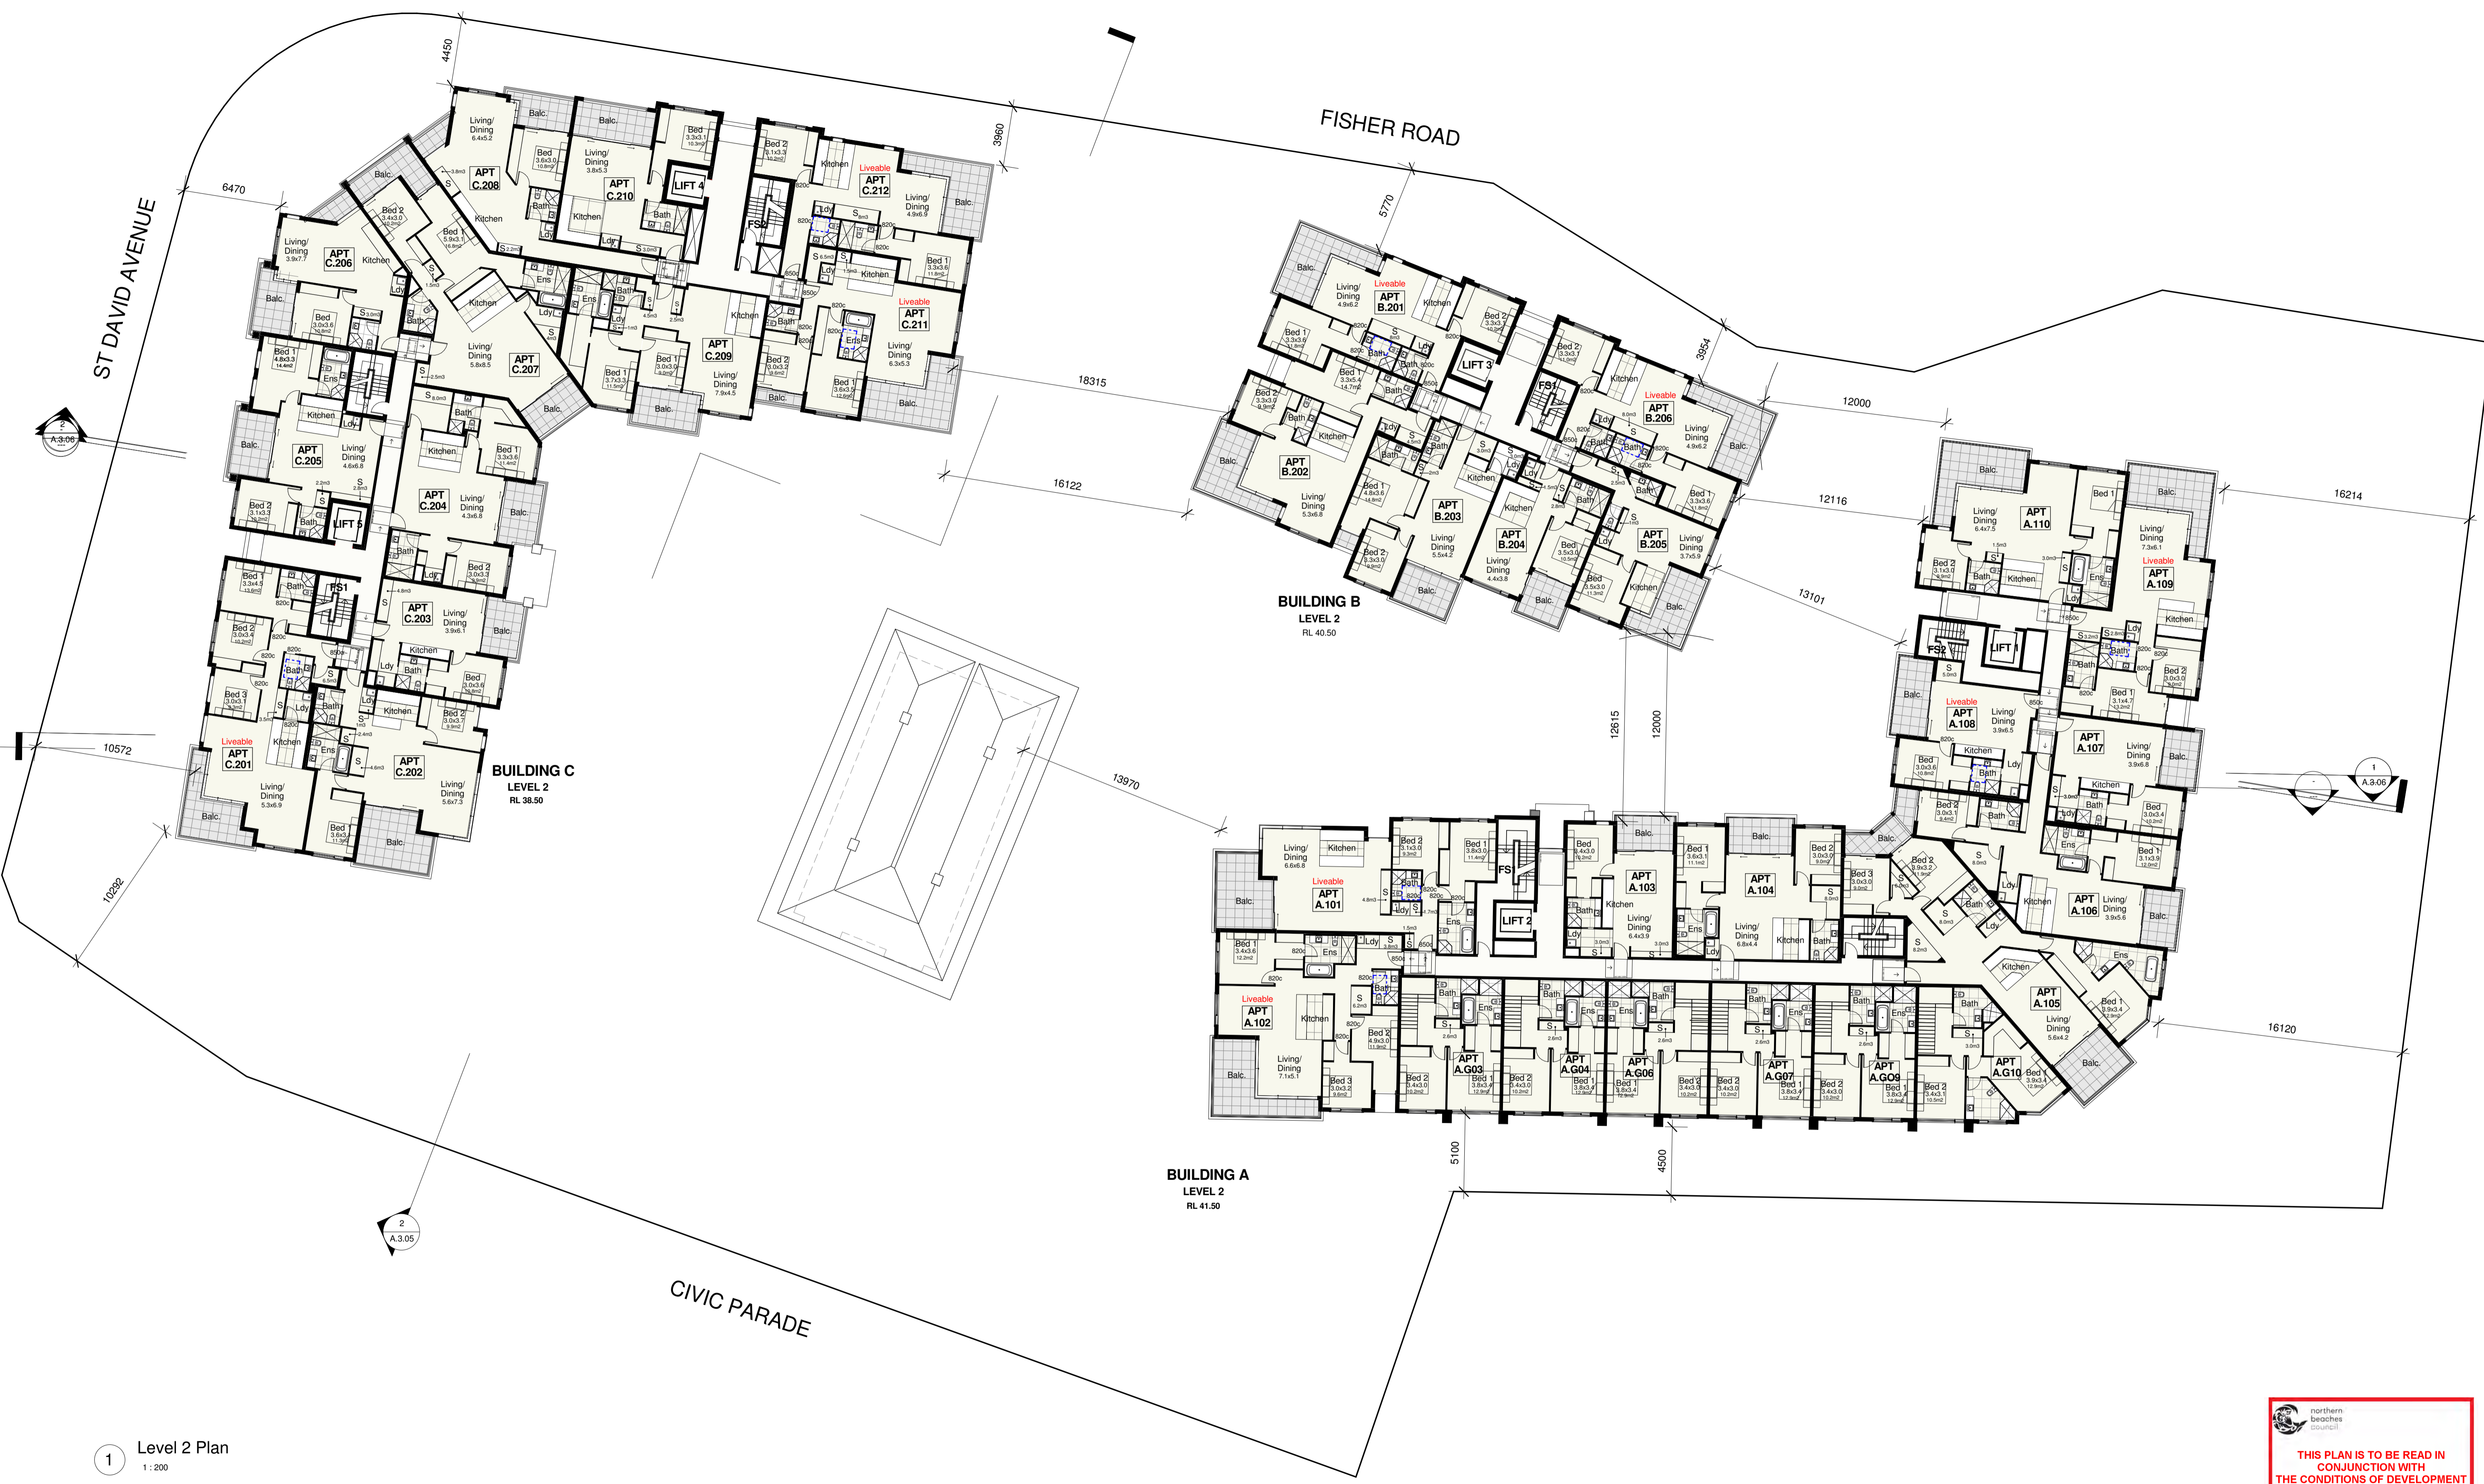
1 Level 2 Plan  
1:200

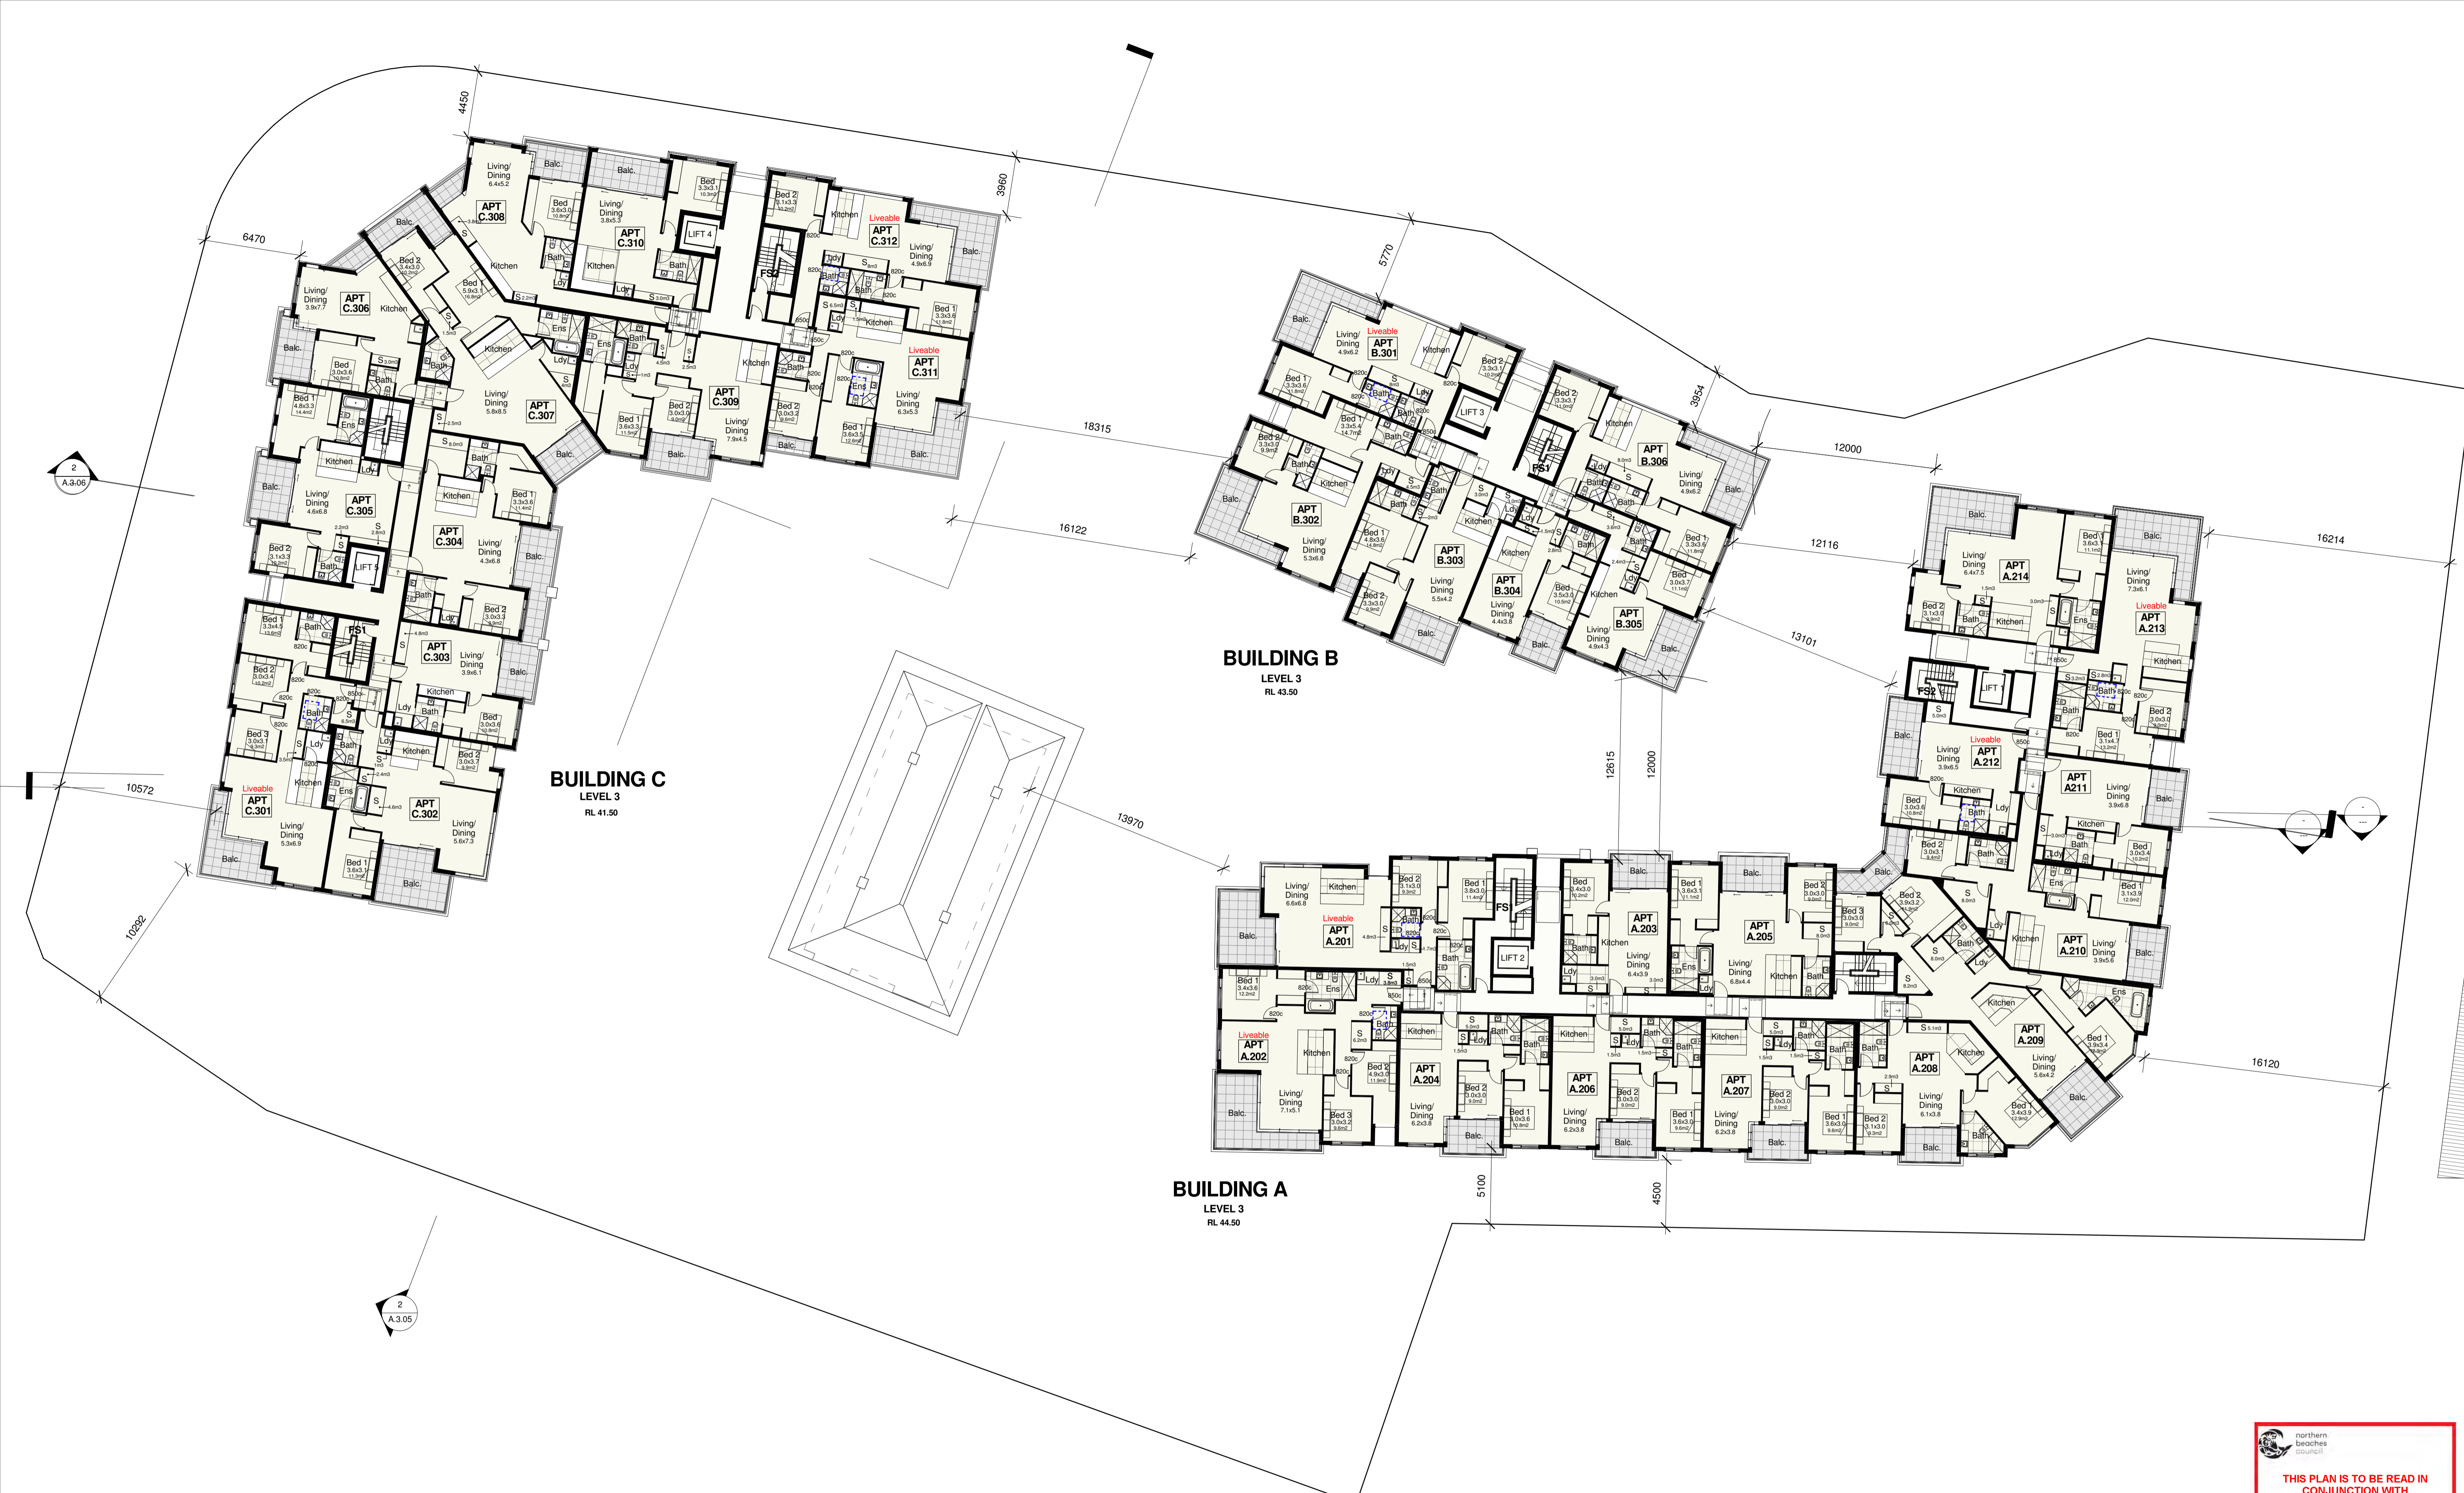
1 Level 3 plan  
1 : 200

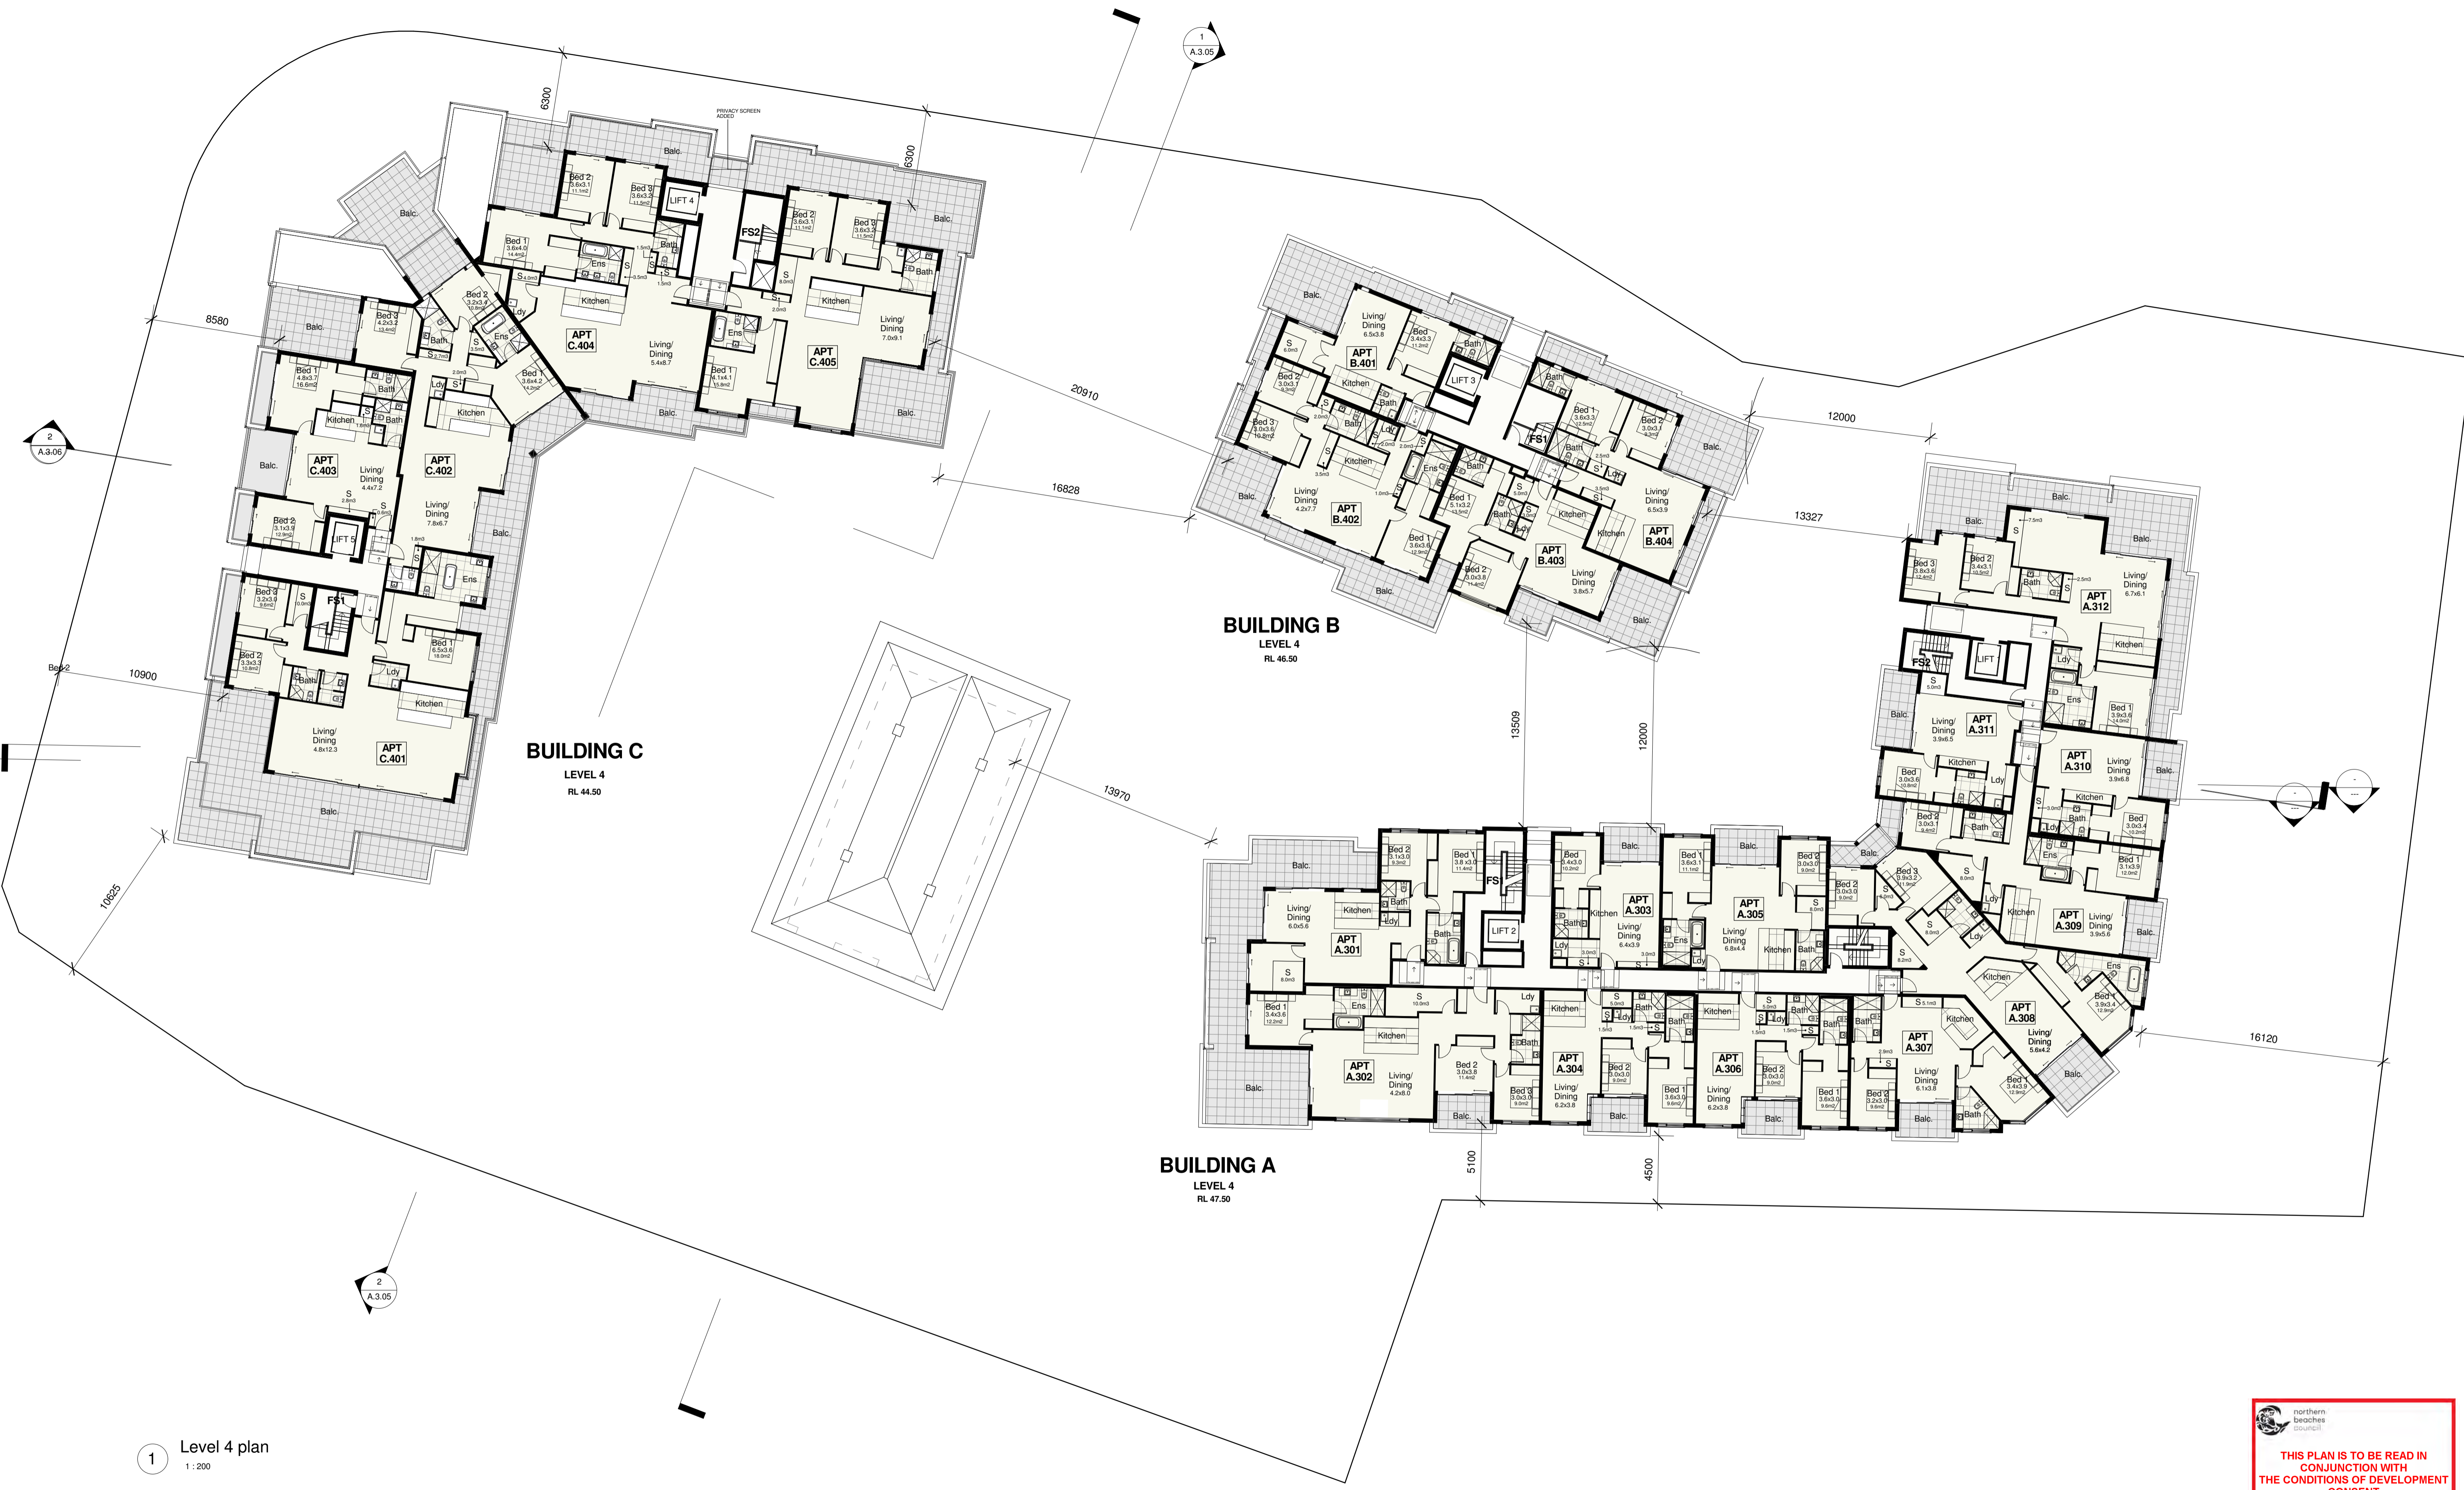
1 Level 4 plan  
1:200
