**Hamptons by Rose Pty Ltd ATF Northern Beaches Trust  
15-23 Fisher Road, Dee Why - Geotechnical Investigation Report  
SYDGE271604AA**

# 15-23 Fisher Road, Dee Why - Geotechnical Investigation Report

Prepared for  
Hamptons by Rose Pty Ltd ATF Northern Beaches Trust

SYDGE271604AA

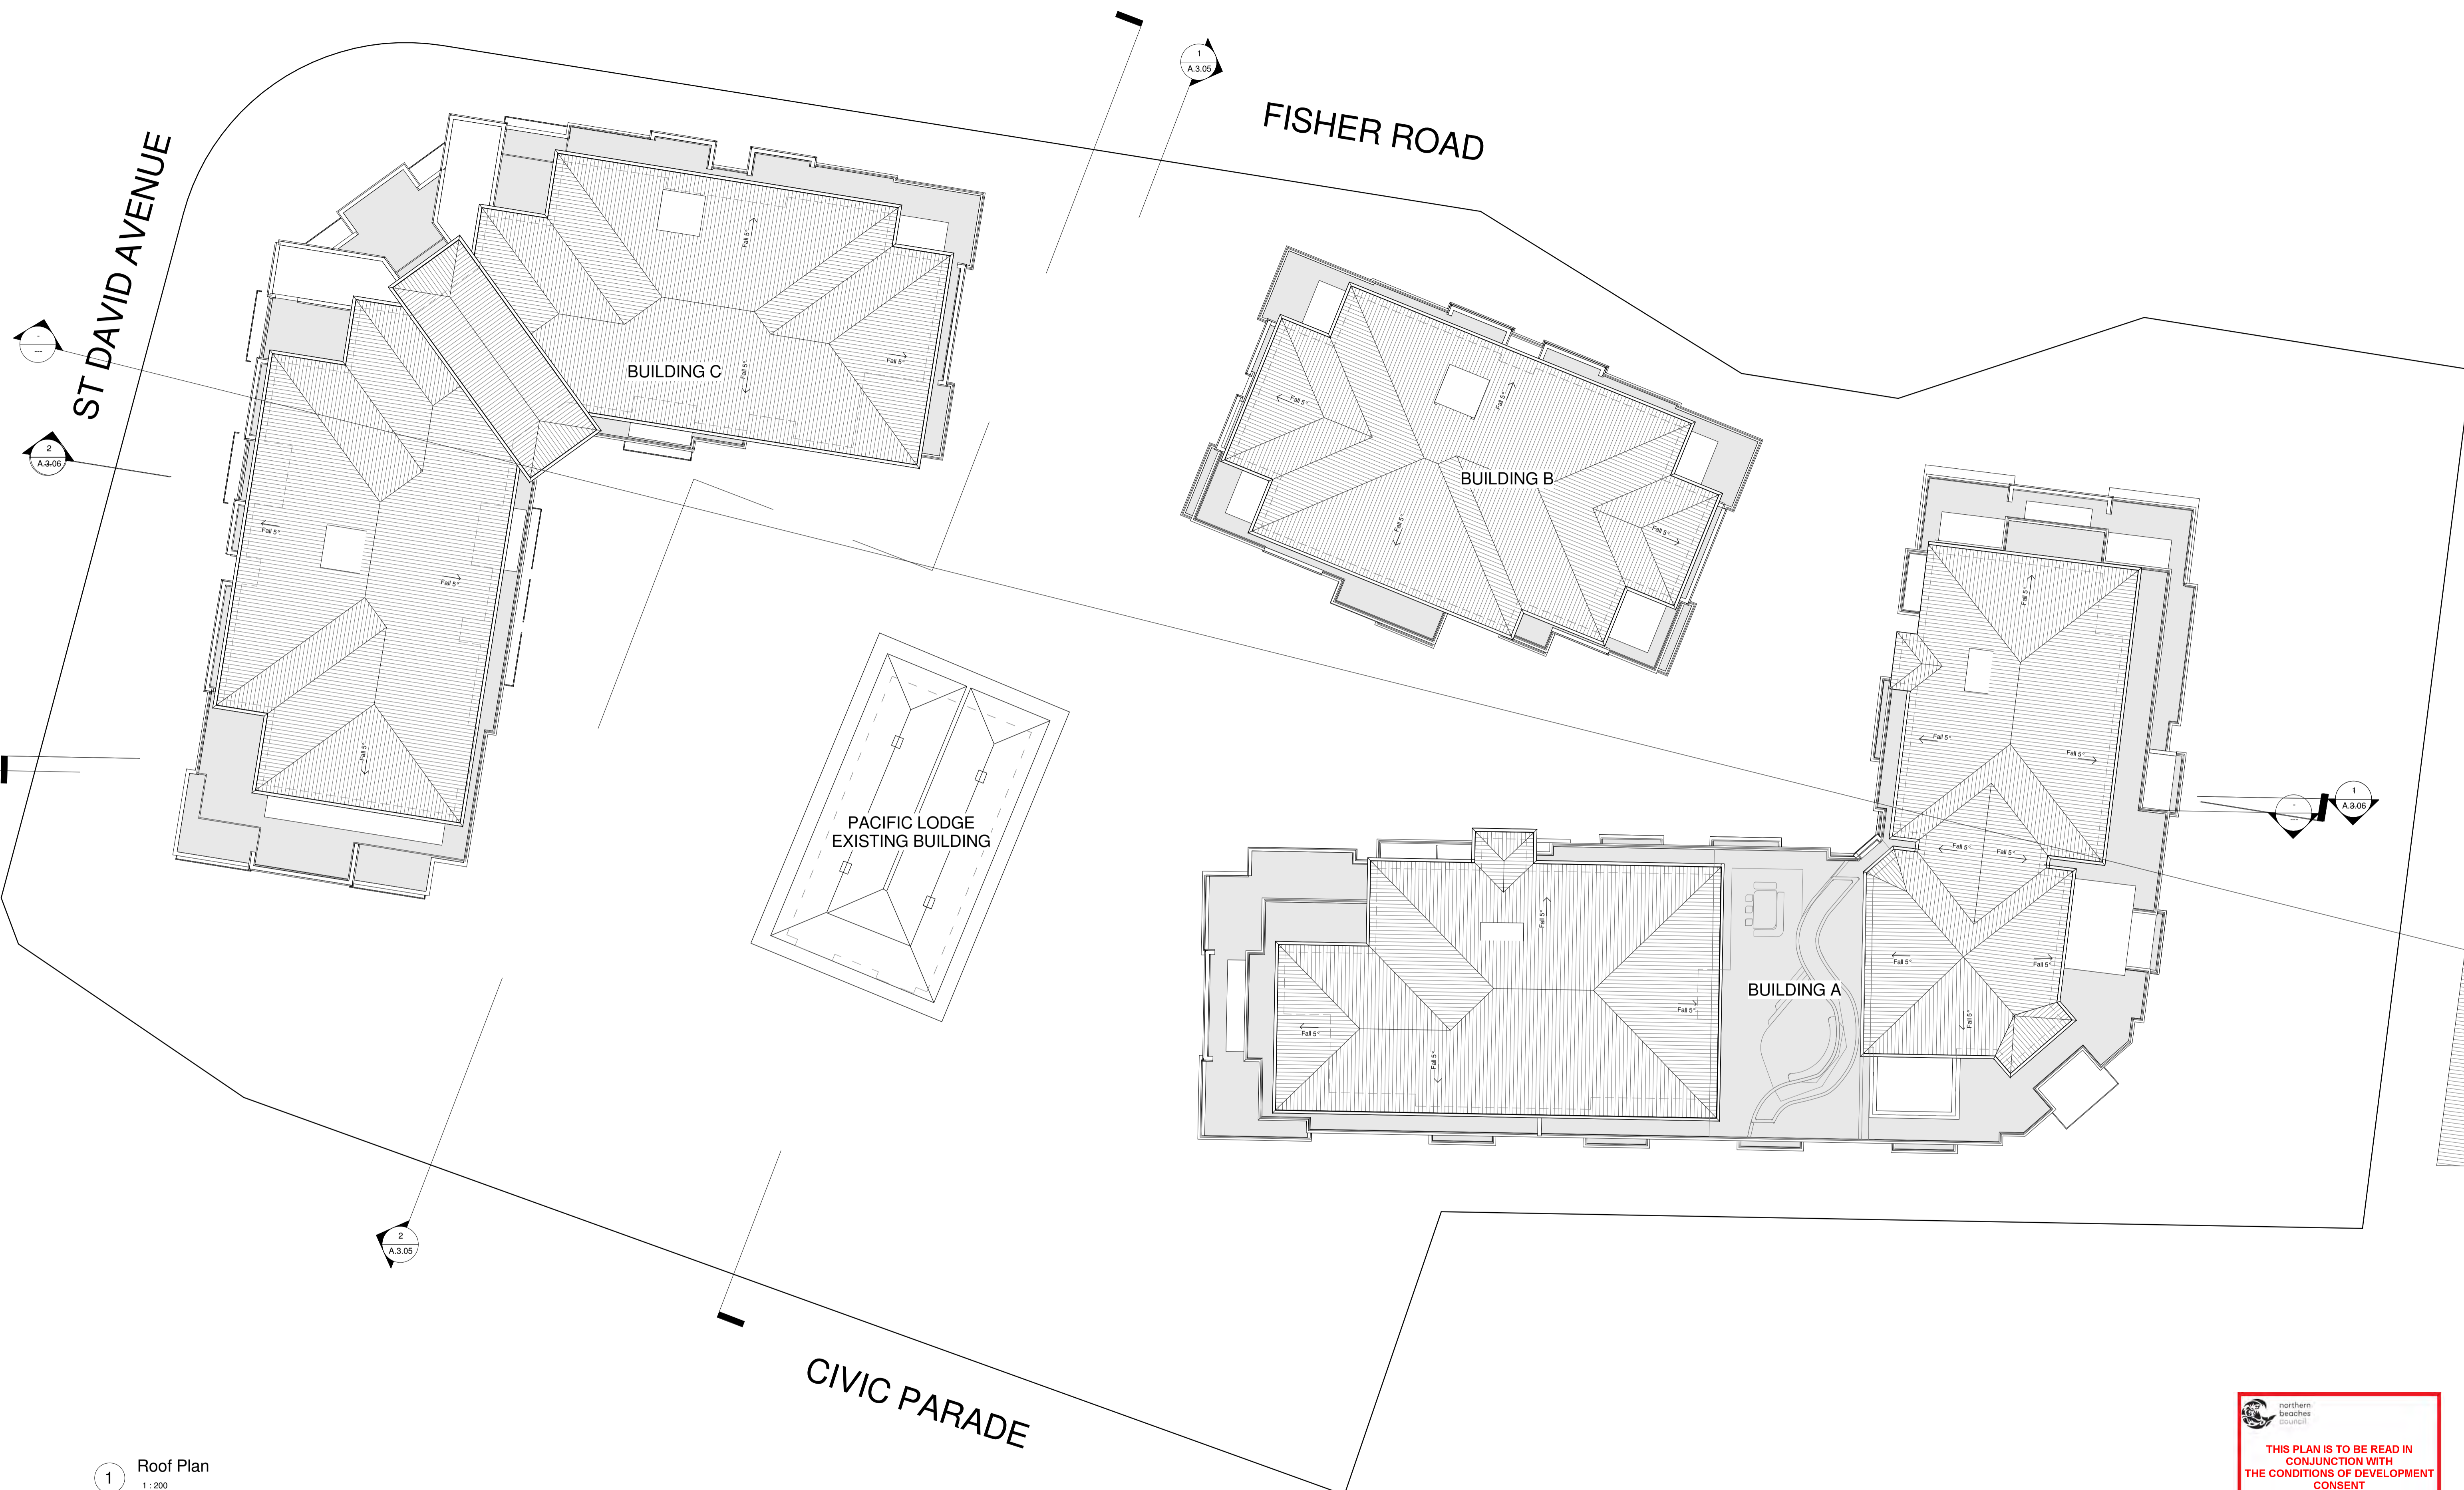
1 Roof Plan  
1:200

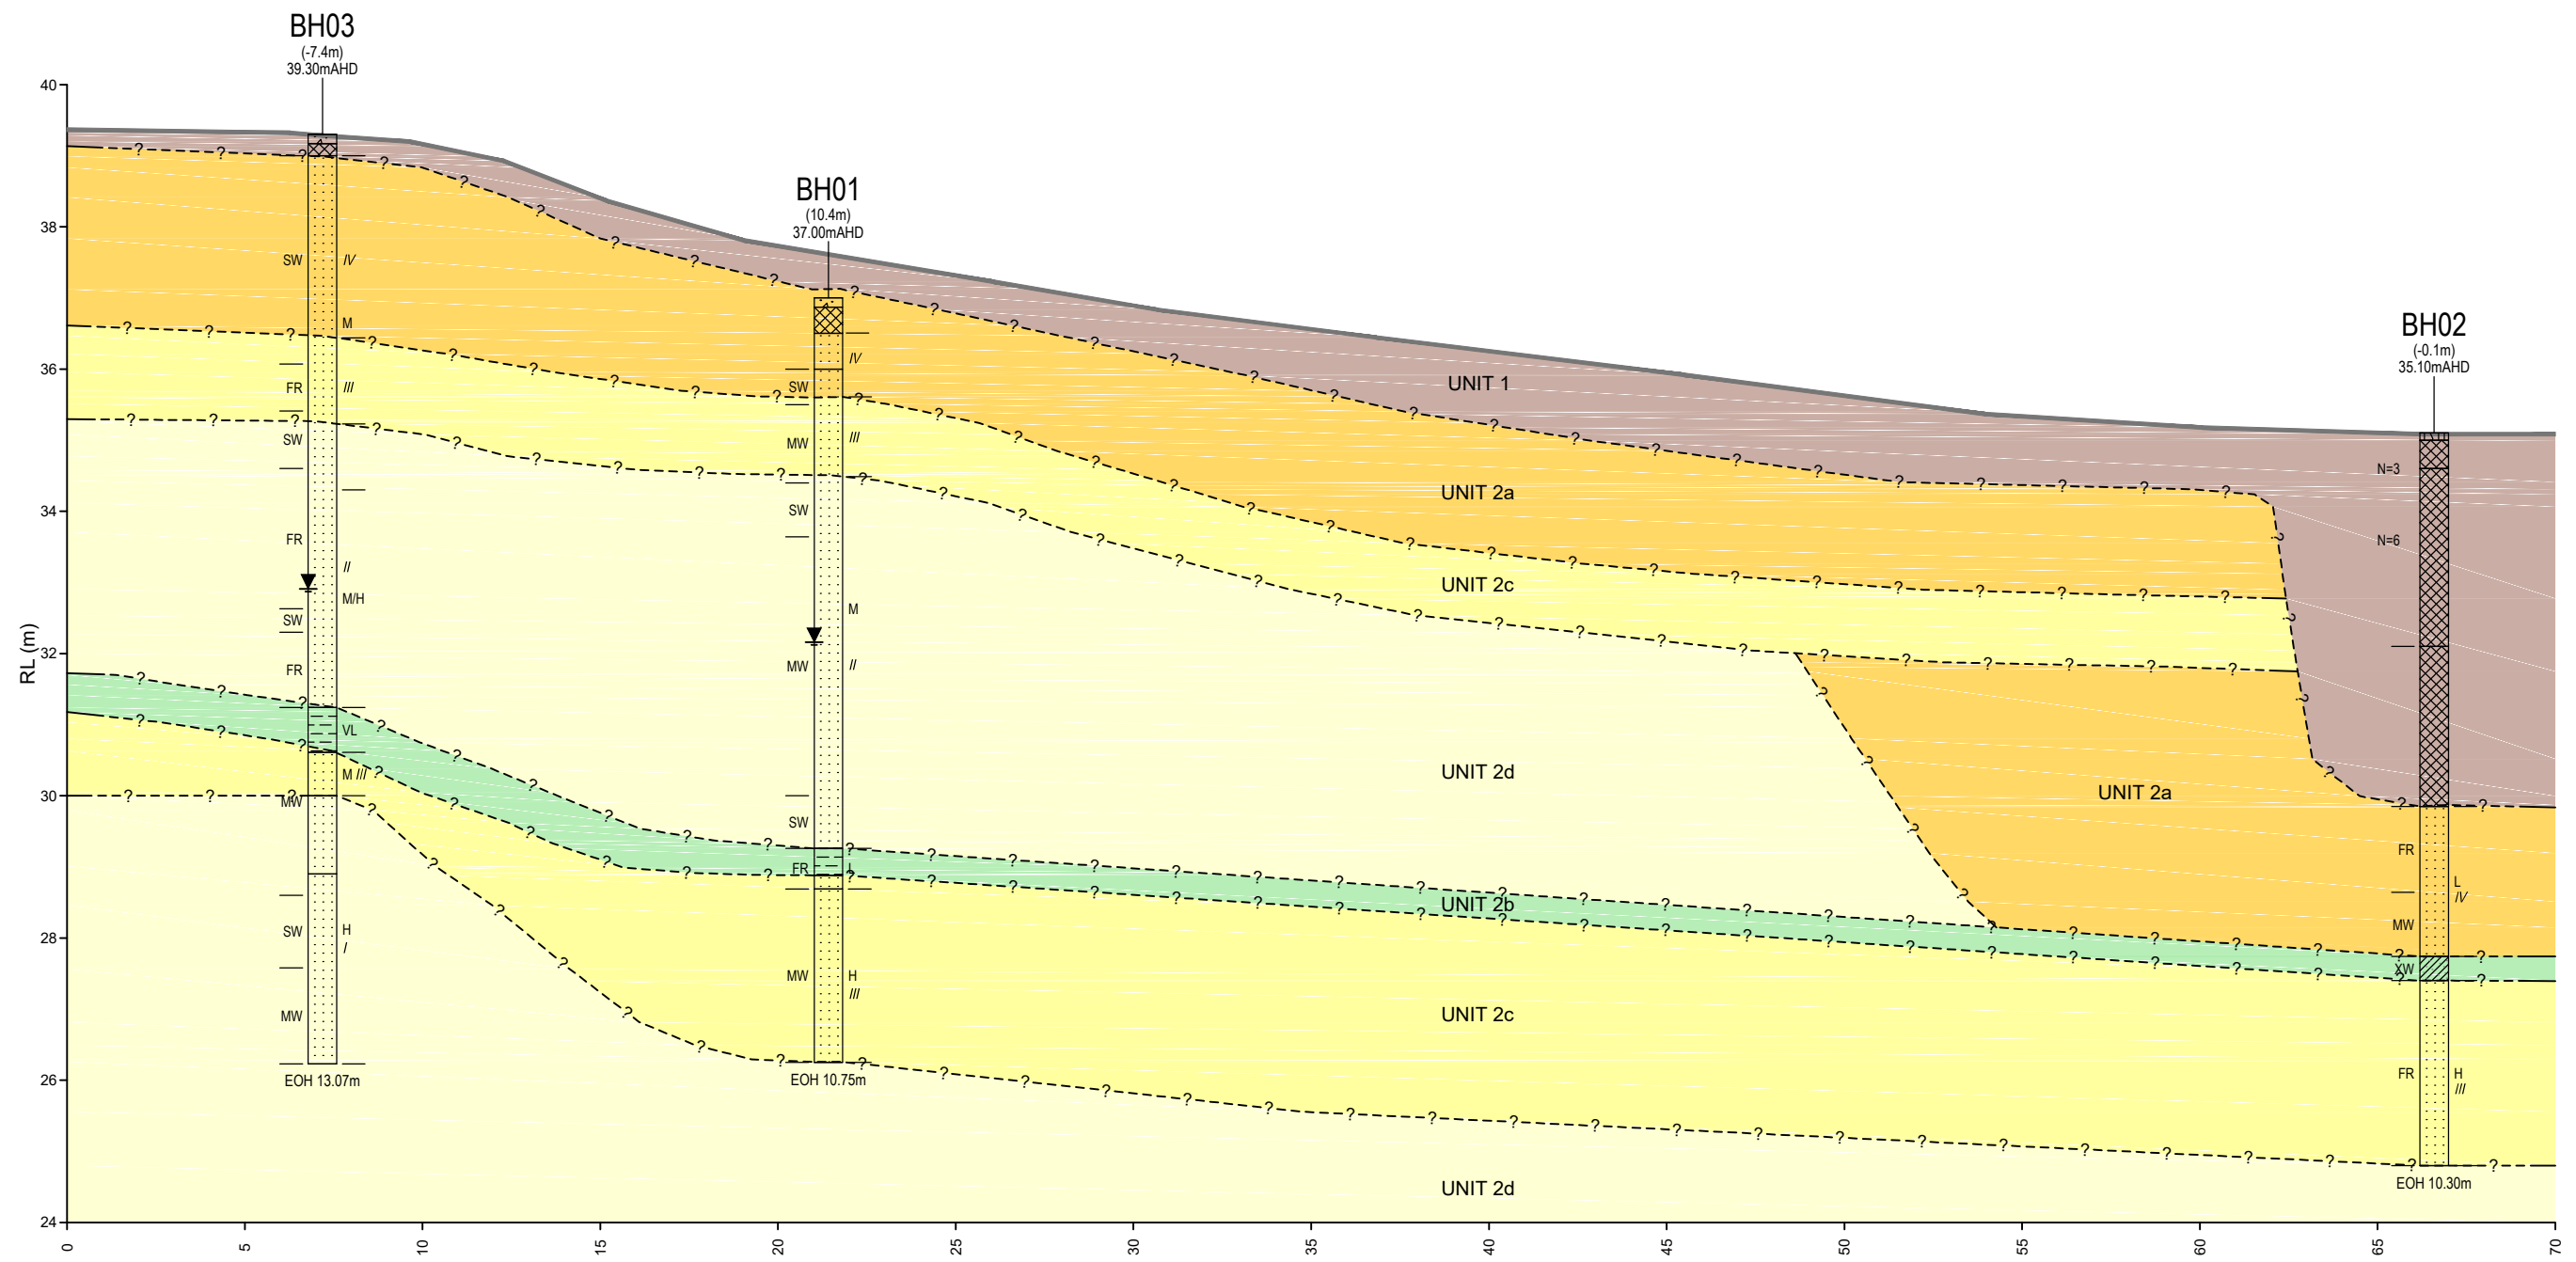
NORTH-EAST

SOUTH-WEST

- UNIT 1 - FILL/TOPSOIL
- UNIT 2a - CLASS V/IV SANDSTONE
- UNIT 2b - CLASS IV/V AND EXTREMELY WEATHERED SHALE
- UNIT 2c - CLASS III SANDSTONE
- UNIT 2d - CLASS III/I SANDSTONE

client:	HAMPTONS BY ROSE PTY LTD ATF NORTHERN BEACHES TRUST		
project:	GEOTECHNICAL INVESTIGATION REPORT 15-23 FISHER ROAD, DEE WHY, NSW		
title:	SECTION A-A'		
project no:	754-SYDGE271604AA	figure no:	FIGURE 2
rev:	A

For the purpose of geotechnical characterisation of the subsurface conditions, the soil and rock profiles encountered during Coffey's investigations have been characterise into the following geotechnical units shown in Table 1. Indicative cross-sections across the site illustrating the inferred ground profile based on the identified soil and rock units below are included in Appendix B – FIGURES 2 & 3.

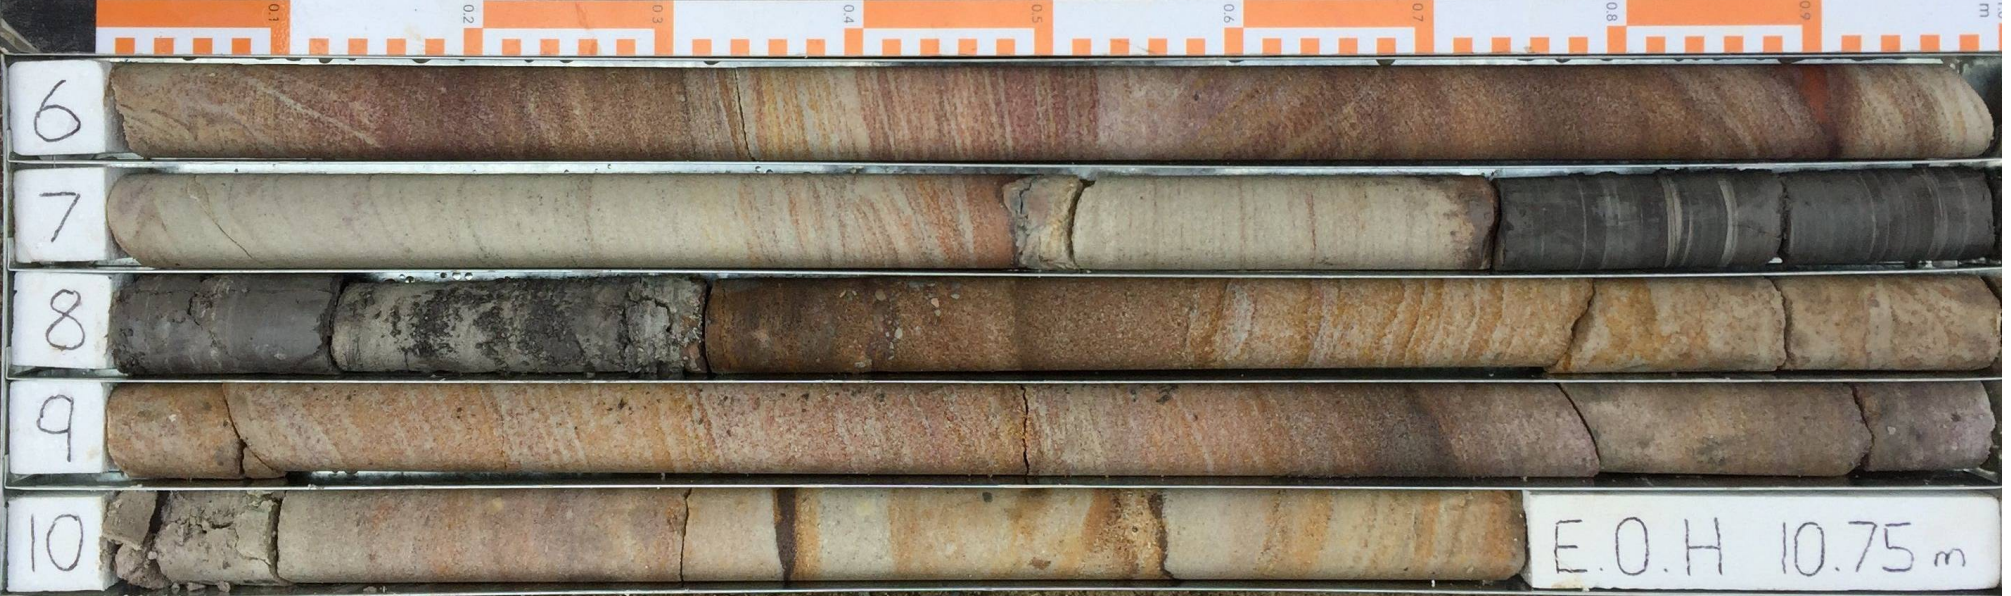
BH01 6.00 - 10.75 m

DEPTH: 6.0-10.75m

drawn	<b>A.W.</b>		client: Hamptons by Rose Pty Ltd ATF Northern Beaches Trust		
approved	<b>A.M.</b>		project: 15-23 Fisher Road, Dee Why - Geotechnical Investigation Report Fisher Road, Dee Why, NSW		
date	<b>27/04/2020</b>		title: <b>CORE PHOTOGRAPH BH01</b>		
scale	<b>N.T.S.</b>		project no: 754-SYDGE271604	fig no: <b>FIGURE 2</b>	rev:
original size	<b>A4</b>

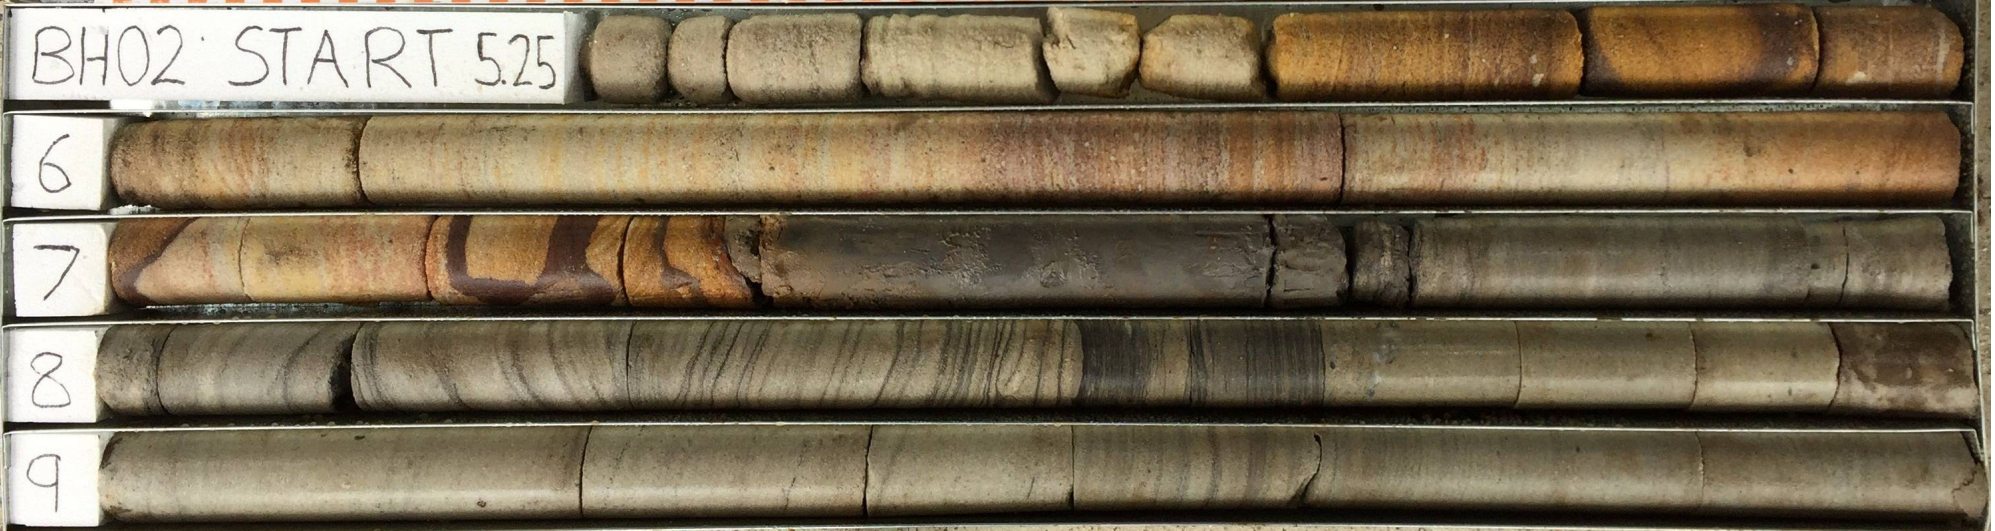
BH02 5.25 - 10.00 m

DEPTH: 5.25-10.0m

A TETRA TECH COMPANY	client: Hamptons by Rose Pty Ltd ATF Northern Beaches Trust	
approved	<b>A.M.</b>		project: 15-23 Fisher Road, Dee Why - Geotechnical Investigation Report Fisher Road, Dee Why, NSW	
date	<b>27/04/2020</b>		title: <b>CORE PHOTOGRAPH BH02</b>	
scale	<b>N.T.S.</b>		project no: 754-SYDGE271604	fig no: <b>FIGURE 3</b>
original size	<b>A4</b>		rev:

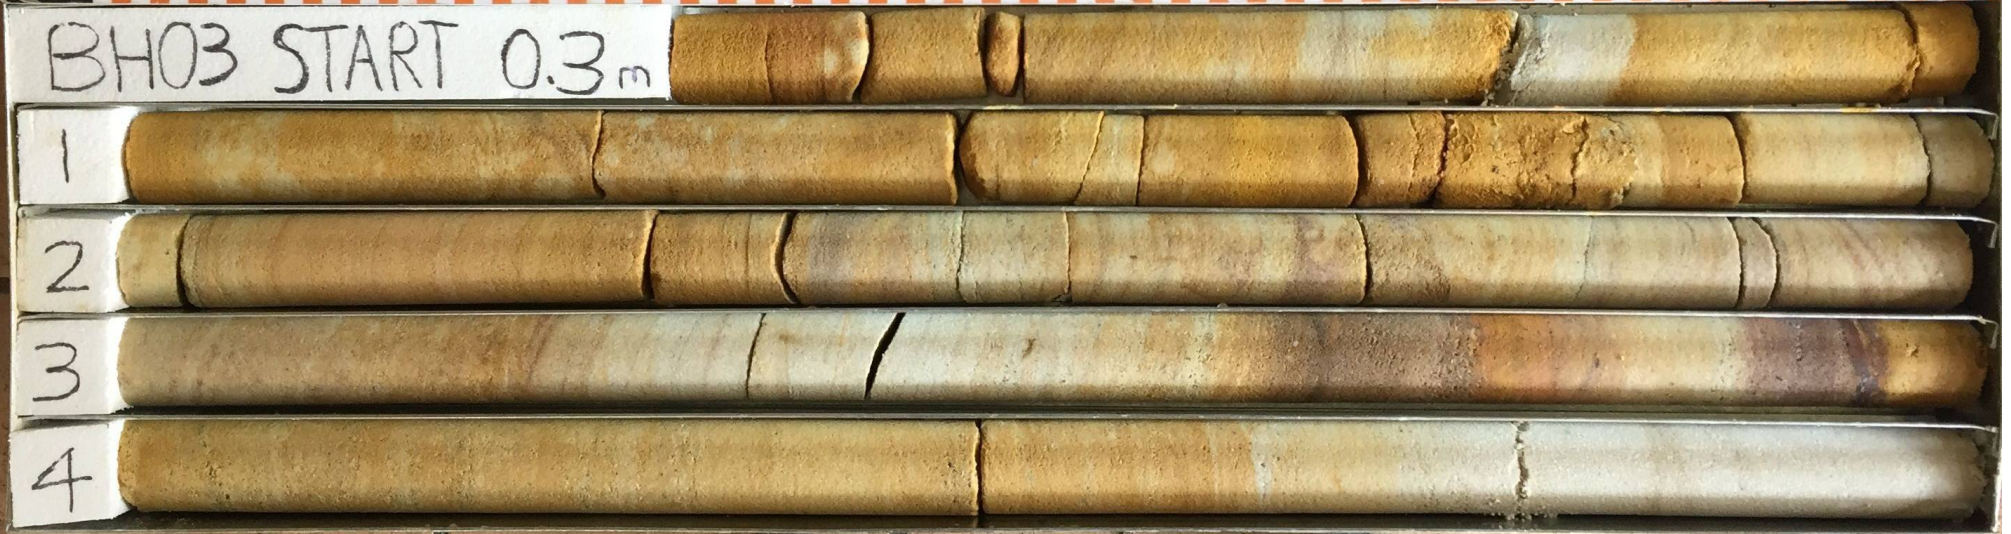
BH03 0.30 - 5.00 m

DEPTH: 0.3-5.0m

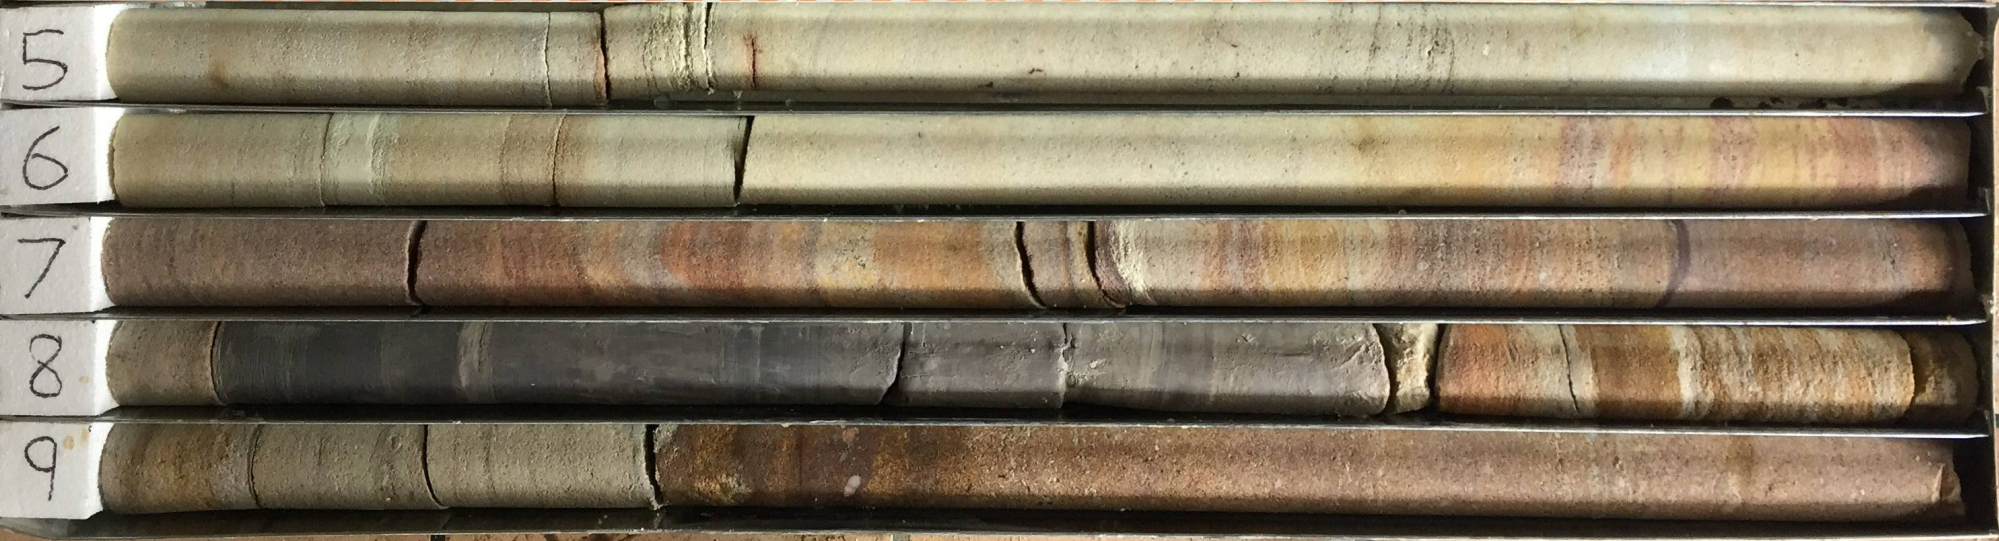
BH03 5.00 - 10.00 m

DEPTH: 5.0-10.0m

drawn	<b>A.W.</b>		client: Hamptons by Rose Pty Ltd ATF Northern Beaches Trust		
approved	<b>A.M.</b>		project: 15-23 Fisher Road, Dee Why - Geotechnical Investigation Report Fisher Road, Dee Why, NSW		
date	<b>27/04/2020</b>		title: <b>CORE PHOTOGRAPH BH03</b>		
scale	<b>N.T.S.</b>		project no: 754-SYDGE271604	fig no: <b>FIGURE 6</b>	rev:
original size	<b>A4</b>

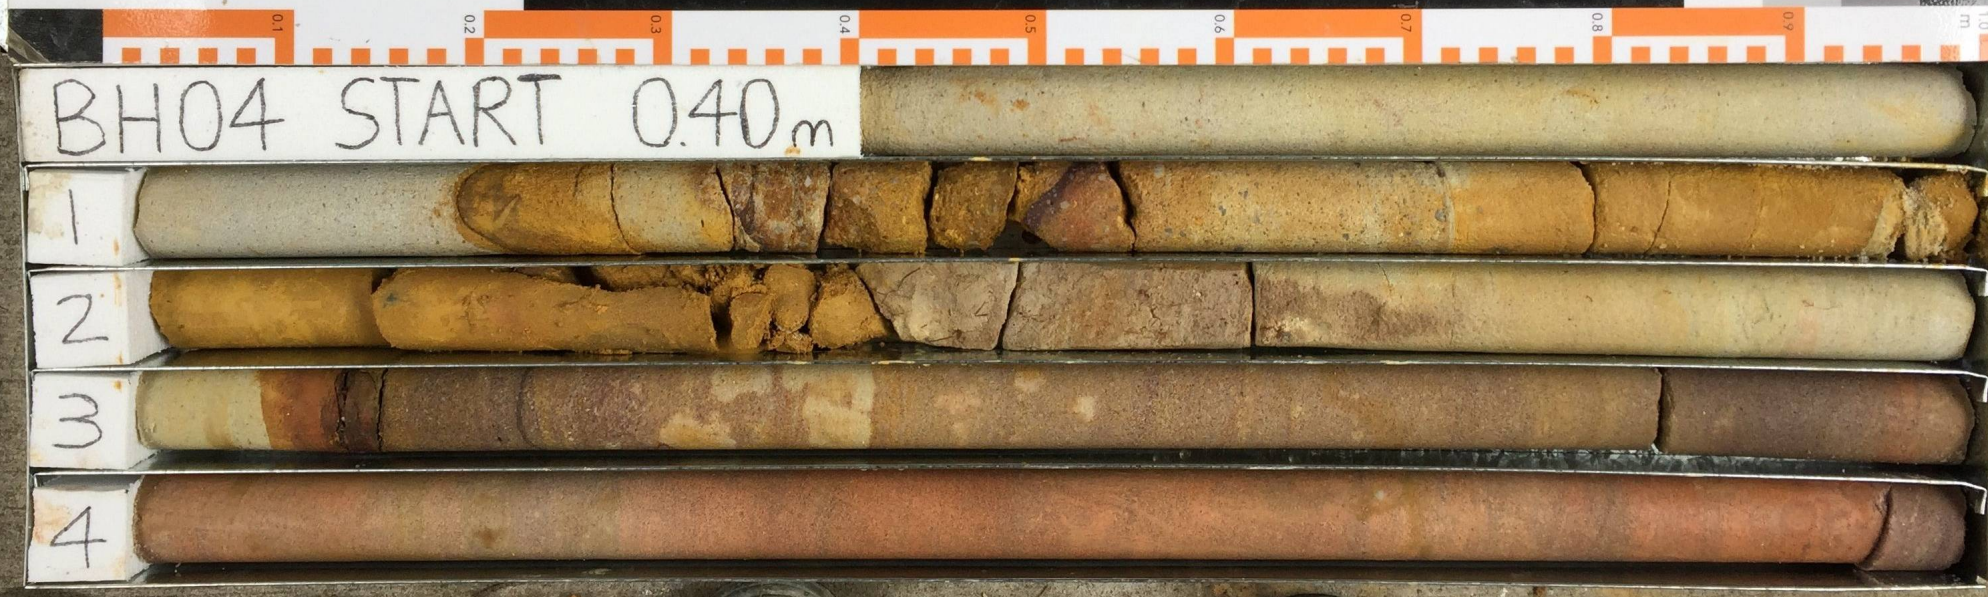
BH04 0.40 - 5.00 m

DEPTH: 0.4-5.0m

drawn	<b>A.W.</b>	<p>A TETRA TECH COMPANY</p>	client: Hamptons by Rose Pty Ltd ATF Northern Beaches Trust		
approved	<b>A.M.</b>		project: 15-23 Fisher Road, Dee Why - Geotechnical Investigation Report Fisher Road, Dee Why, NSW		
date	<b>27/04/2020</b>		title: <b>CORE PHOTOGRAPH BH04</b>		
scale	<b>N.T.S.</b>		project no: 754-SYDGE271604	fig no: <b>FIGURE 8</b>	rev:
original size	<b>A4</b>
