## **Preliminary Geotechnical Assessment**

**Project:** Alterations & Additions  
47 Hilltop Road, Avalon NSW

**REF: AG 22015**  
27 January 2022

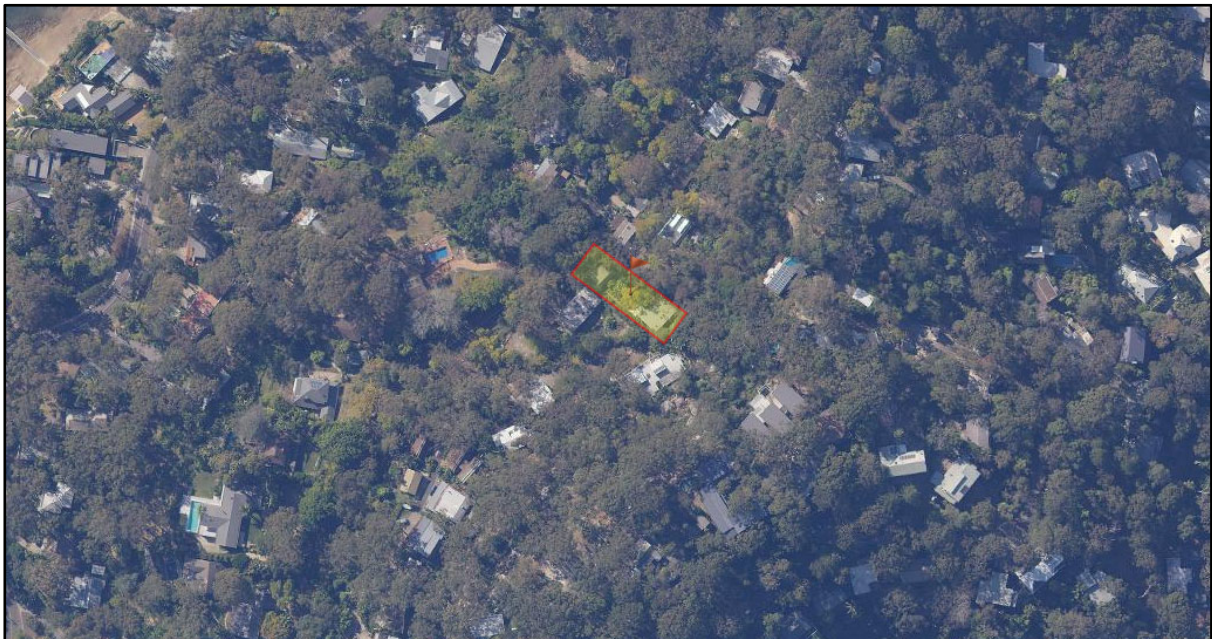
**Image 2.** Site location: 47 Hilltop Road, Avalon Beach NSW (© SIX Maps NSW Gov)

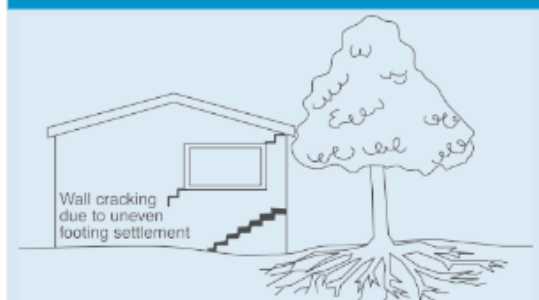
#### Trees can cause shrinkage and damage

As the weather pattern changes and the soil begins to dry out, the external footings will be first affected, beginning with the locations where the sun's effect is strongest. This has the effect of lowering the external footings. The doming is accentuated and cracking reduces or disappears where it occurred because of dishing, but other cracks open up. The roof lines may become convex.
