Geotechnical Assessment

Project: New Primary & Secondary Dwellings
86 Quirk Street, Dee Why NSW.

For New Primary and Secondary Dwelling at
86 Quirk Street, Dee Why NSW

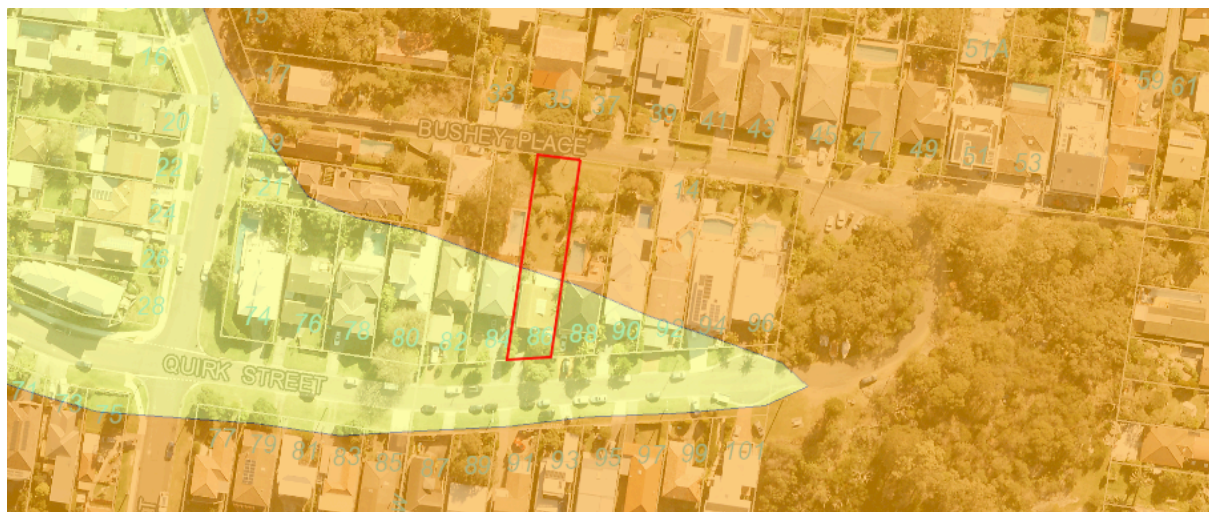
WARRINGAH LANDSLIP RISK MAP

- No evidence of significant soil creep, tension cracks or other indicators of slope instability were identified at the time of our inspection.
- The existing structures displayed no evidence of significant cracking or settlement that could be attributed to slope instability.
- The property is classified as **Areas A & B** with reference to Northern Beaches Council WLEP Landslip Risk Map (WLEP Landslip Risk Map **Image 2** below).

- Area A - Slope less than 5 degrees
- Area B - Flanking Slopes from 5 to 25 degrees
- Area C - Slopes more than 25 degrees
- Area D - Collaroy Plateau Area Flanking Slopes 5 to 15 degrees
- Area E - Collaroy Plateau Area Slopes more than 15 degrees
