# Geotechnical Assessment

**Project:** Alterations & Additions  
21 Wallumatta Road, Newport NSW

**Ref:** AG 24473  
6 November 2024

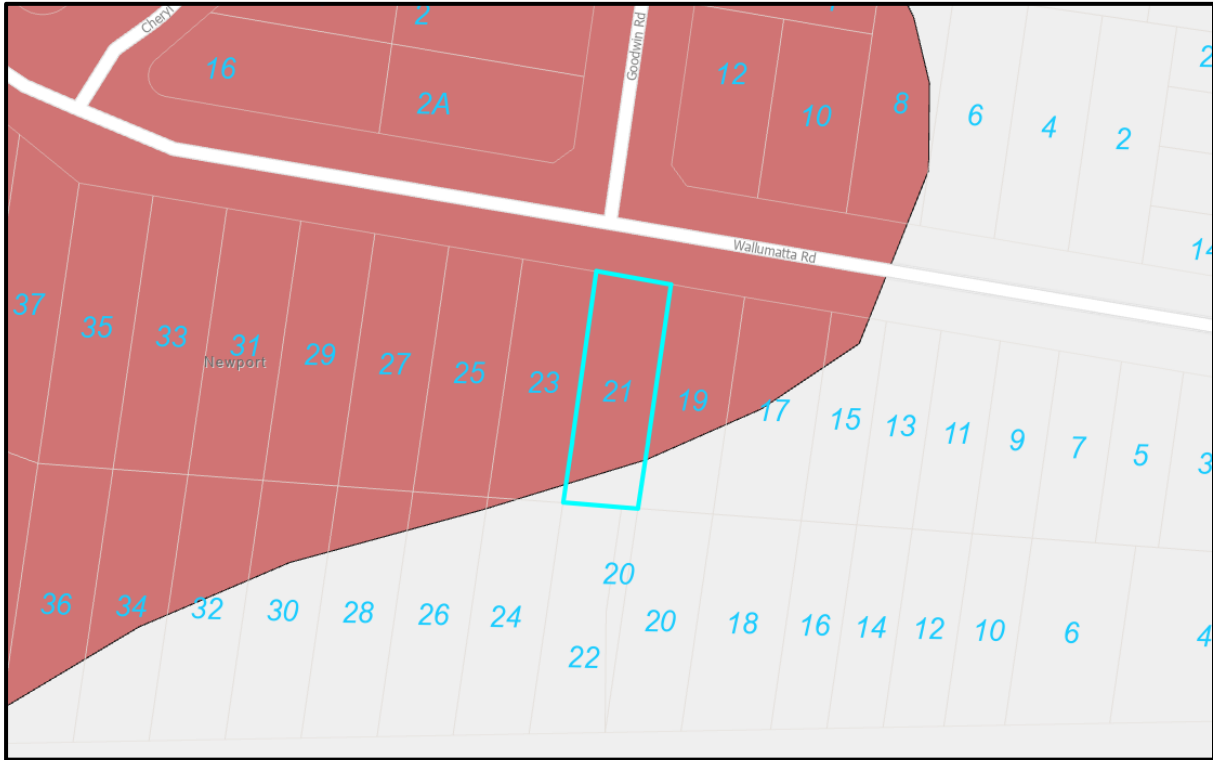
**Image 1.** Pittwater Geotechnical Hazard Risk Map:  
21 Wallumatta Road, Newport (© NBC Maps)

Based on reference to the plan entitled 'Geotechnical Hazard Mapping' (Ref. P21DCP-BC-MDCP2002, dated 2007) prepared by GHD LONGMAC on behalf of Pittwater Council, the site is located within **Geotechnical Hazard Zone H1**.
