Preliminary Geotechnical Assessment

Project: Alterations & Additions
14 Epping Drive, Frenchs Forest NSW

Ref: AG 22459
2 November 2022

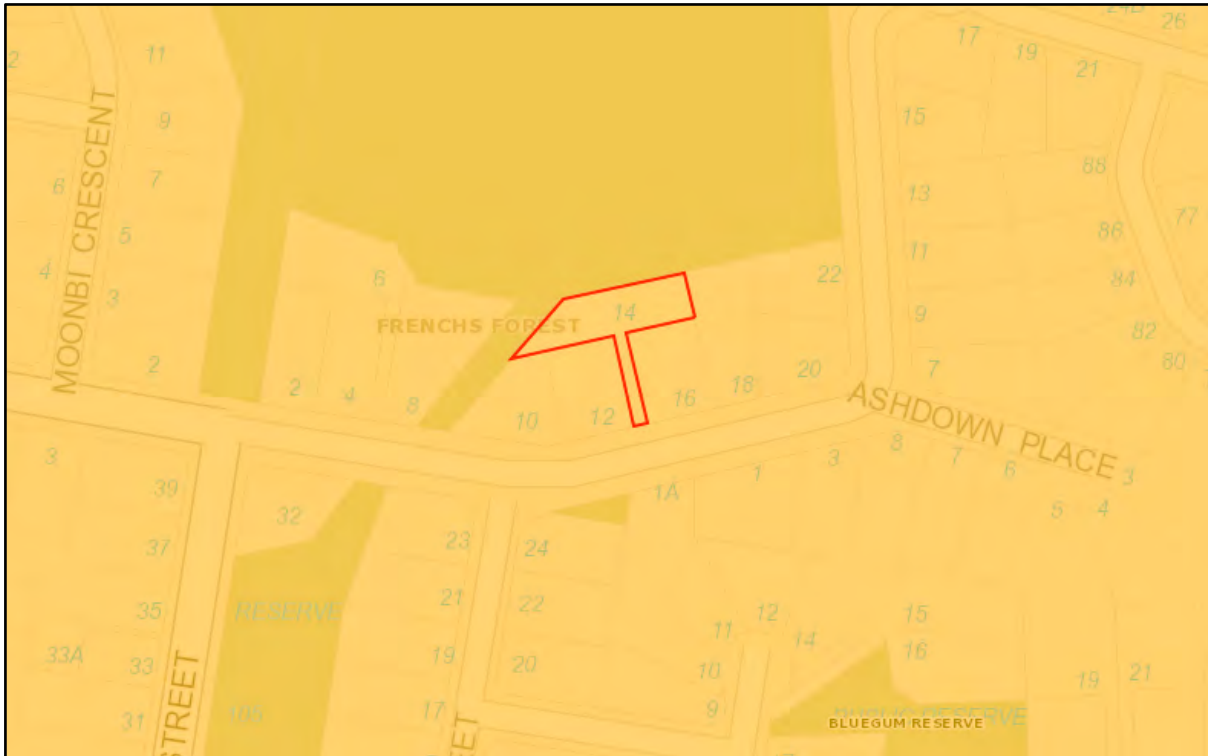
Image 1. Warringah Landslip Risk Map:
14 Epping Drive, Frenchs Forest NSW (© NBC Maps)

The site is mapped as **Area B** subject to specific landslip risk/geotechnical hazard mapping with reference to the Warringah (WLEP) Landslip Risk Map, Northern Beaches Council (**Image 1**).

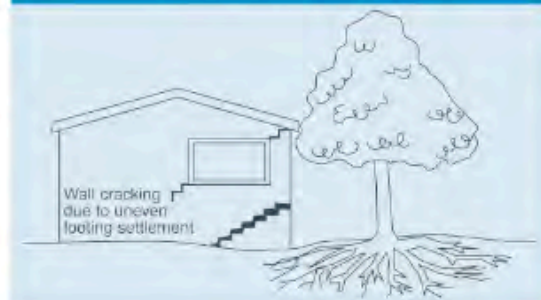
Trees can cause shrinkage and damage

As the weather pattern changes and the soil begins to dry out, the external footings will be first affected, beginning with the locations where the sun's effect is strongest. This has the effect of lowering the external footings. The doming is accentuated and cracking reduces or disappears where it occurred because of dishing, but other cracks open up. The roof lines may become convex.

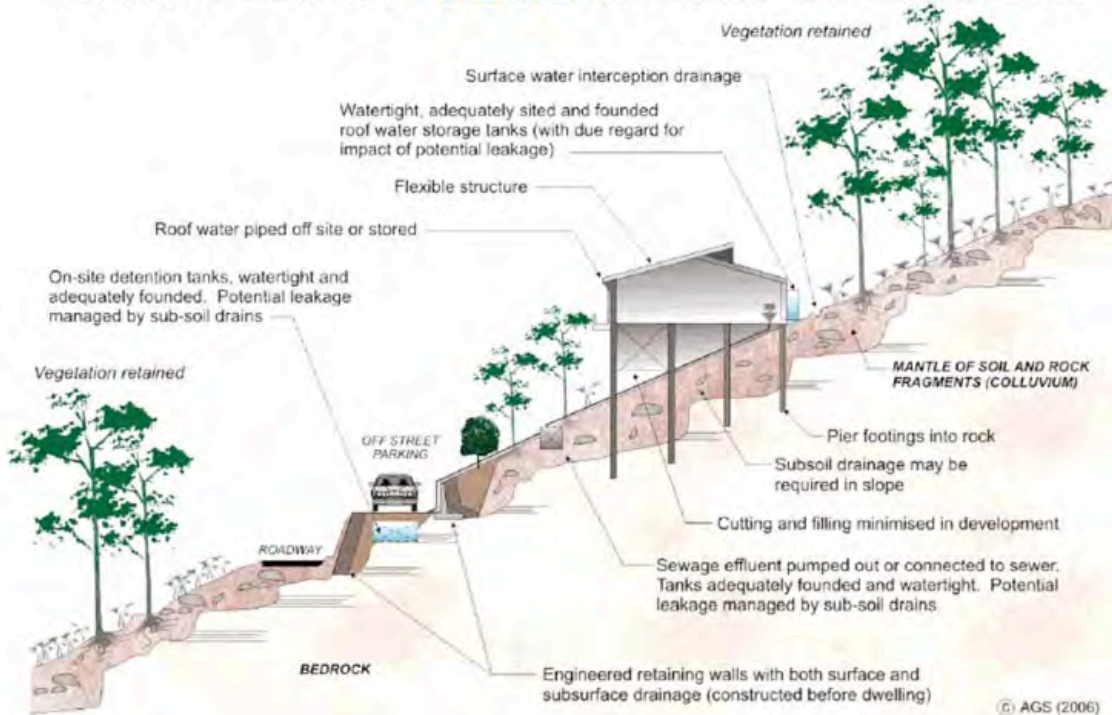
EXAMPLES OF **GOOD** HILLSIDE PRACTICE

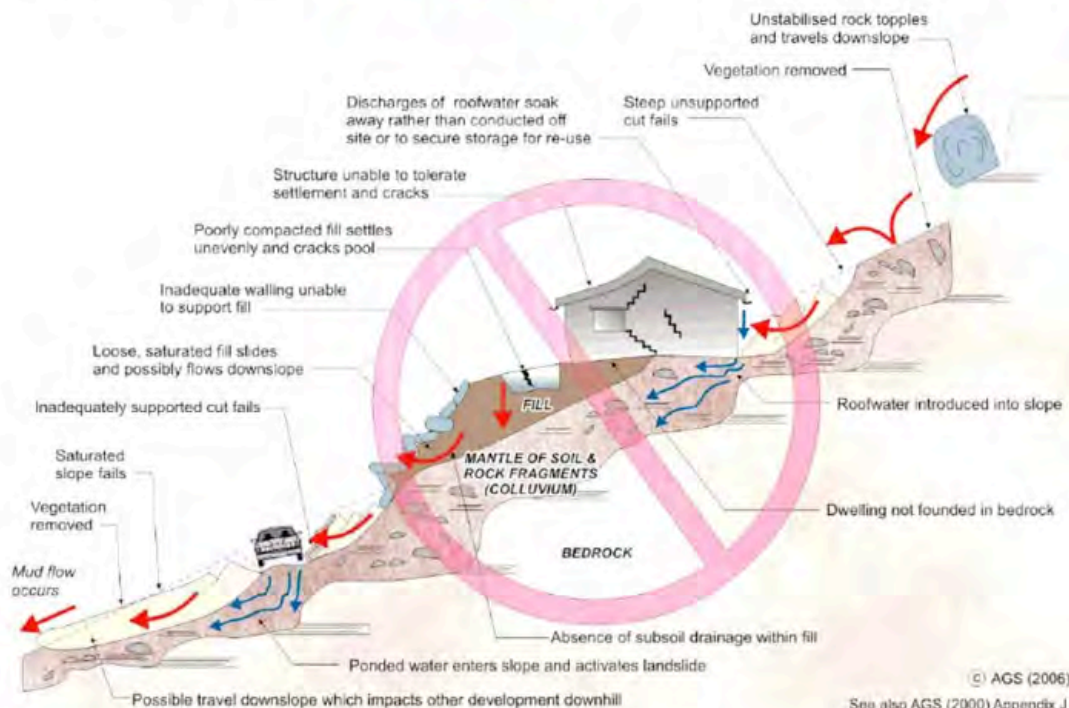
EXAMPLES OF **POOR** HILLSIDE PRACTICE
