Preliminary Geotechnical Assessment

For Alterations and Additions at

79B Lauderdale Avenue, Fairlight NSW

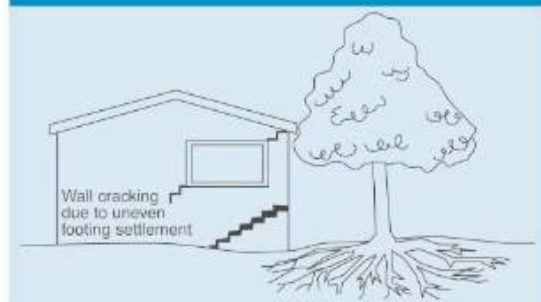
Trees can cause shrinkage and damage

As the weather pattern changes and the soil begins to dry out, the external footings will be first affected, beginning with the locations where the sun's effect is strongest. This has the effect of lowering the external footings. The doming is accentuated and cracking reduces or disappears where it occurred because of dishing, but other cracks open up. The roof lines may become convex.
