Preliminary Geotechnical Assessment

For Alterations & Additions at
44 Lovett Street, Manly Vale NSW

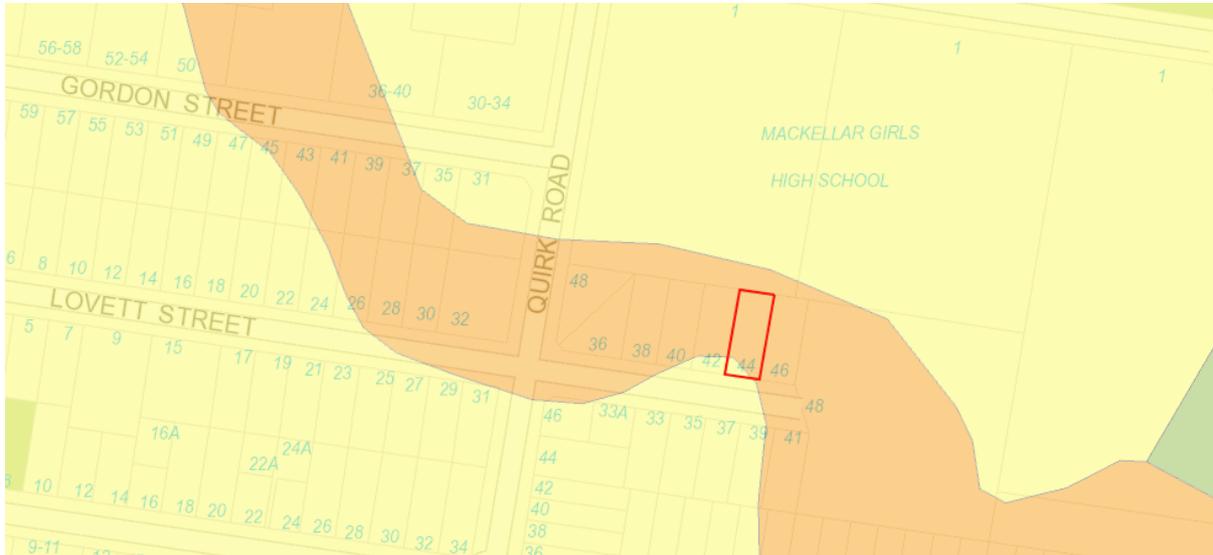
WARRINGAH LANDSLIP RISK MAP

The site is mapped as **Areas A & B** on the Landslip Risk Map WLEP 2011 (**Image 1**, below).

- Area A - Slope less than 5 degrees
- Area B - Flanking Slopes from 5 to 25 degrees
- Area C - Slopes more than 25 degrees
- Area D - Collaroy Plateau Area Flanking Slopes 5 to 15 degrees
- Area E - Collaroy Plateau Area Slopes more than 15 degrees
