PRELIMINARY GEOTECHNICAL ASSESSMENT: **23 Wakehurst Parkway, Seaforth**

1.0 Proposed Development

- 1.1** Demolish the existing house and driveway. Construct a new two storey house and driveway requiring minor levelling and minor filling.
- 1.2** No significant excavations or fills are shown on the plans.
- 1.3** Details of the proposed development are shown on 23 drawings prepared by Fowler Homes, job number 21-1418, drawings numbered 001 to 016 and 018 to 024, Revision B-2, dated 21/11/22.

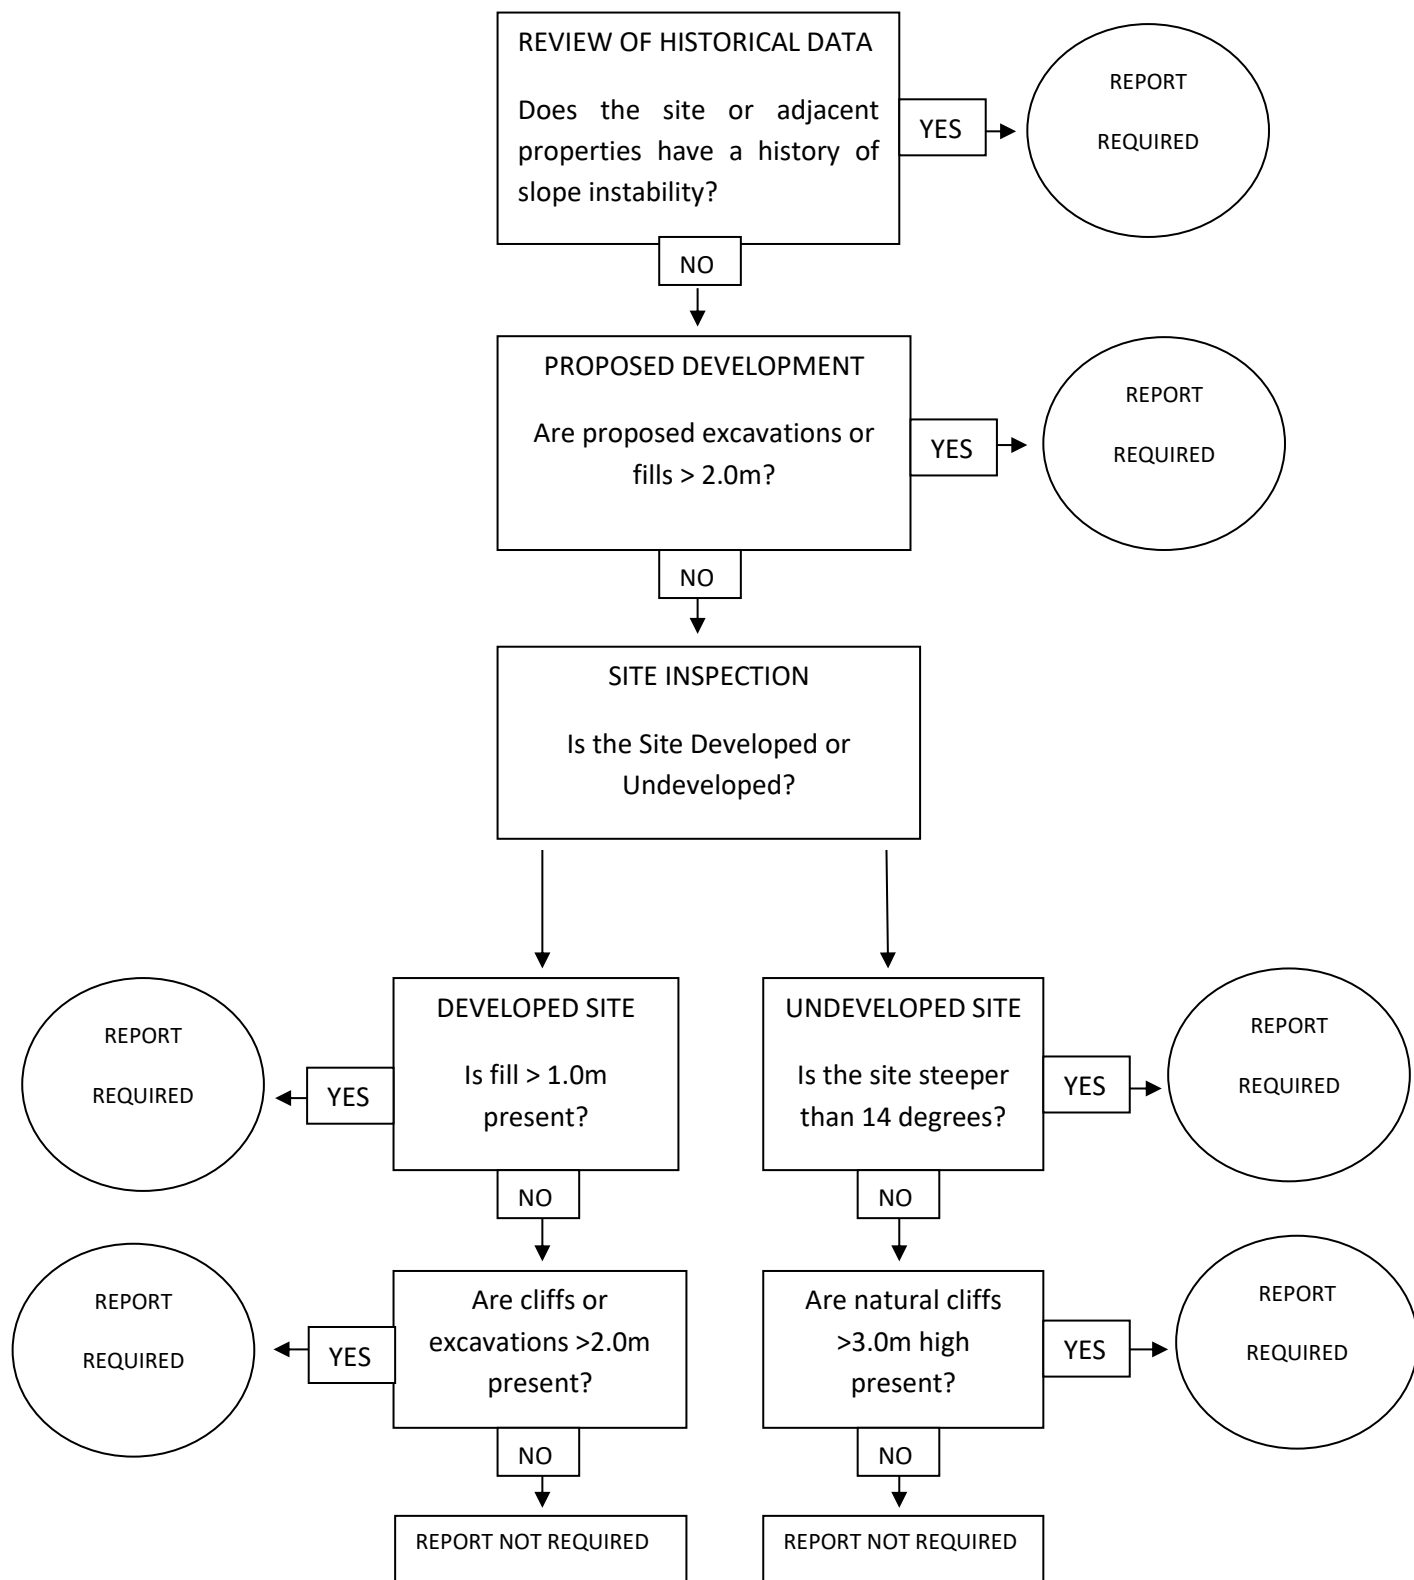
Preliminary Assessment Flow Chart – Northern Beaches Council (Manly)

The proposed development and site conditions were considered and applied to the Council Flow Chart.
