PRELIMINARY GEOTECHNICAL ASSESSMENT:

27 Marinella Street, Manly Vale

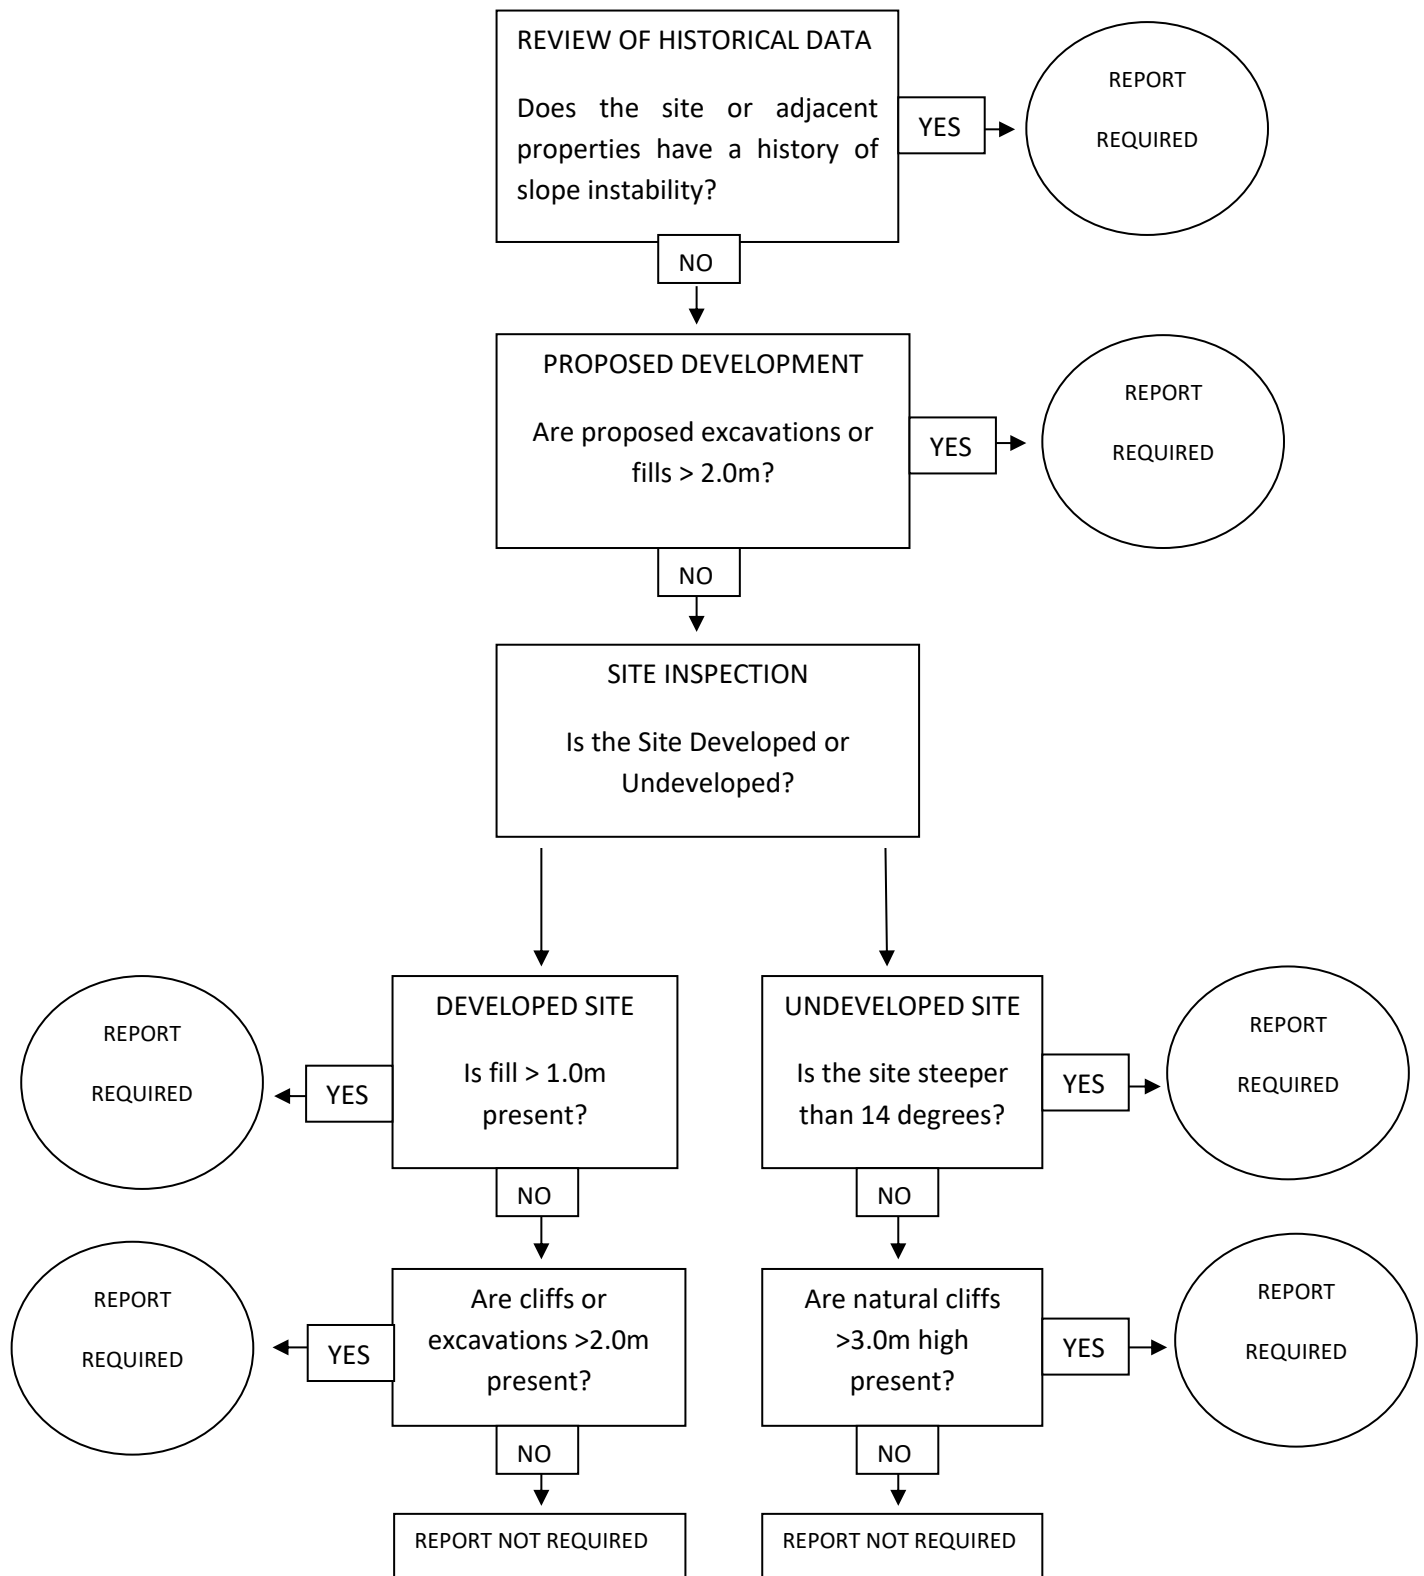
Preliminary Assessment Flow Chart – Northern Beaches Council (Warringah)

The proposed development and site conditions were considered and applied to the Council Flow Chart.
