PRELIMINARY GEOTECHNICAL ASSESSMENT:
160 Parr Parade, Beacon Hill

2.0 Proposed Development

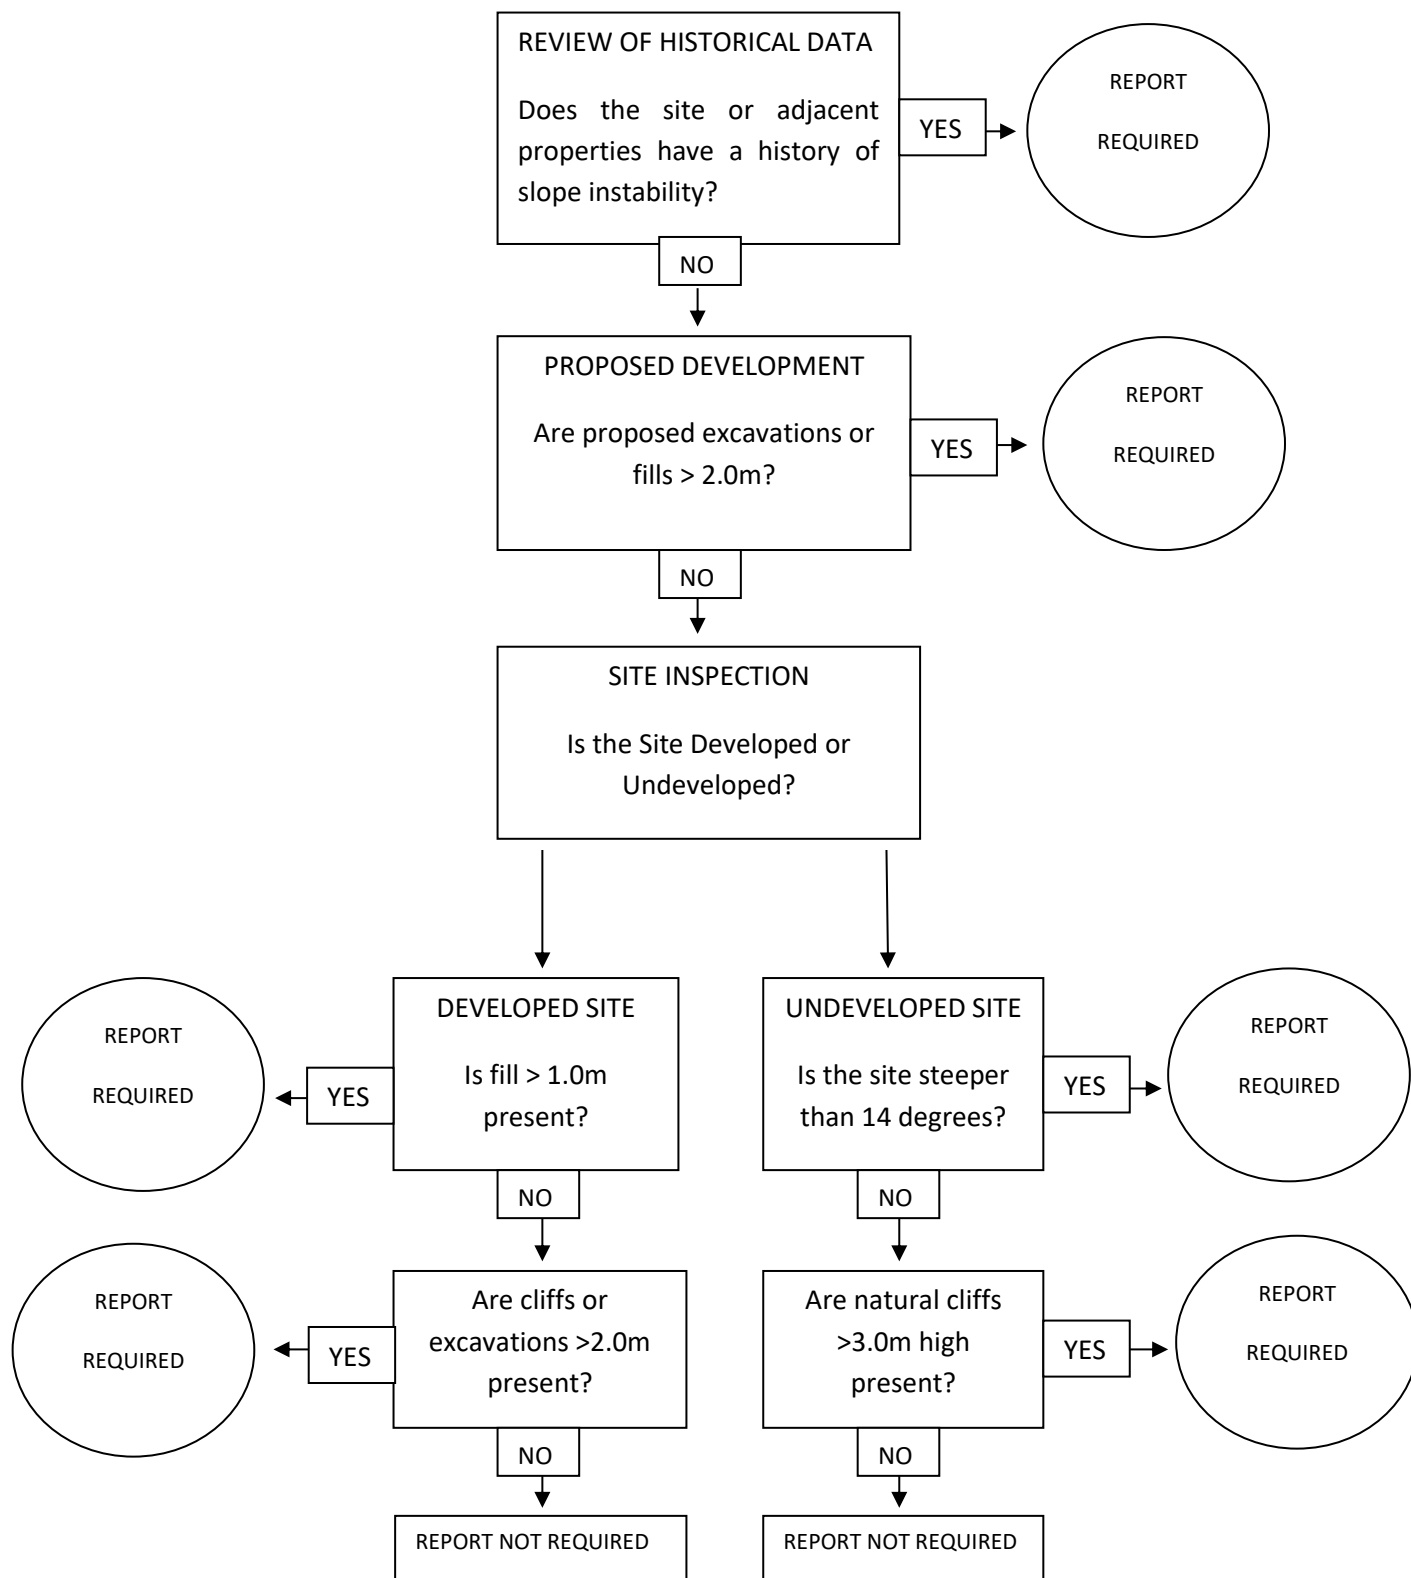
Preliminary Assessment Flow Chart – Northern Beaches Council (Warringah)

The proposed development and site conditions were considered and applied to the Council Flow Chart.
