Geotechnical Assessment

Project: Alterations & Additions
76 Nandi Avenue, Frenchs Forest NSW

REF: AG 21001
20 January 2021

For **Alterations & Additions** at
76 Nandi Avenue, Frenchs Forest NSW

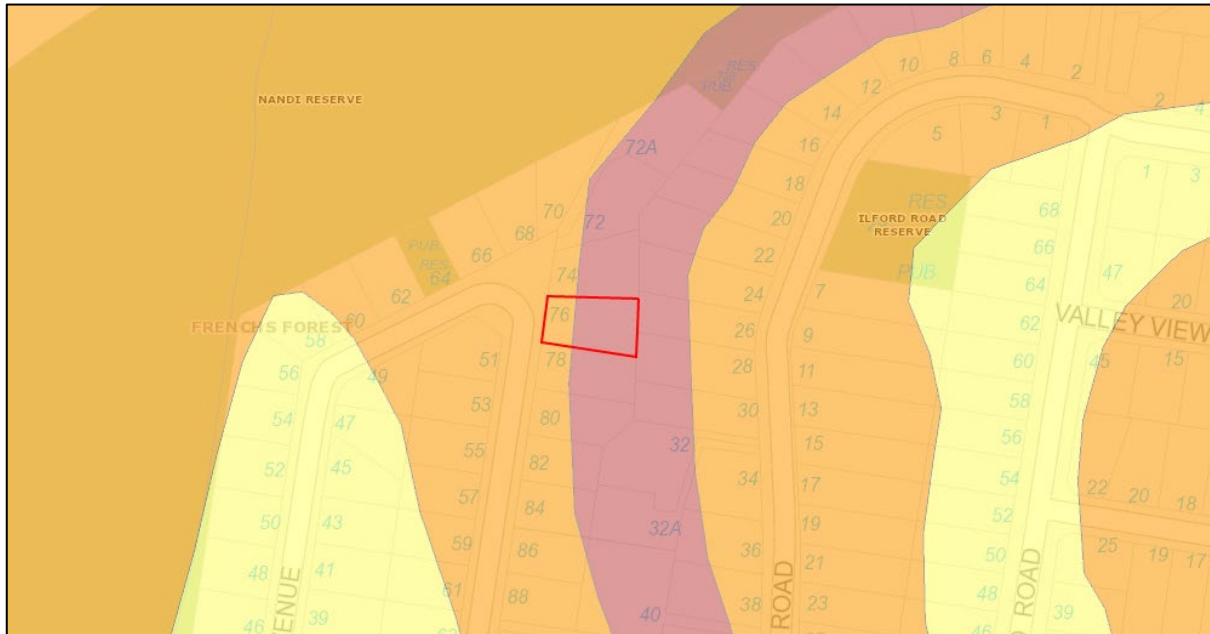
Image 2. WLEP Landslip Risk Map
– 76 Nandi Avenue, Frenchs Forest NSW

- No evidence of significant soil creep, tension cracks or landslip instability were identified across the site or on adjacent properties, as viewed from the subject site at the time of our inspection.
- The property is classified as **Areas B & C** with reference to Northern Beaches Council WLEP Landslip Risk Map Sheet (**Image 2** below).

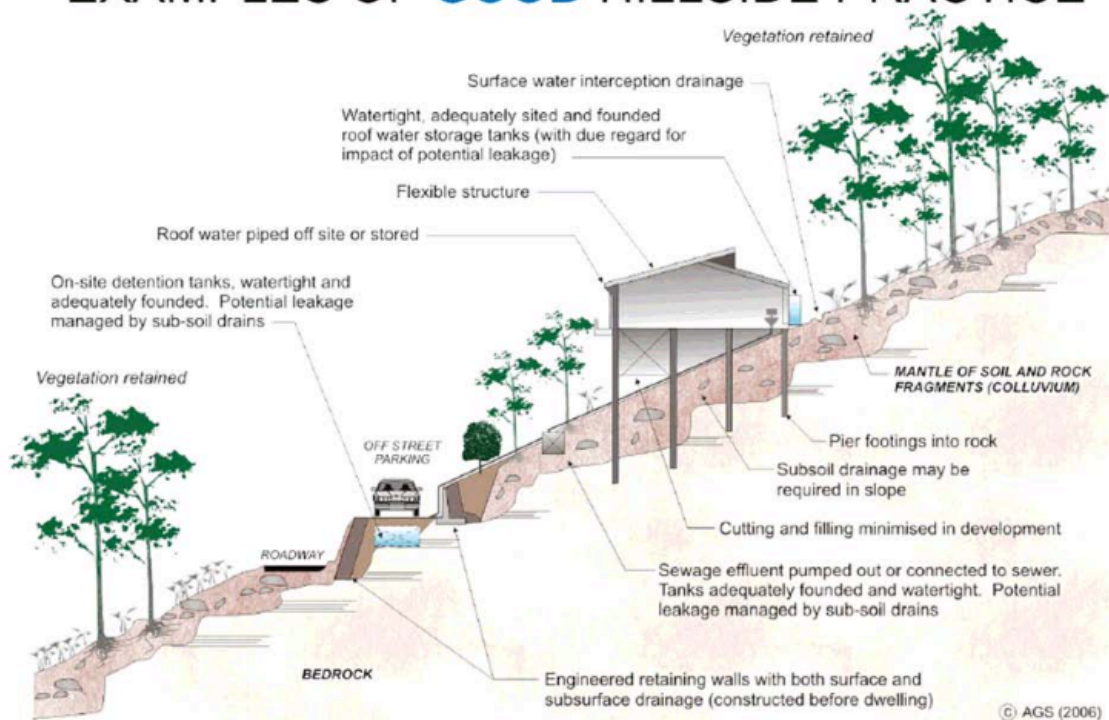
EXAMPLES OF **GOOD** HILLSIDE PRACTICE

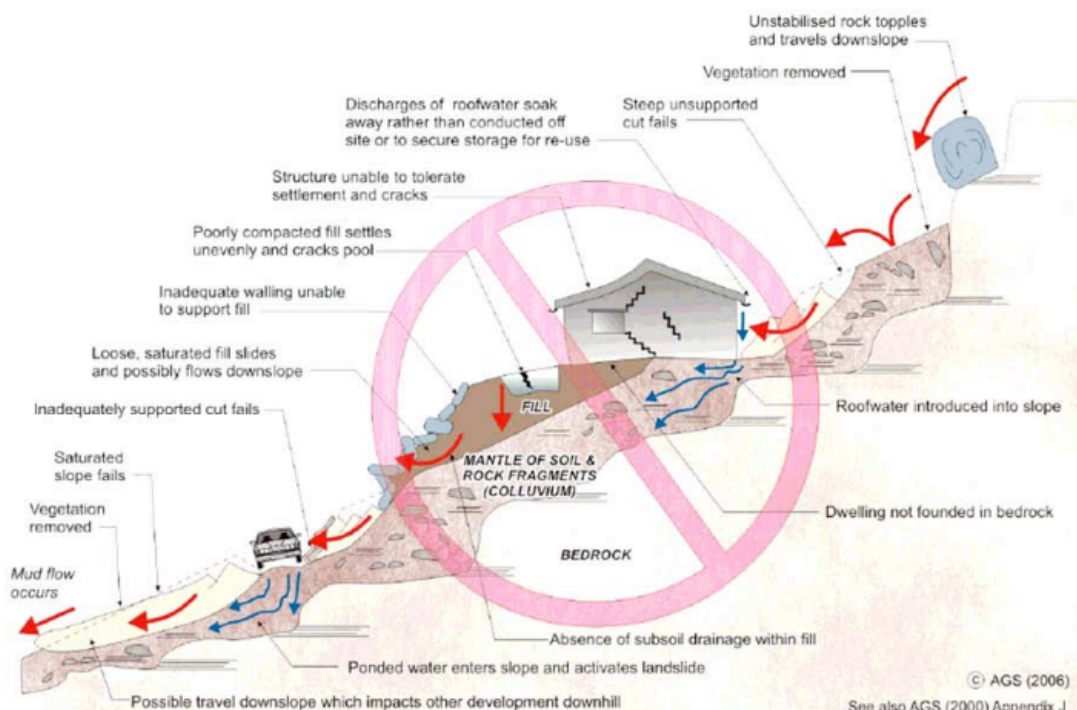
EXAMPLES OF **POOR** HILLSIDE PRACTICE

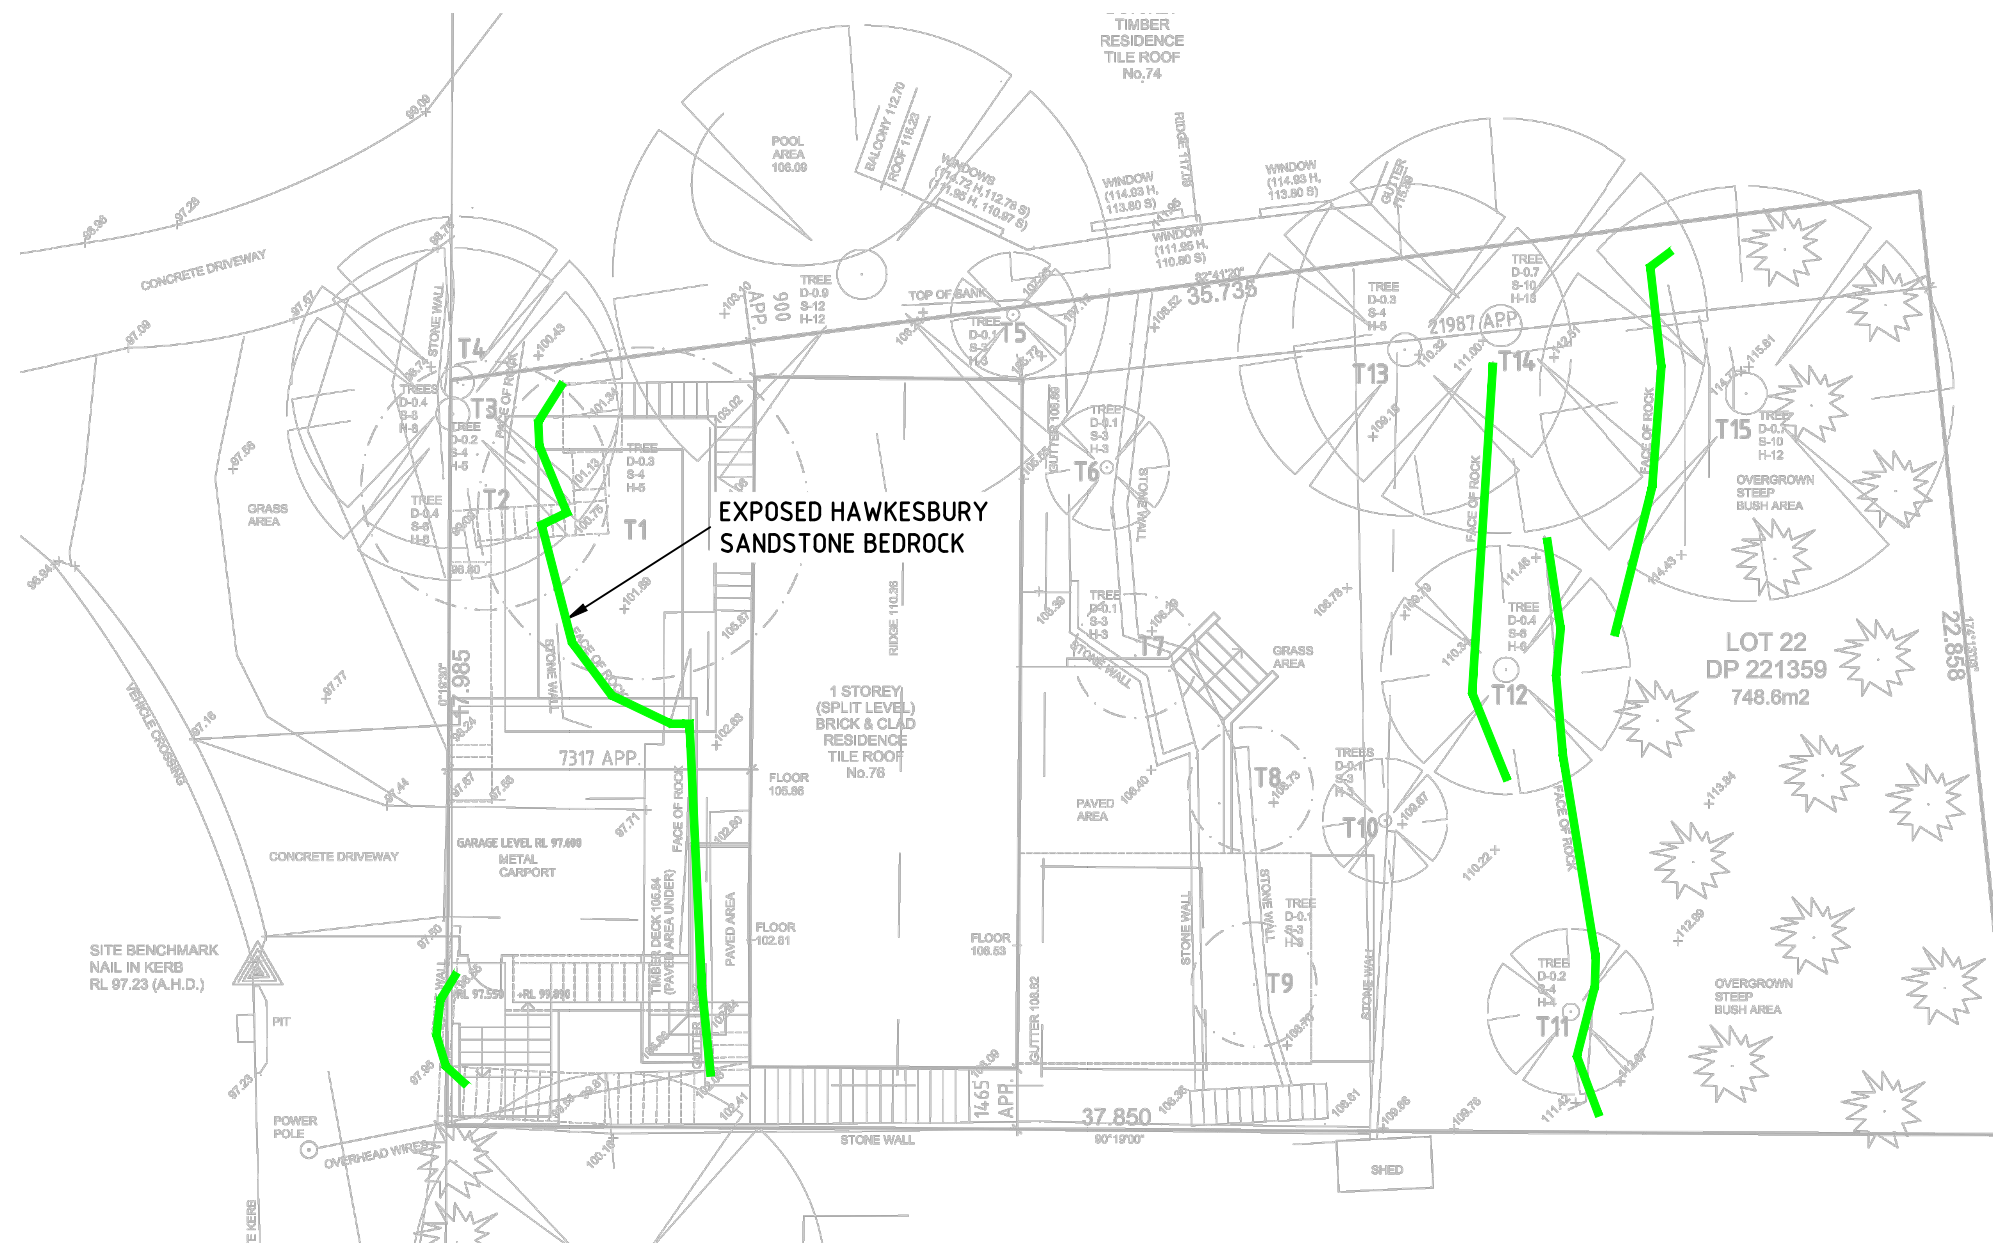
SITE PLAN/GROUND TEST LOCATIONS
SCALE NTS

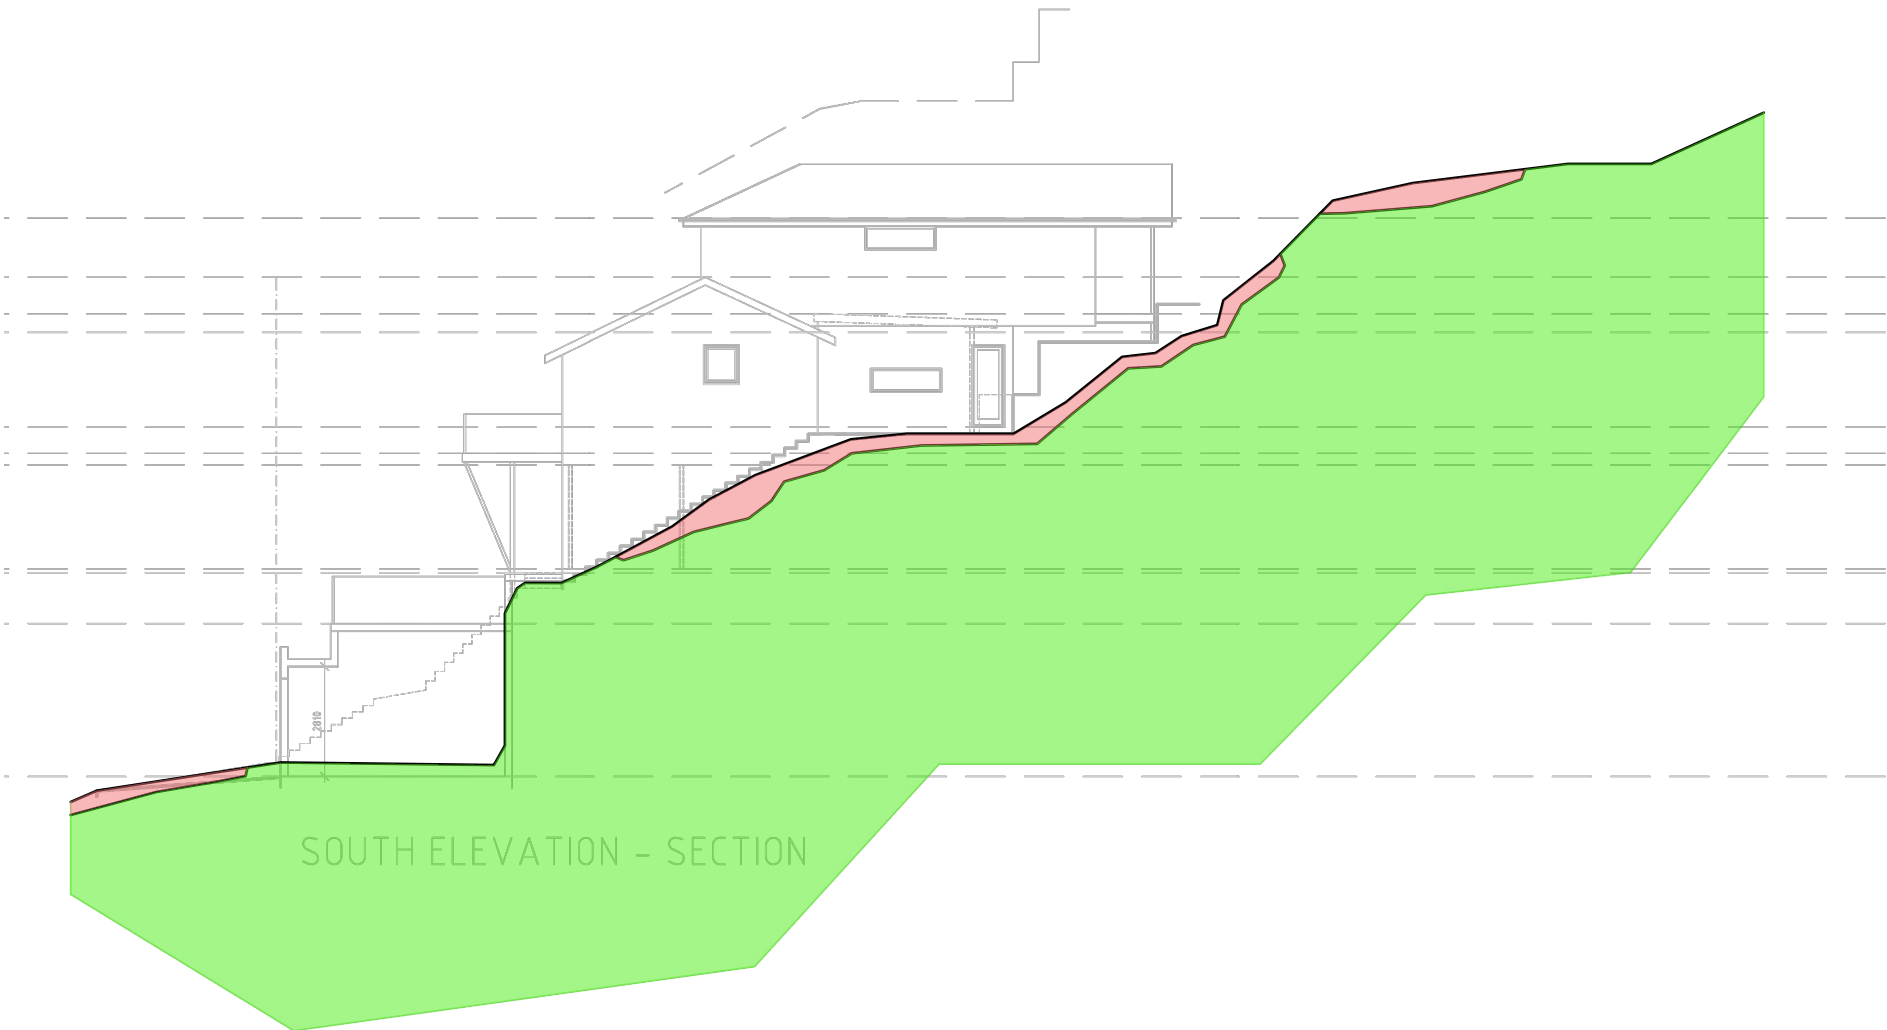
INTERPRETED SUBSURFACE SECTION ONLY.
ACTUAL GROUND CONDITIONS MAY VARY.

INFERRED GEOLOGICAL SECTION
SCALE NTS

The soil profile consists of shallow uncontrolled fill and silty/sandy topsoils (O & A Horizons), clayey sand (B Horizon), and weathered sandstone bedrock (C Horizon). Based on our observations and the results of testing on site, we would expect competent weathered bedrock, to be found within 200–800mm from current surface levels across the area of the proposed works, where not already exposed.
