# MARINE POLLUTION RESEARCH PTY LTD

## AQUATIC ECOLOGY ASSESSMENT

### PROPOSED DECK, BOATSHED REFURBISHMENT AND RAMP AT 214 HUDSON PDE, CLAREVILLE.

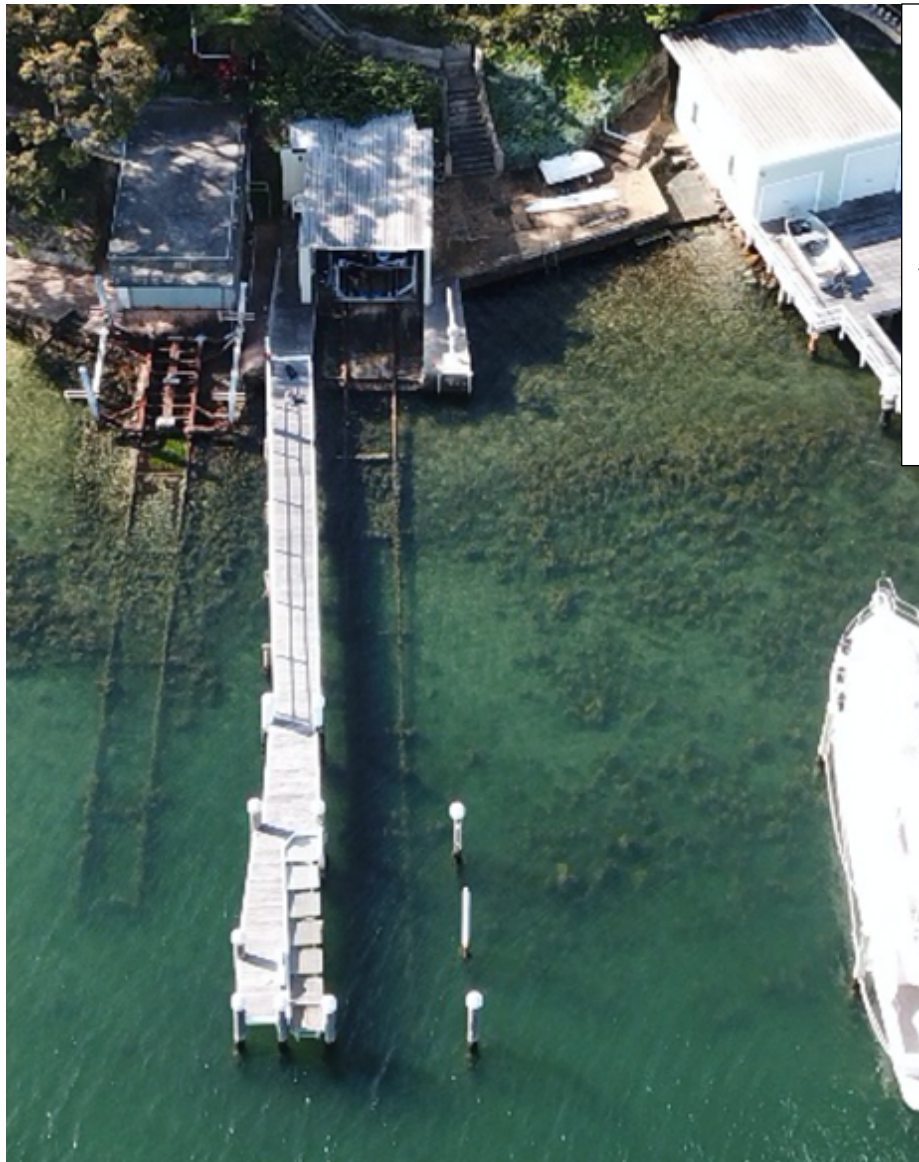
**Figure 2**

Drone view of present facility showing the relationship of jetty, mooring pen, slipway boathouse and associated reclamations.

**Figures 2 to 4** provide drone and photographic views of the existing facility which comprises a jetty plus sea-stairs and mooring pen to be retained, an enclosed boatshed structure over a concrete ramp and slipway facility and associated reclamations.

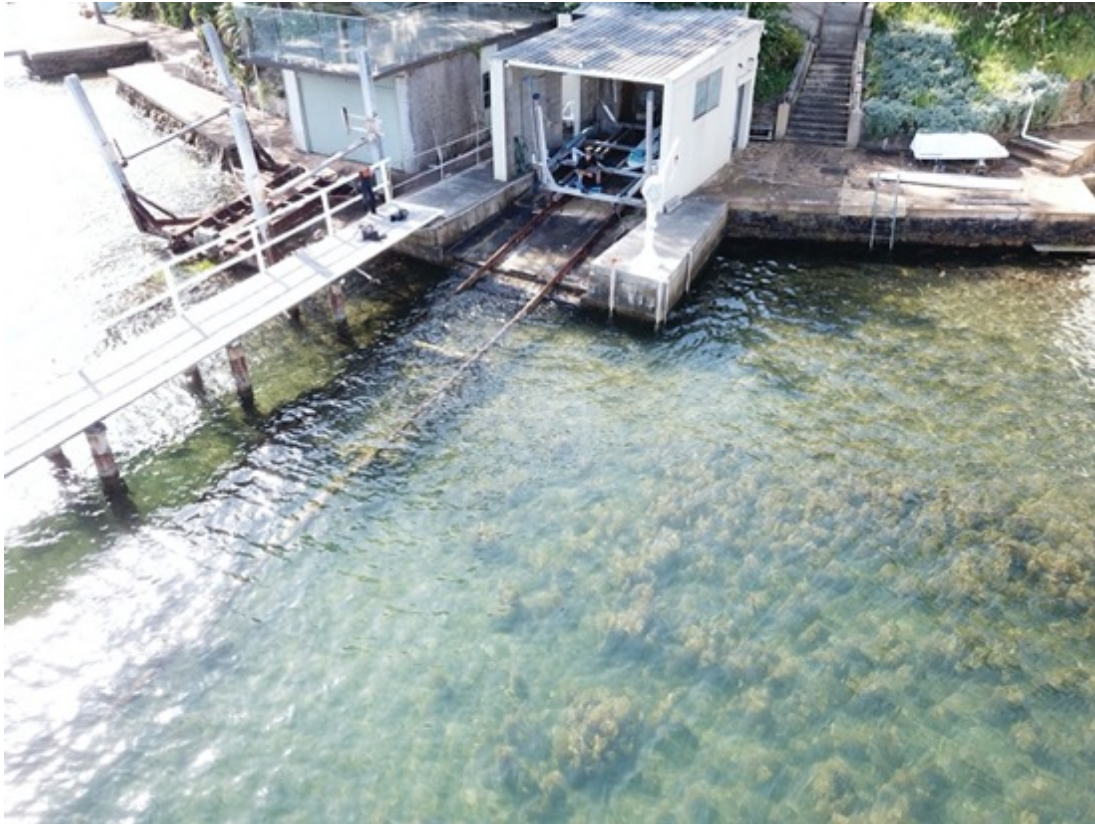
**Figure 3** Oblique, low drone view showing concrete ramp plus slipway and boat cradle extending into the boatshed, the block sandstone seawalls and concrete plus sandstone flagged reclamations at the property.

- The riparian zone comprises reclamations with concrete decks on either side of the sloping concrete ramp (**Figure 3**) and stone flagged decking over a sandstone block seawall to the east of the concrete ramp structures (**Figure 4**).

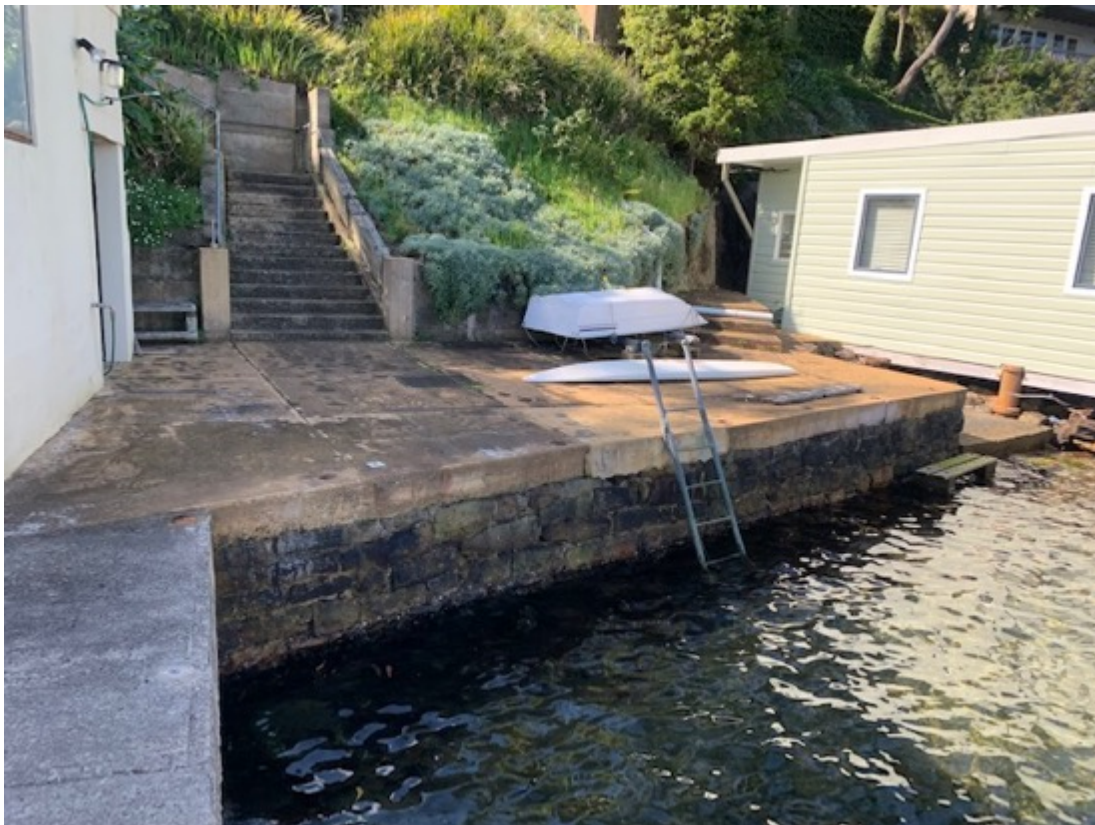
**Figure 4** Sandstone seawall and reclamation on eastern side of present facility.

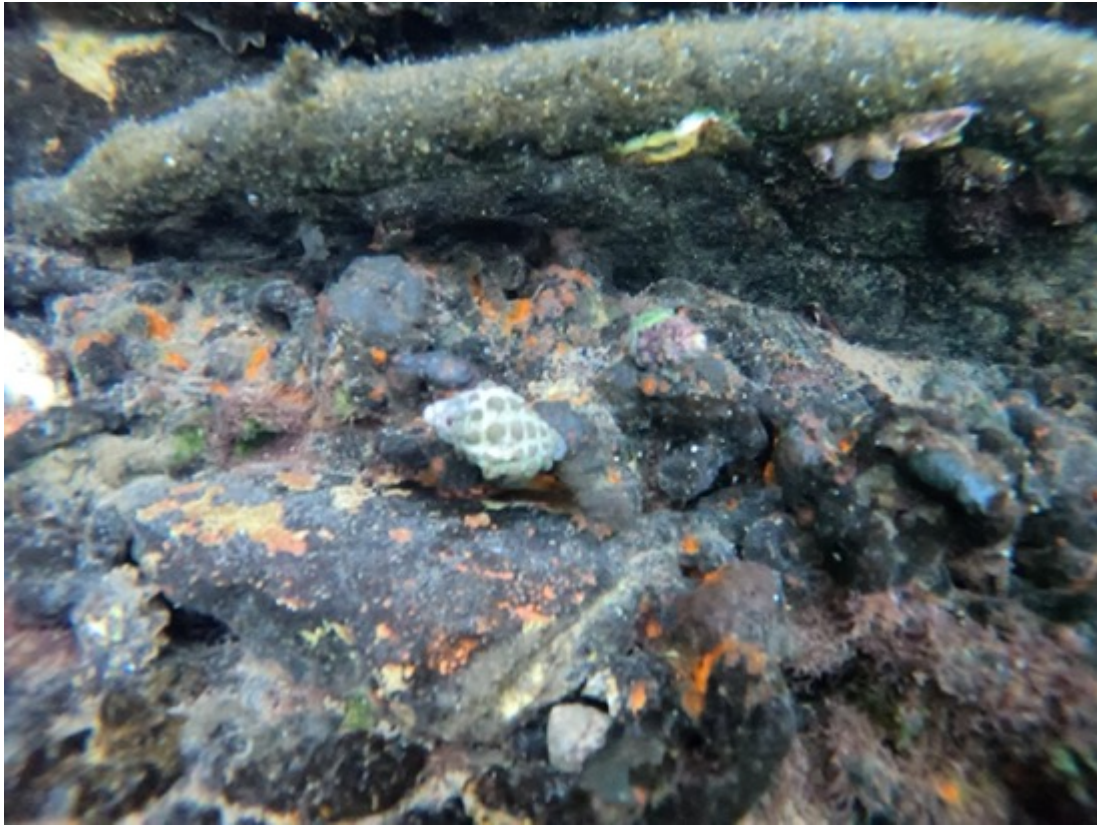
**Figure 7** *Morula sp.* and *Bembicium sp.* within intertidal oyster-based assemblage.

- The intertidal wetted surfaces of the concrete and sandstone seawall and a small inshore section of rock rubble at the eastern corner rock rubble (inshore of the yellow line in **Figure 6**) supported an oyster-based assemblage with no macro algae (**Figure 7**).

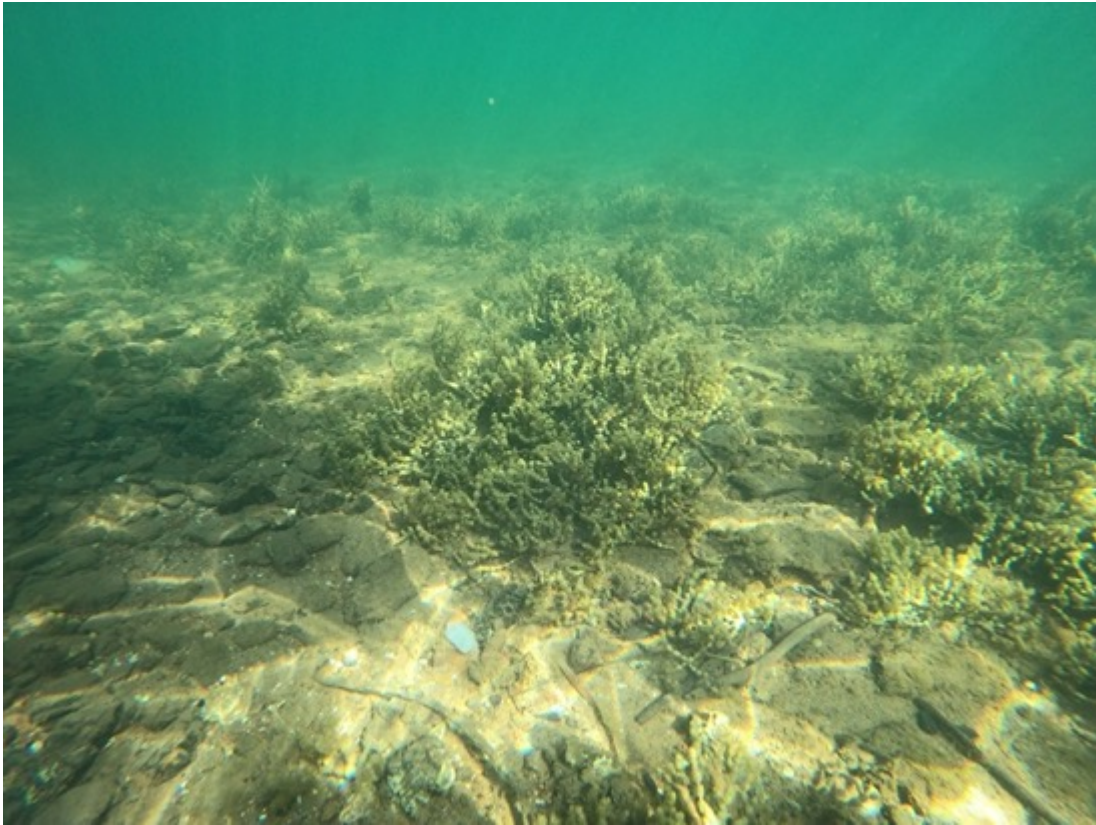
**Figure 9** Neptune's necklace and gastropod habitat on lower intertidal basement rock with rock rubble habitat.

- The mid-section of intertidal rock rubble over basement rock habitat (yellow to dark blue lines in **Figure 6**) supported a variety of gastropods (*Morula sp.*, *Bembicium sp.* and *Austrocochlea sp.*) and this gastropod assemblage extended into the lower intertidal habitat (dark blue to purple lines) along with patches of Neptune's necklace *Hormosira banksia*, patches of oysters with short form *Sargassum sp.*, some *Colpomenia sp.* and bleached coralline algae (**Figures 8 and 9**).

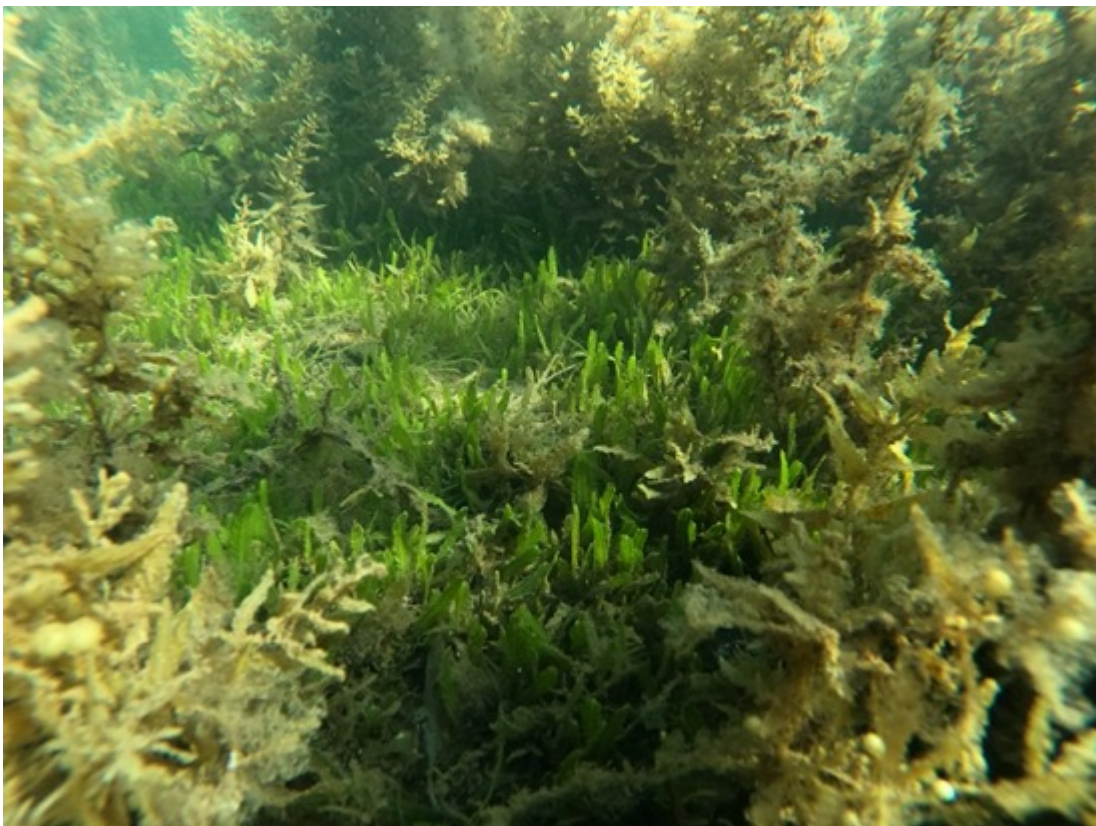
**Figure 10** *Caulerpa taxifolia* patches in-between upper sub-tidal basement rock *Sargassum* habitat confined to larger rocks and rubble.

- The upper to mid subtidal rock rubble over basement rock habitat (blue to green lines in **Figure 6**), supported a *Sargassum* dominated cover on the rock and rubble surfaces with the listed pest green algae *Caulerpa taxifolia* established on the basement rock between rubble and boulders (**Figure 10**). The proportion of *Caulerpa* cover increased offshore as the proportion of exposed rock rubble decreased (**Figure 11**) and lower subtidal sediment seabed habitat supported a dense *Caulerpa taxifolia* cover that extended out offshore from the study area (**Figures 12 & 13**).

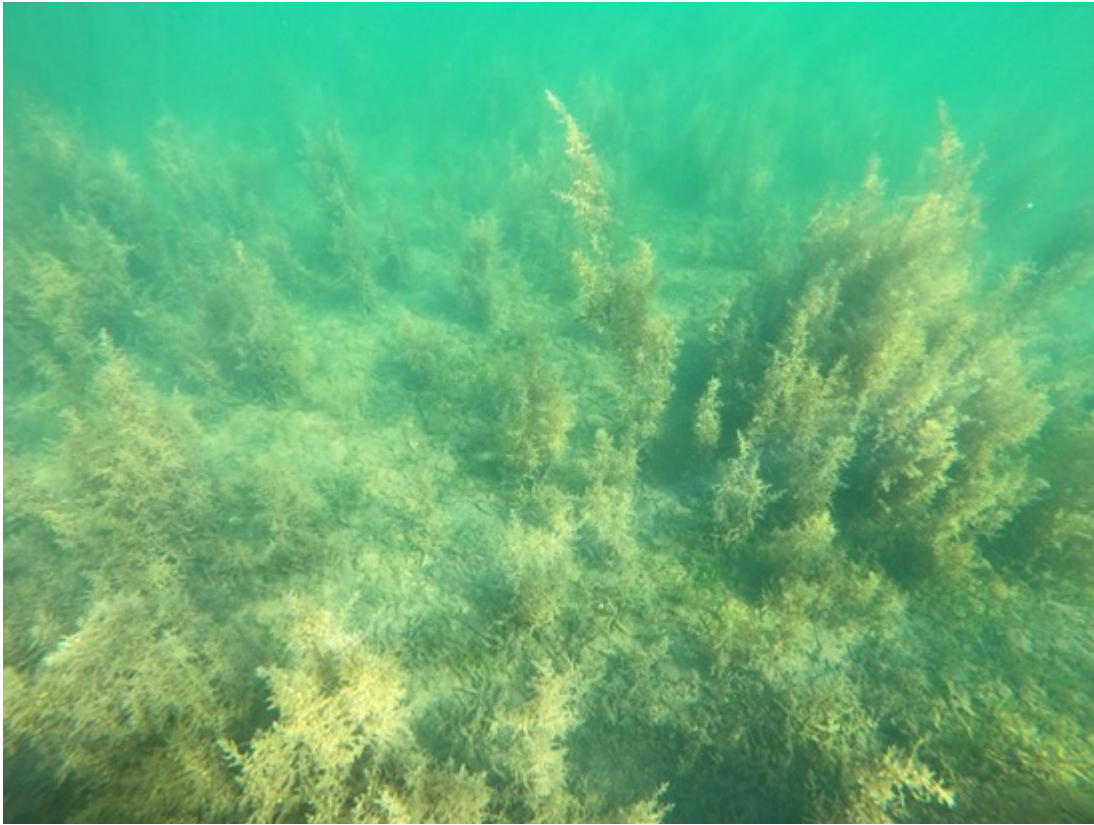
**Figure 11** *Sargassum* sp. on deeper subtidal sediment and rock rubble seabed habitat with dense *Caulerpa taxifolia* cover between rubble.

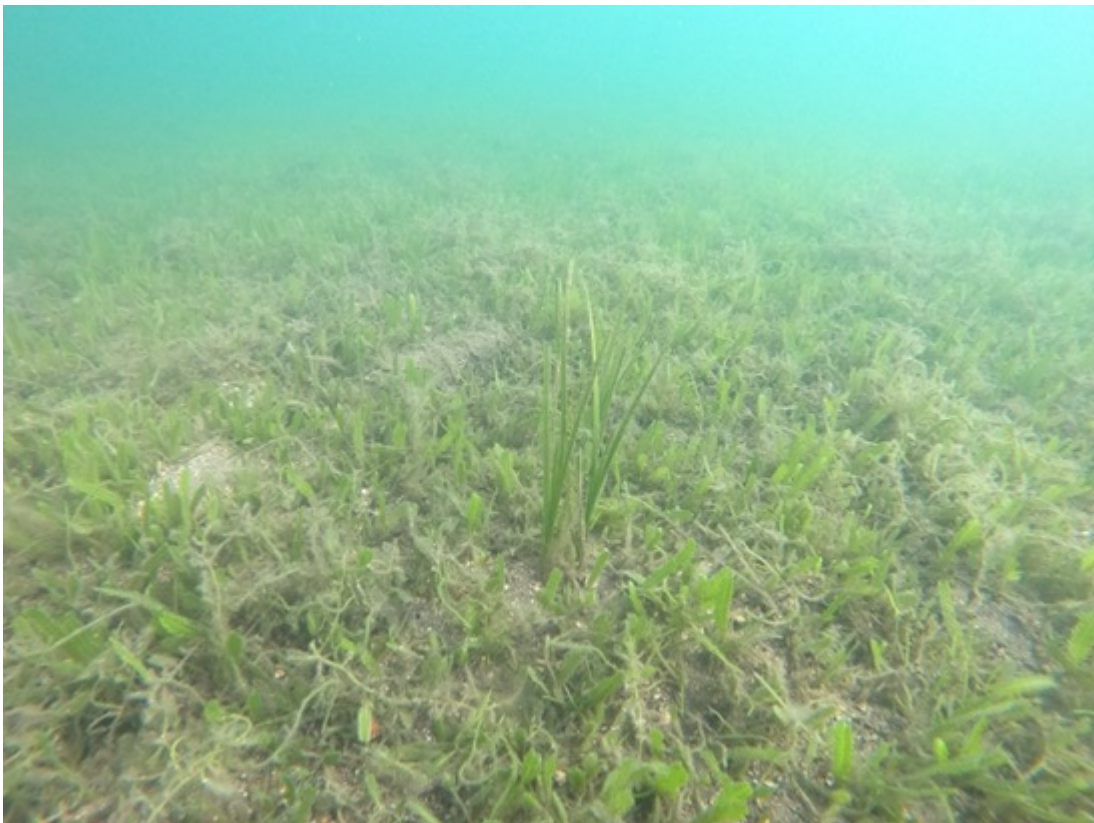
**Figure 12** Only one isolated *Zostera* seagrass patch with four shoots was discovered within the dense *Caulerpa taxifolia* offshore from the sliprails.

- Detailed searches were made throughout the study area for seagrasses with two patches found (**Figure 6**); a patch with four shoots of *Zostera sp.* was located approximately 3m offshore from the end of the sliprails (**Figure 12**), and a group of six shoots of *Posidonia* was located approximately 20m offshore to the south from the end of the jetty (**Figure 13**).

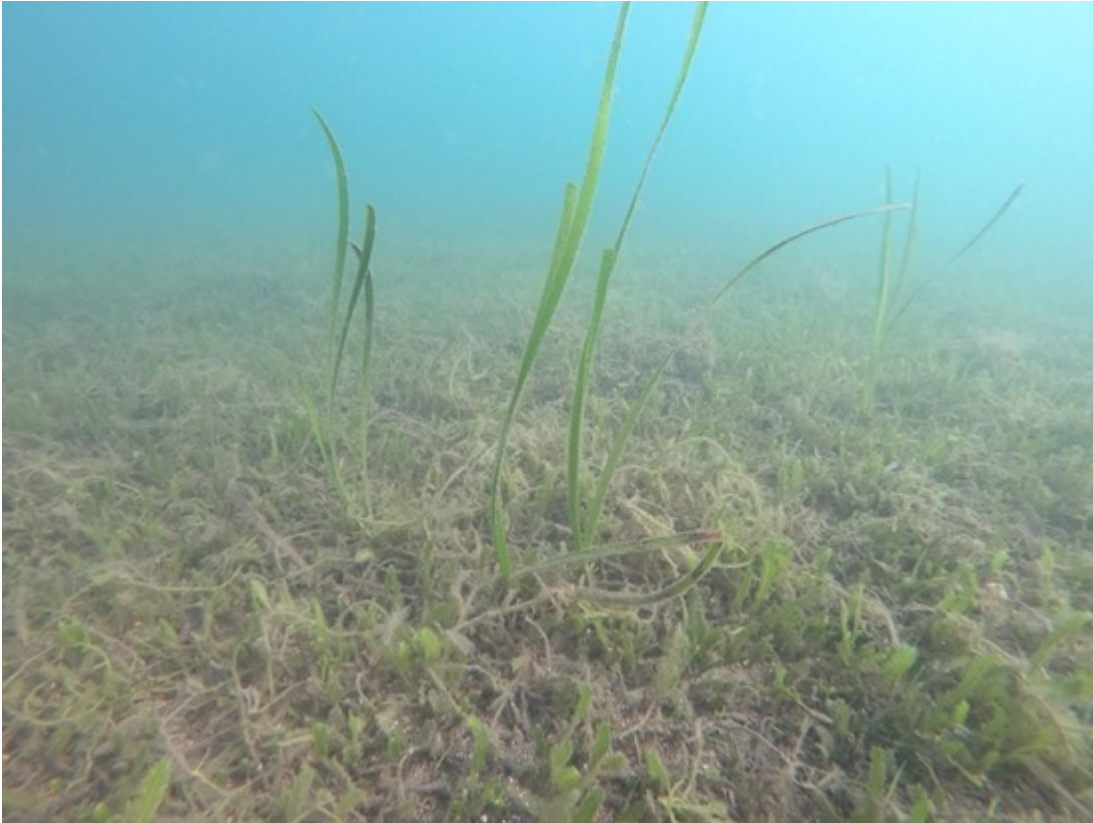
**Figure 13** Only one patch of *Posidonia* seagrass (with 6 shoots) was located within the dense *Caulerpa taxifolia* bed offshore from the existing facility.

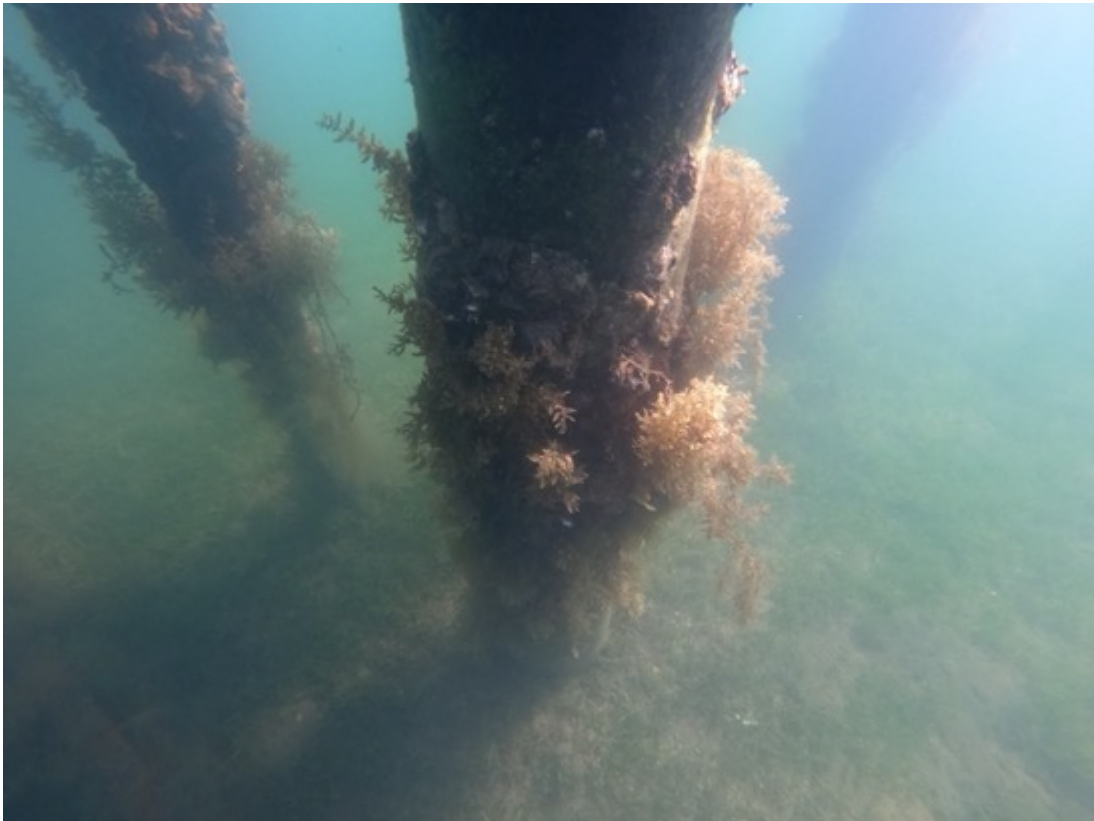
**Figure 16** Oysters on intertidal pile sections with *Sargassum* in the shallow subtidal below.

- The slipway rails supported oysters in the intertidal with *Sargassum* and *Colpomenia* algae habitat sub-tidally (**Figures 14 & 15**).
- The jetty piles supported oyster bands in the intertidal with barnacles, bryozoans, *Sargassum* and *Dictyota* algae below (**Figures 16 & 17**).

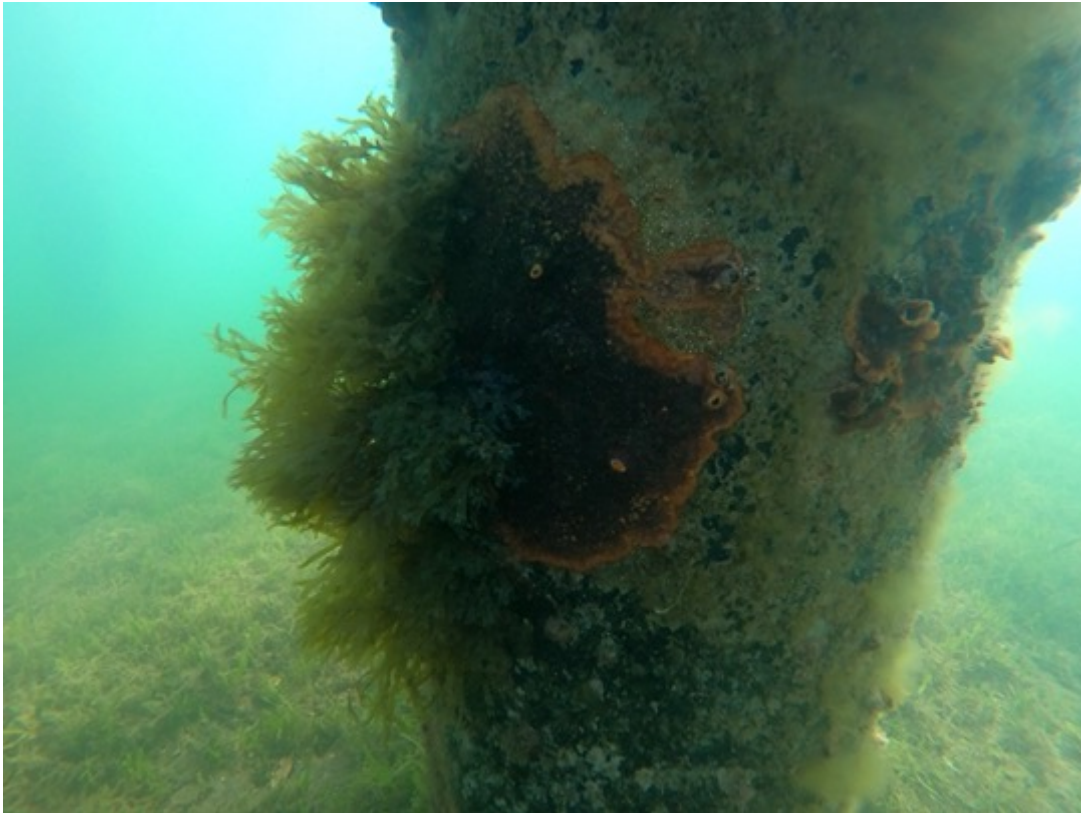
**Figure 17** Barnacles, bryozoans and *Dictyota* algae on deeper subtidal pile sections.

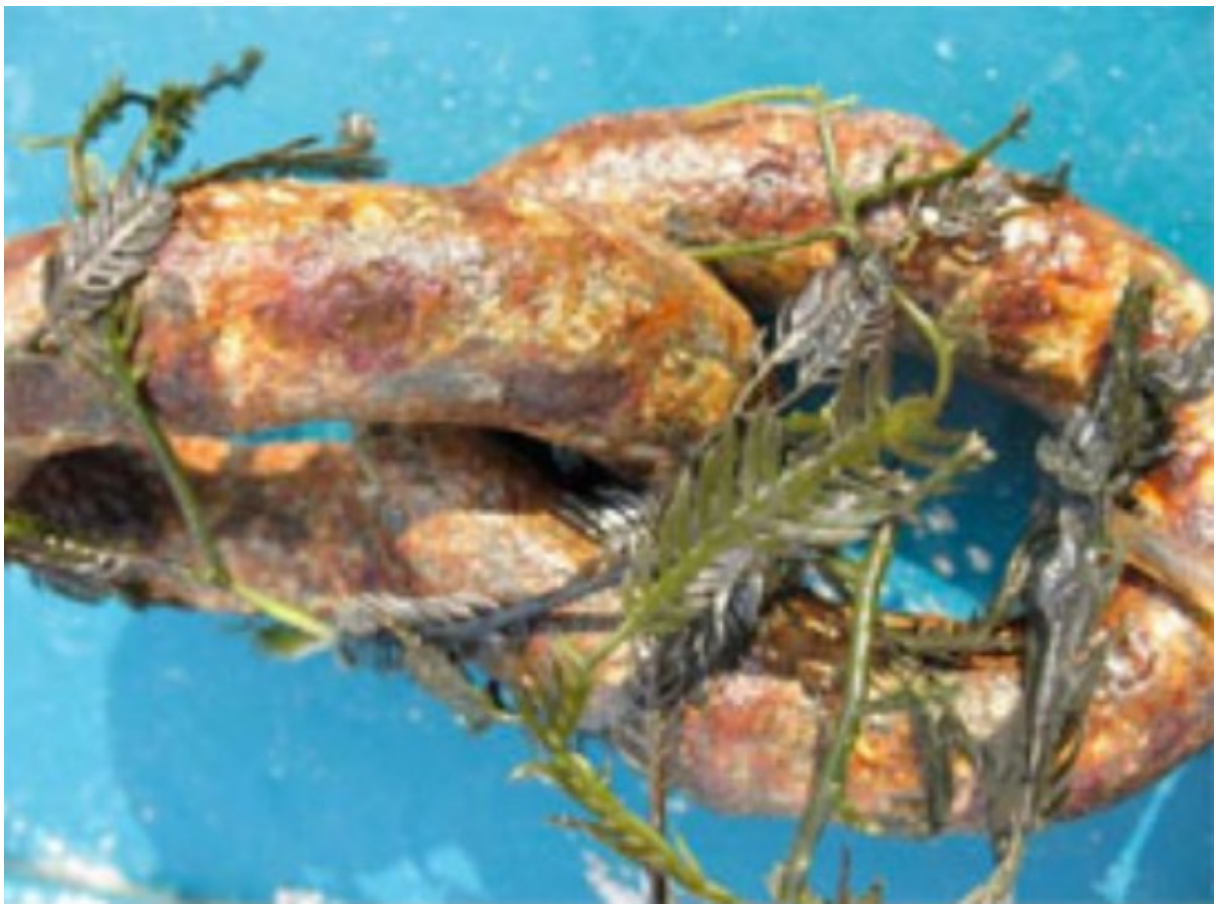
**Figure 18** The pest algae *Caulerpa taxifolia* attached to a segment of chain.

Construction activities may also disturb and mobilise *Caulerpa taxifolia* fragments and fragments can adhere to equipment (ropes, cable, anchors) that can then be transported to other estuaries to infest these estuaries when the equipment is re-deployed (see **Figure 18**).
