## AS2870-2011 SITE CLASSIFICATION

**Lot 4, No 12 Rowe Street  
Freshwater NSW**

Our REF: AWT 82280

AS2870 SITE CLASSIFICATION
<b>Class P</b>
ESTIMATED AS4055-2021 WIND CLASSIFICATION
<b>N2</b>

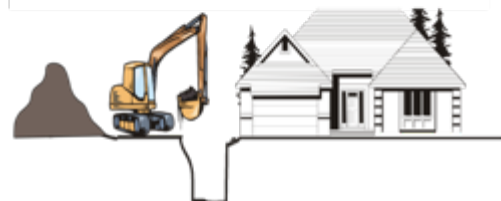
Fig. 11 De-stabilizing house foundations

- Ensuring that excavations are well supported or are dug to avoid collapses. (Fig. 11)
- Constructing well-compacted and retained 'soil aprons' around the building to stop erosion.

- Special considerations if any excavations are to be dug near adjoining structures. (Fig. 11)
- Sloping the soil and paths away from the building by the minimum amount required by the building regulations to prevent water flowing towards the building foundations. (Fig. 10 & 18)

- Running machinery over shallow drain pipes may break them causing leaks and subsequent foundation movements.
- Any excavations close to building footings can cause them to sink by disturbing the foundation material or by drying the foundation clay. (Fig 11)
