Bayview Golf Club

Acid Sulfate Soil Management Plan:
Green Renovation Works
Bayview Golf Course, Cabbage Tree
Road, Bayview, NSW

P2309440JR03V01

April 2023

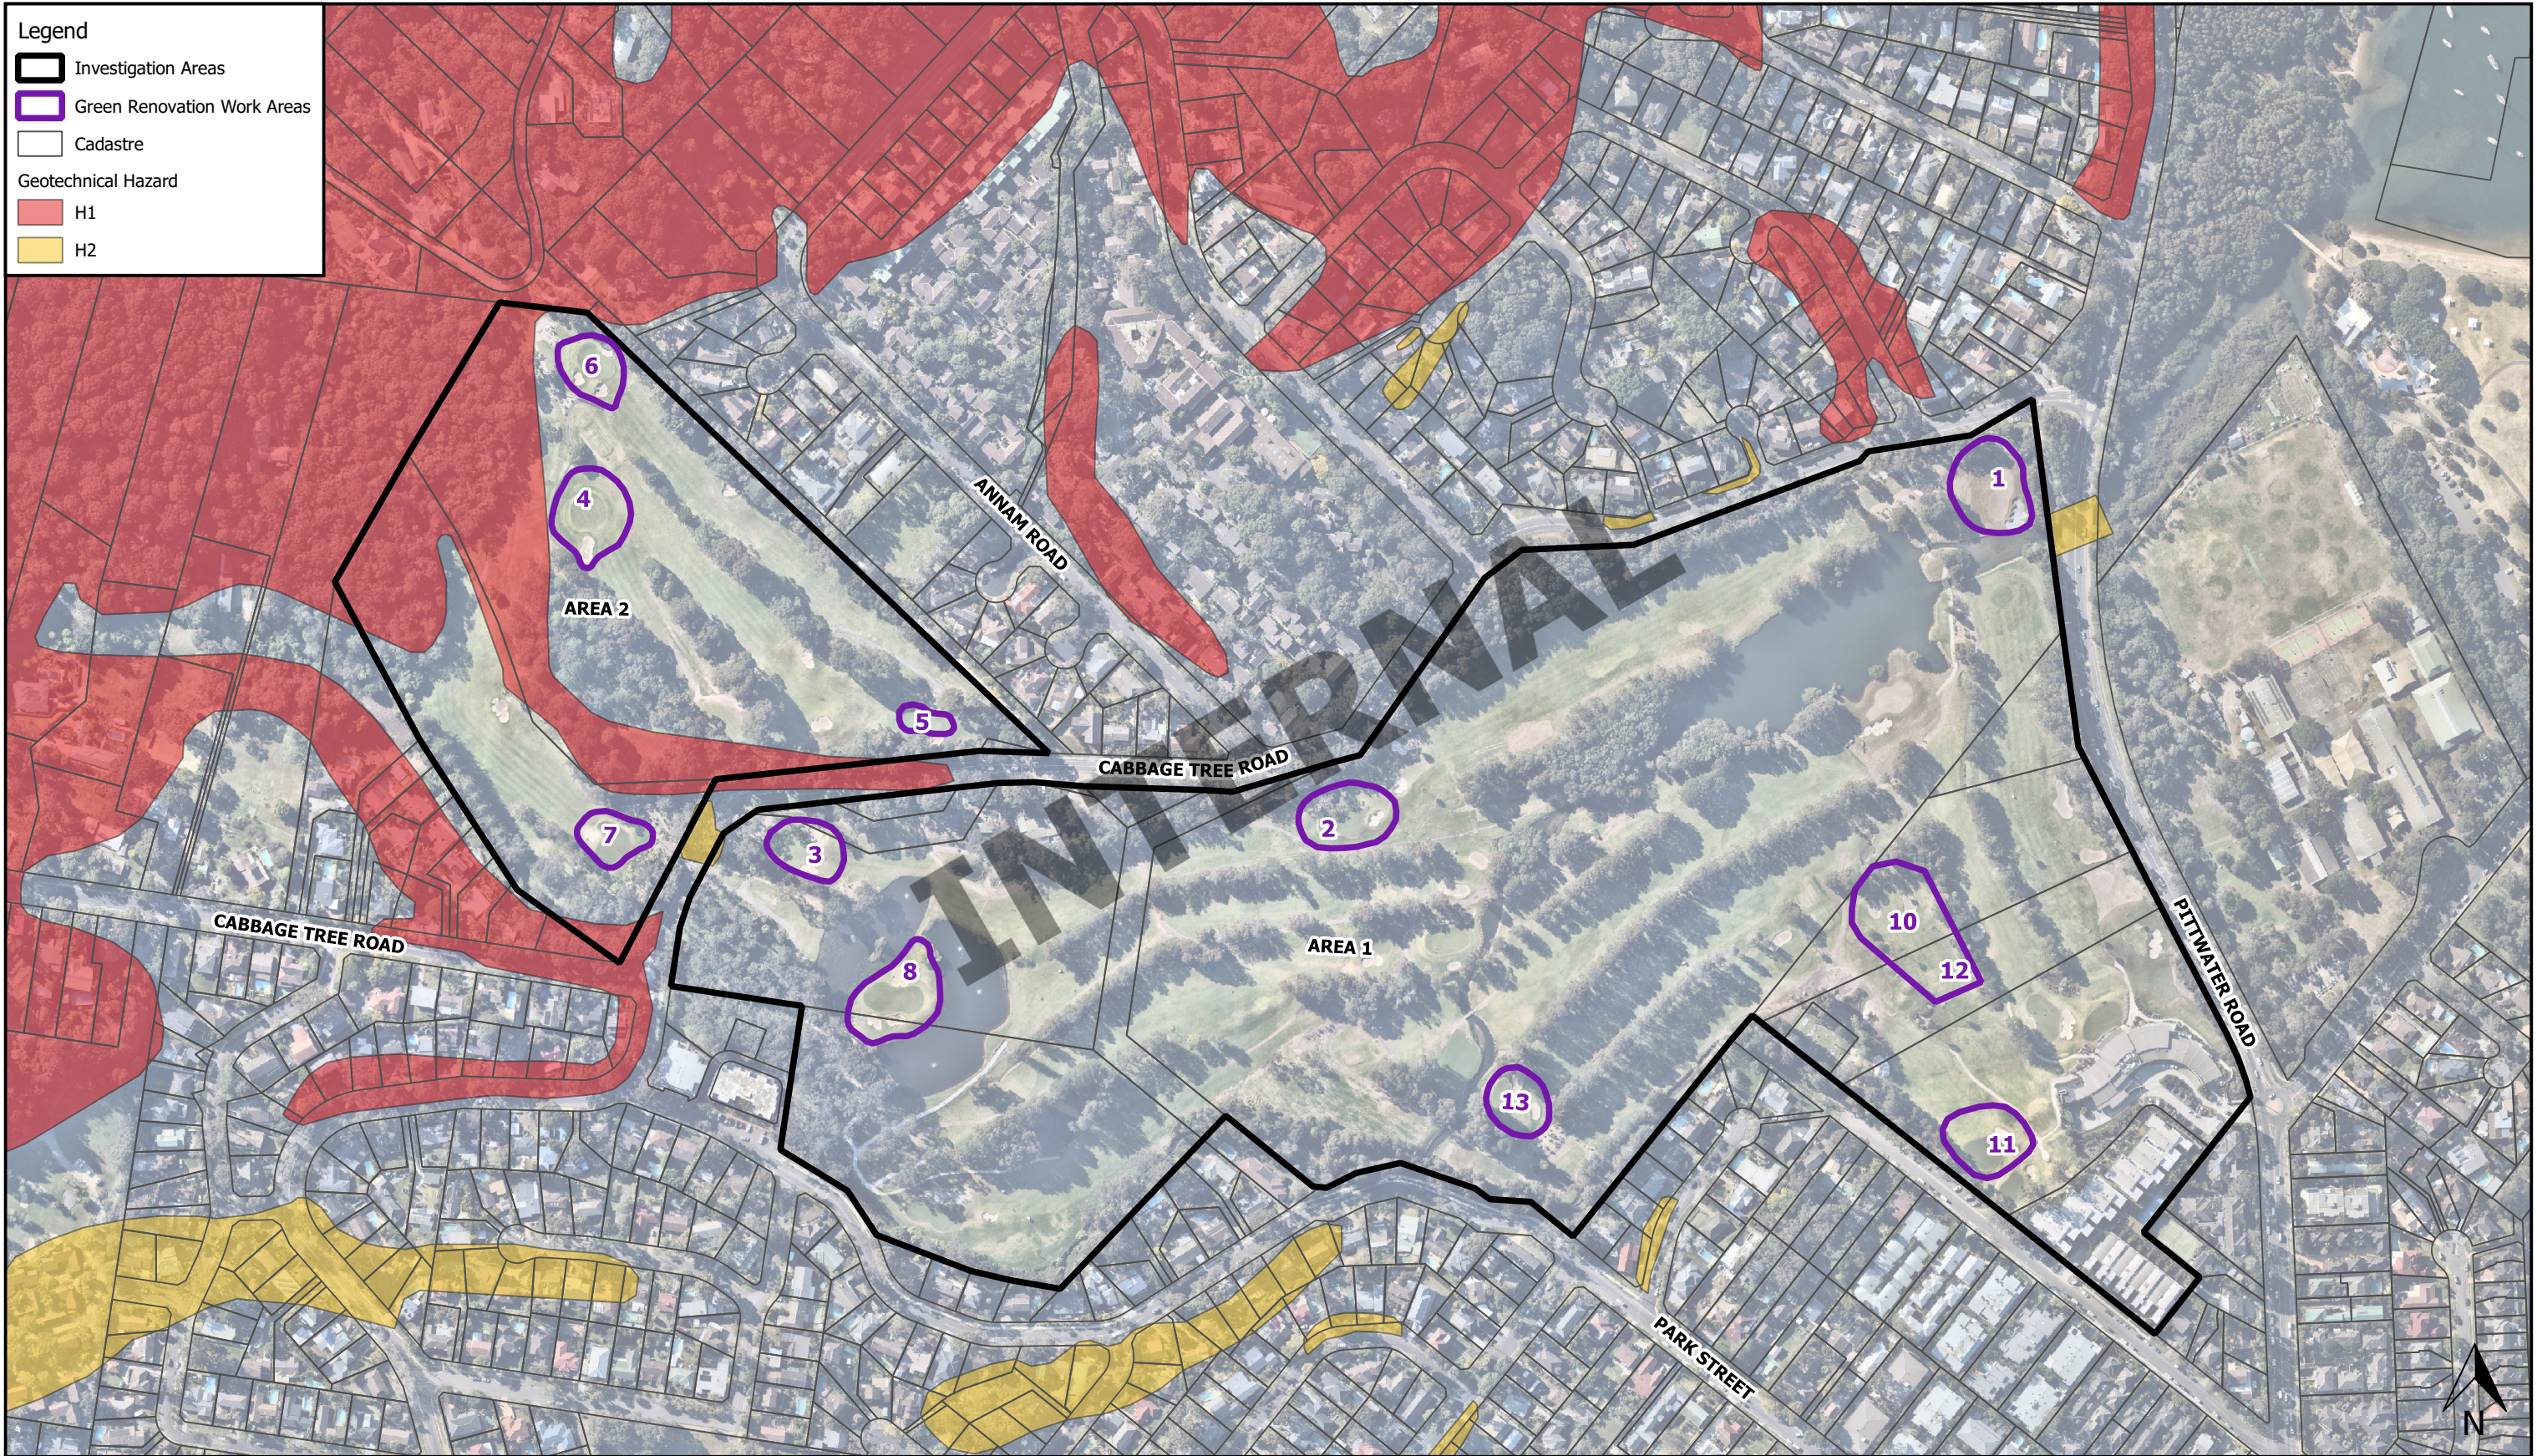
Map Title / Figure:
Geotechnical Hazard Identification

Geotechnical Hazard

- H1
- H2

Notes:
 - Aerial from Nearmap (2021)
 - Cadastre from NSW DFSI Clip and Ship (2023)
 - Geotechnical hazard areas from Pittwater Local Environmental Plan LEP 2014

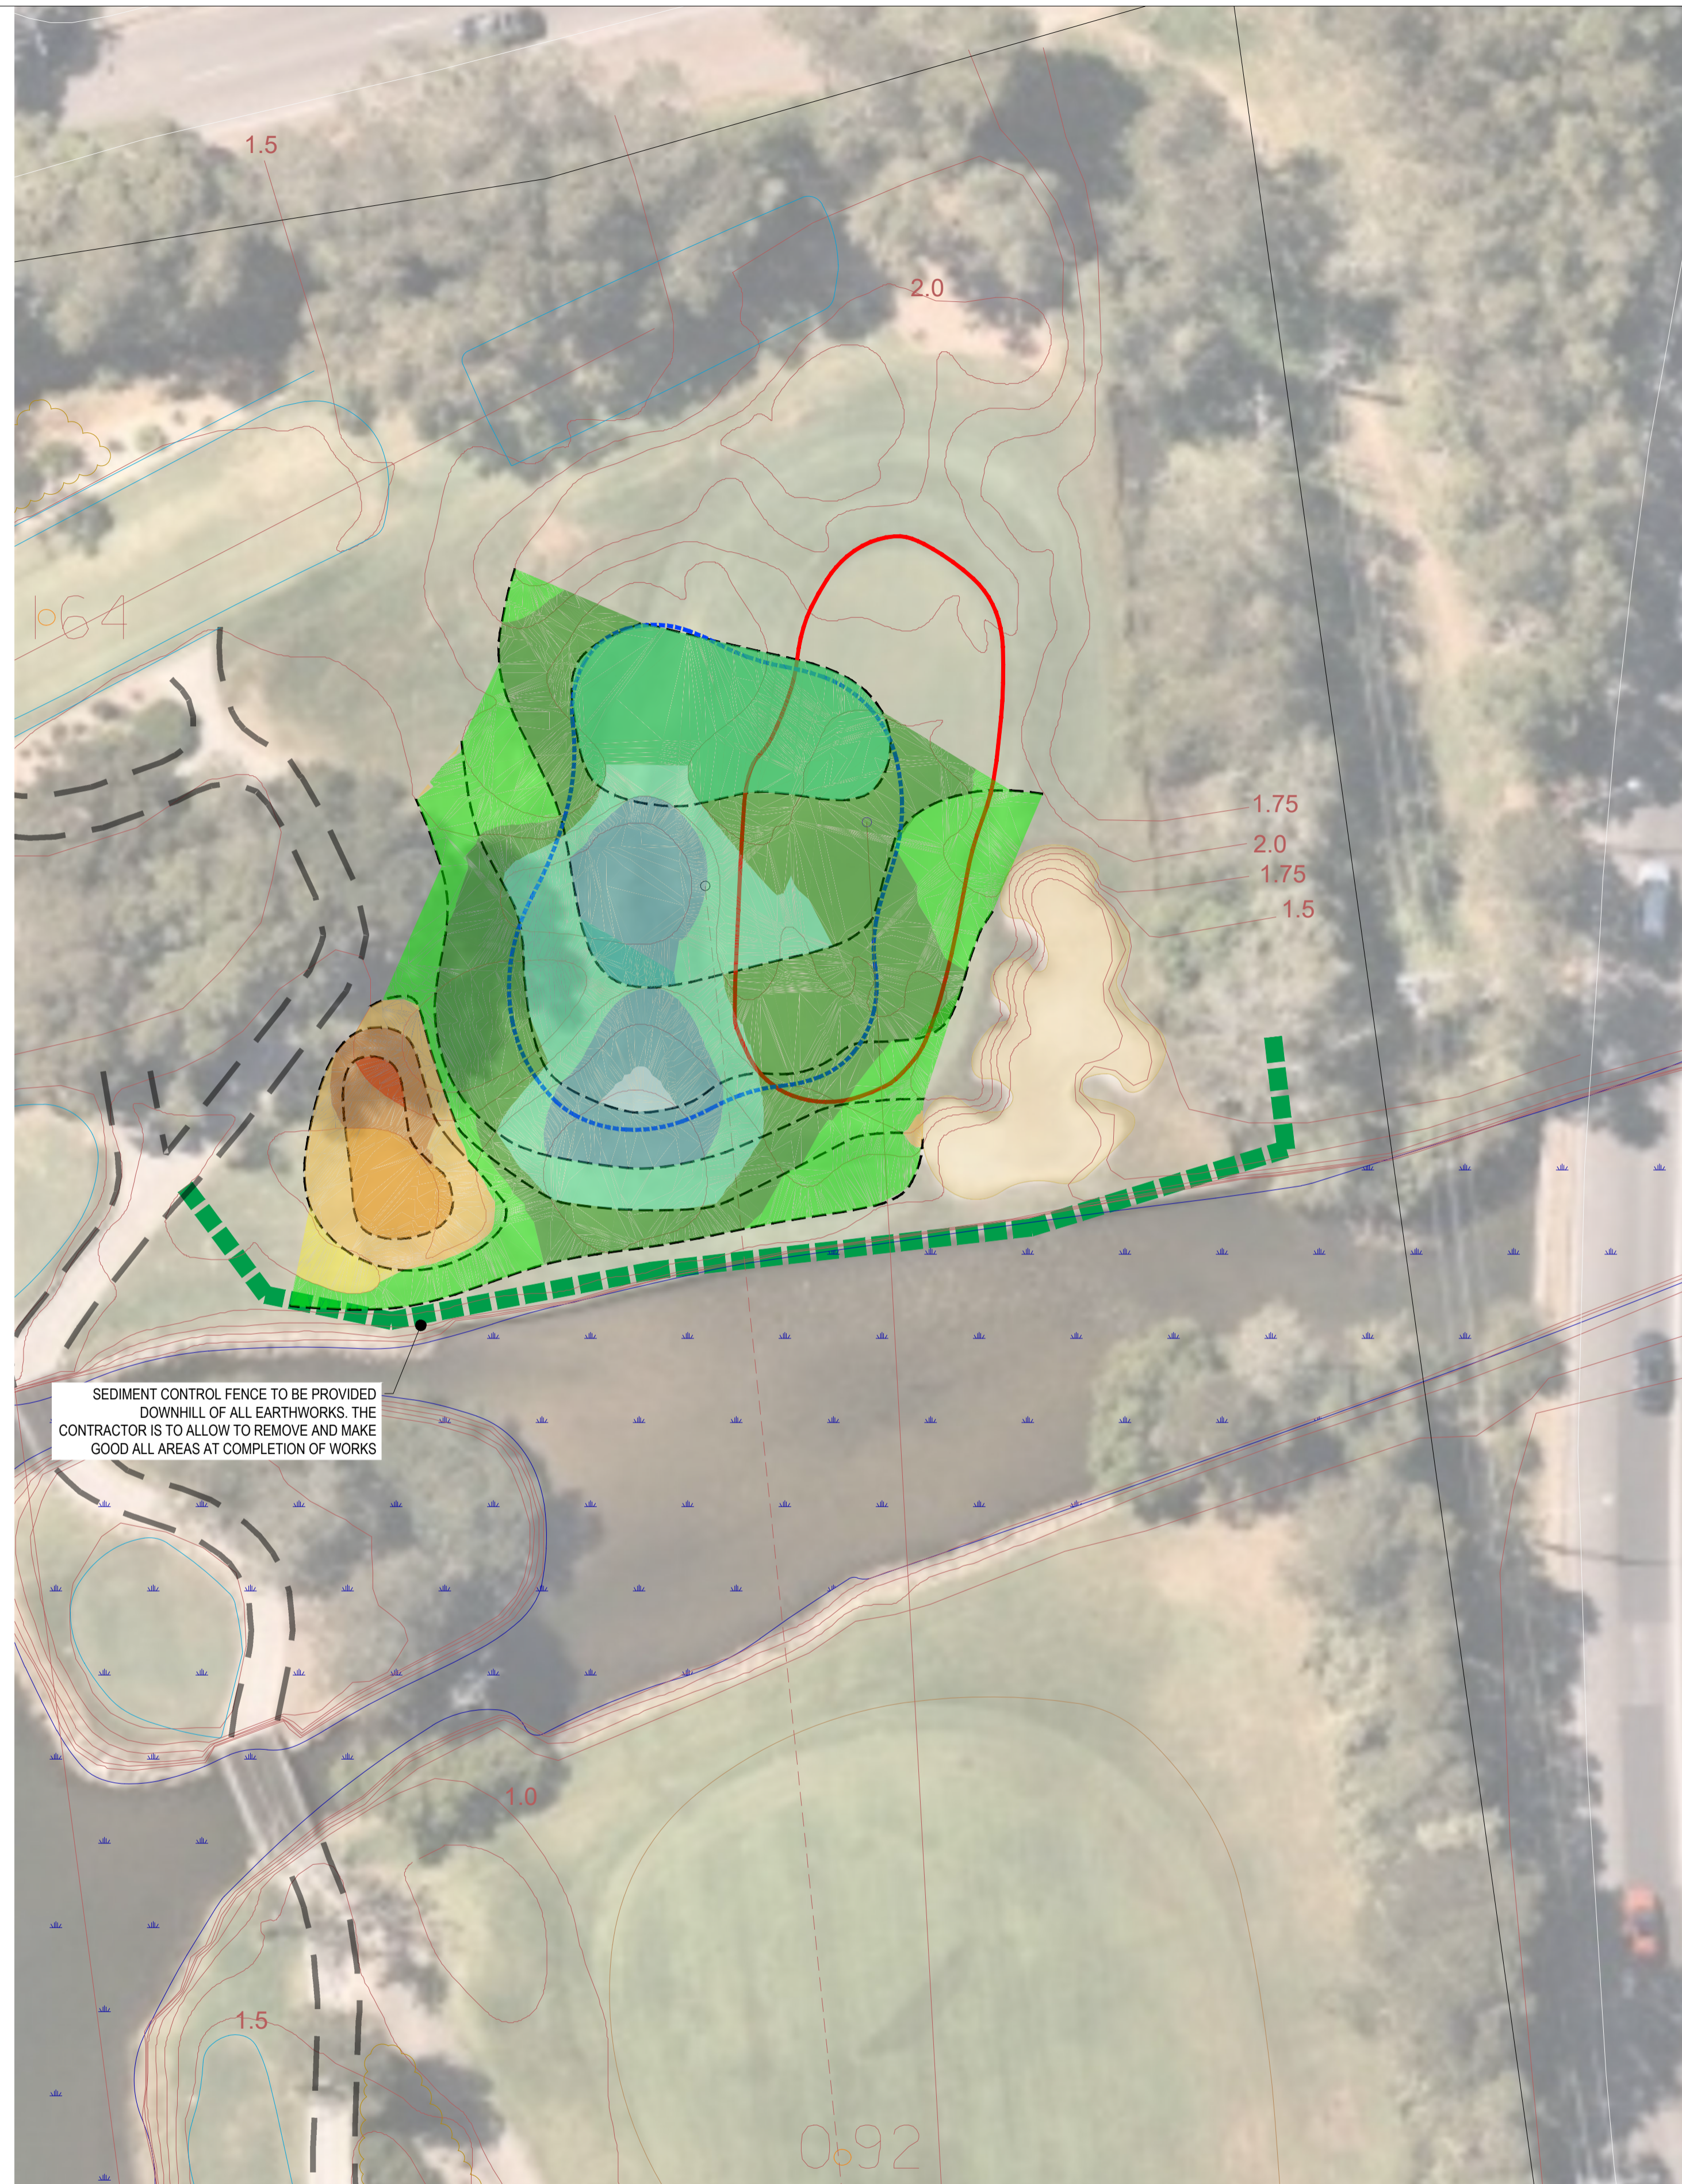
CUT & FILL LEGEND

FROM	TO
	-2.00	-1.75
	-1.75	-1.50
	-1.50	-1.25
	-1.25	-1.00
	-1.00	-0.75
	-0.75	-0.50
	-0.50	-0.25
	-0.25	-0.001
	-0.000	0.000
	0.001	0.25
	0.25	0.50
	0.50	0.75
	0.75	1.00
	1.00	1.25
	1.25	1.50

CUT AND FILL VOLUMES

Assessment Surfaces	Volumes m3	Hole												TOTAL m3
		1st	2nd	3rd	4th	5th	6th	7th	8th	10th	11th	12th	13th	
Final Surface	Cut	26	40	102	1230	35	1026	103	193	5	1060	0	6	3826
v	Fill	461	149	188	3	199	38	125	44	549	7	470	432	2665
Existing Surface	Balance	435	109	86	-1227	164	-988	22	-149	544	-1053	470	426	-1161

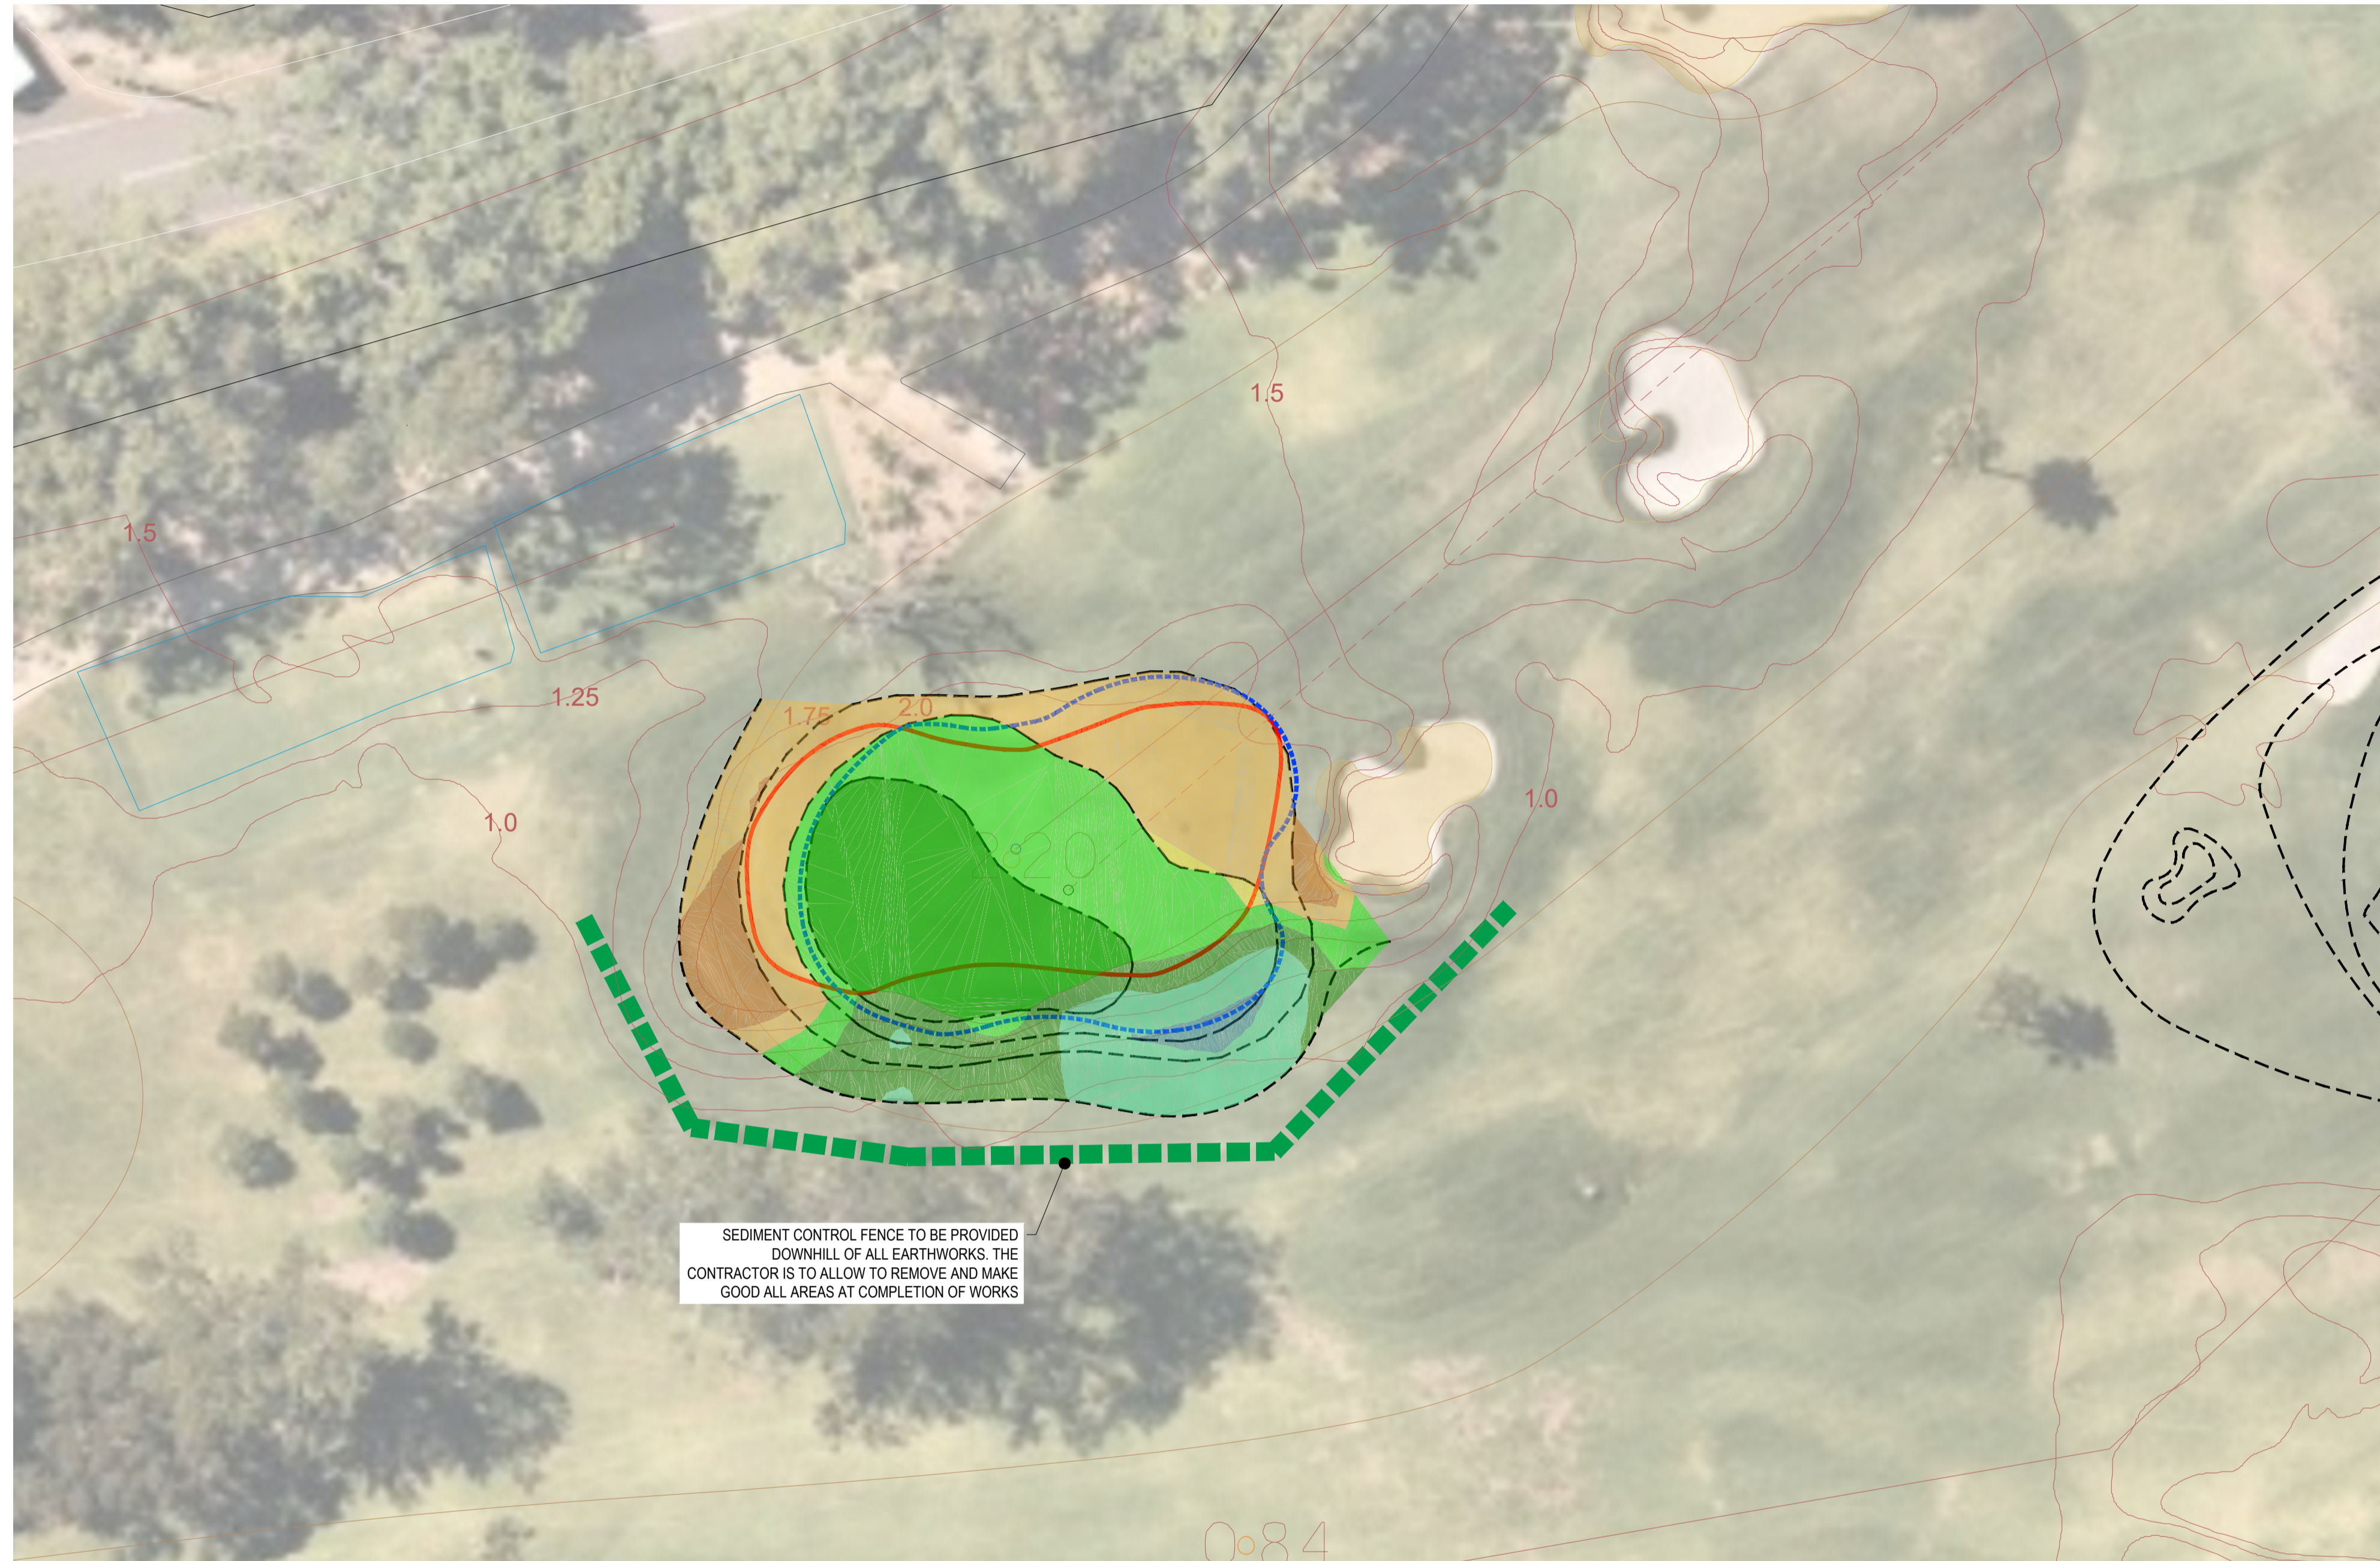
CUT & FILL LEGEND

FROM	TO
	-2.00 -1.75
	-1.75 -1.50
	-1.50 -1.25
	-1.25 -1.00
	-1.00 -0.75
	-0.75 -0.50
	-0.50 -0.25
	-0.25 -0.001
	-0.000 0.000
	0.001 0.25
	0.25 0.50
	0.50 0.75
	0.75 1.00
	1.00 1.25
	1.25 1.50

CUT AND FILL VOLUMES

Assessment Surfaces	Volumes m3	Hole											TOTAL m3	
		1st	2nd	3rd	4th	5th	6th	7th	8th	10th	11th	12th		13th
Final Surface	Cut	26	40	102	1230	35	1026	103	193	5	1060	0	6	3826
v	Fill	461	149	188	3	199	38	125	44	549	7	470	432	2665
Existing Surface	Balance	435	109	86	-1227	164	-988	22	-149	544	-1053	470	426	-1161

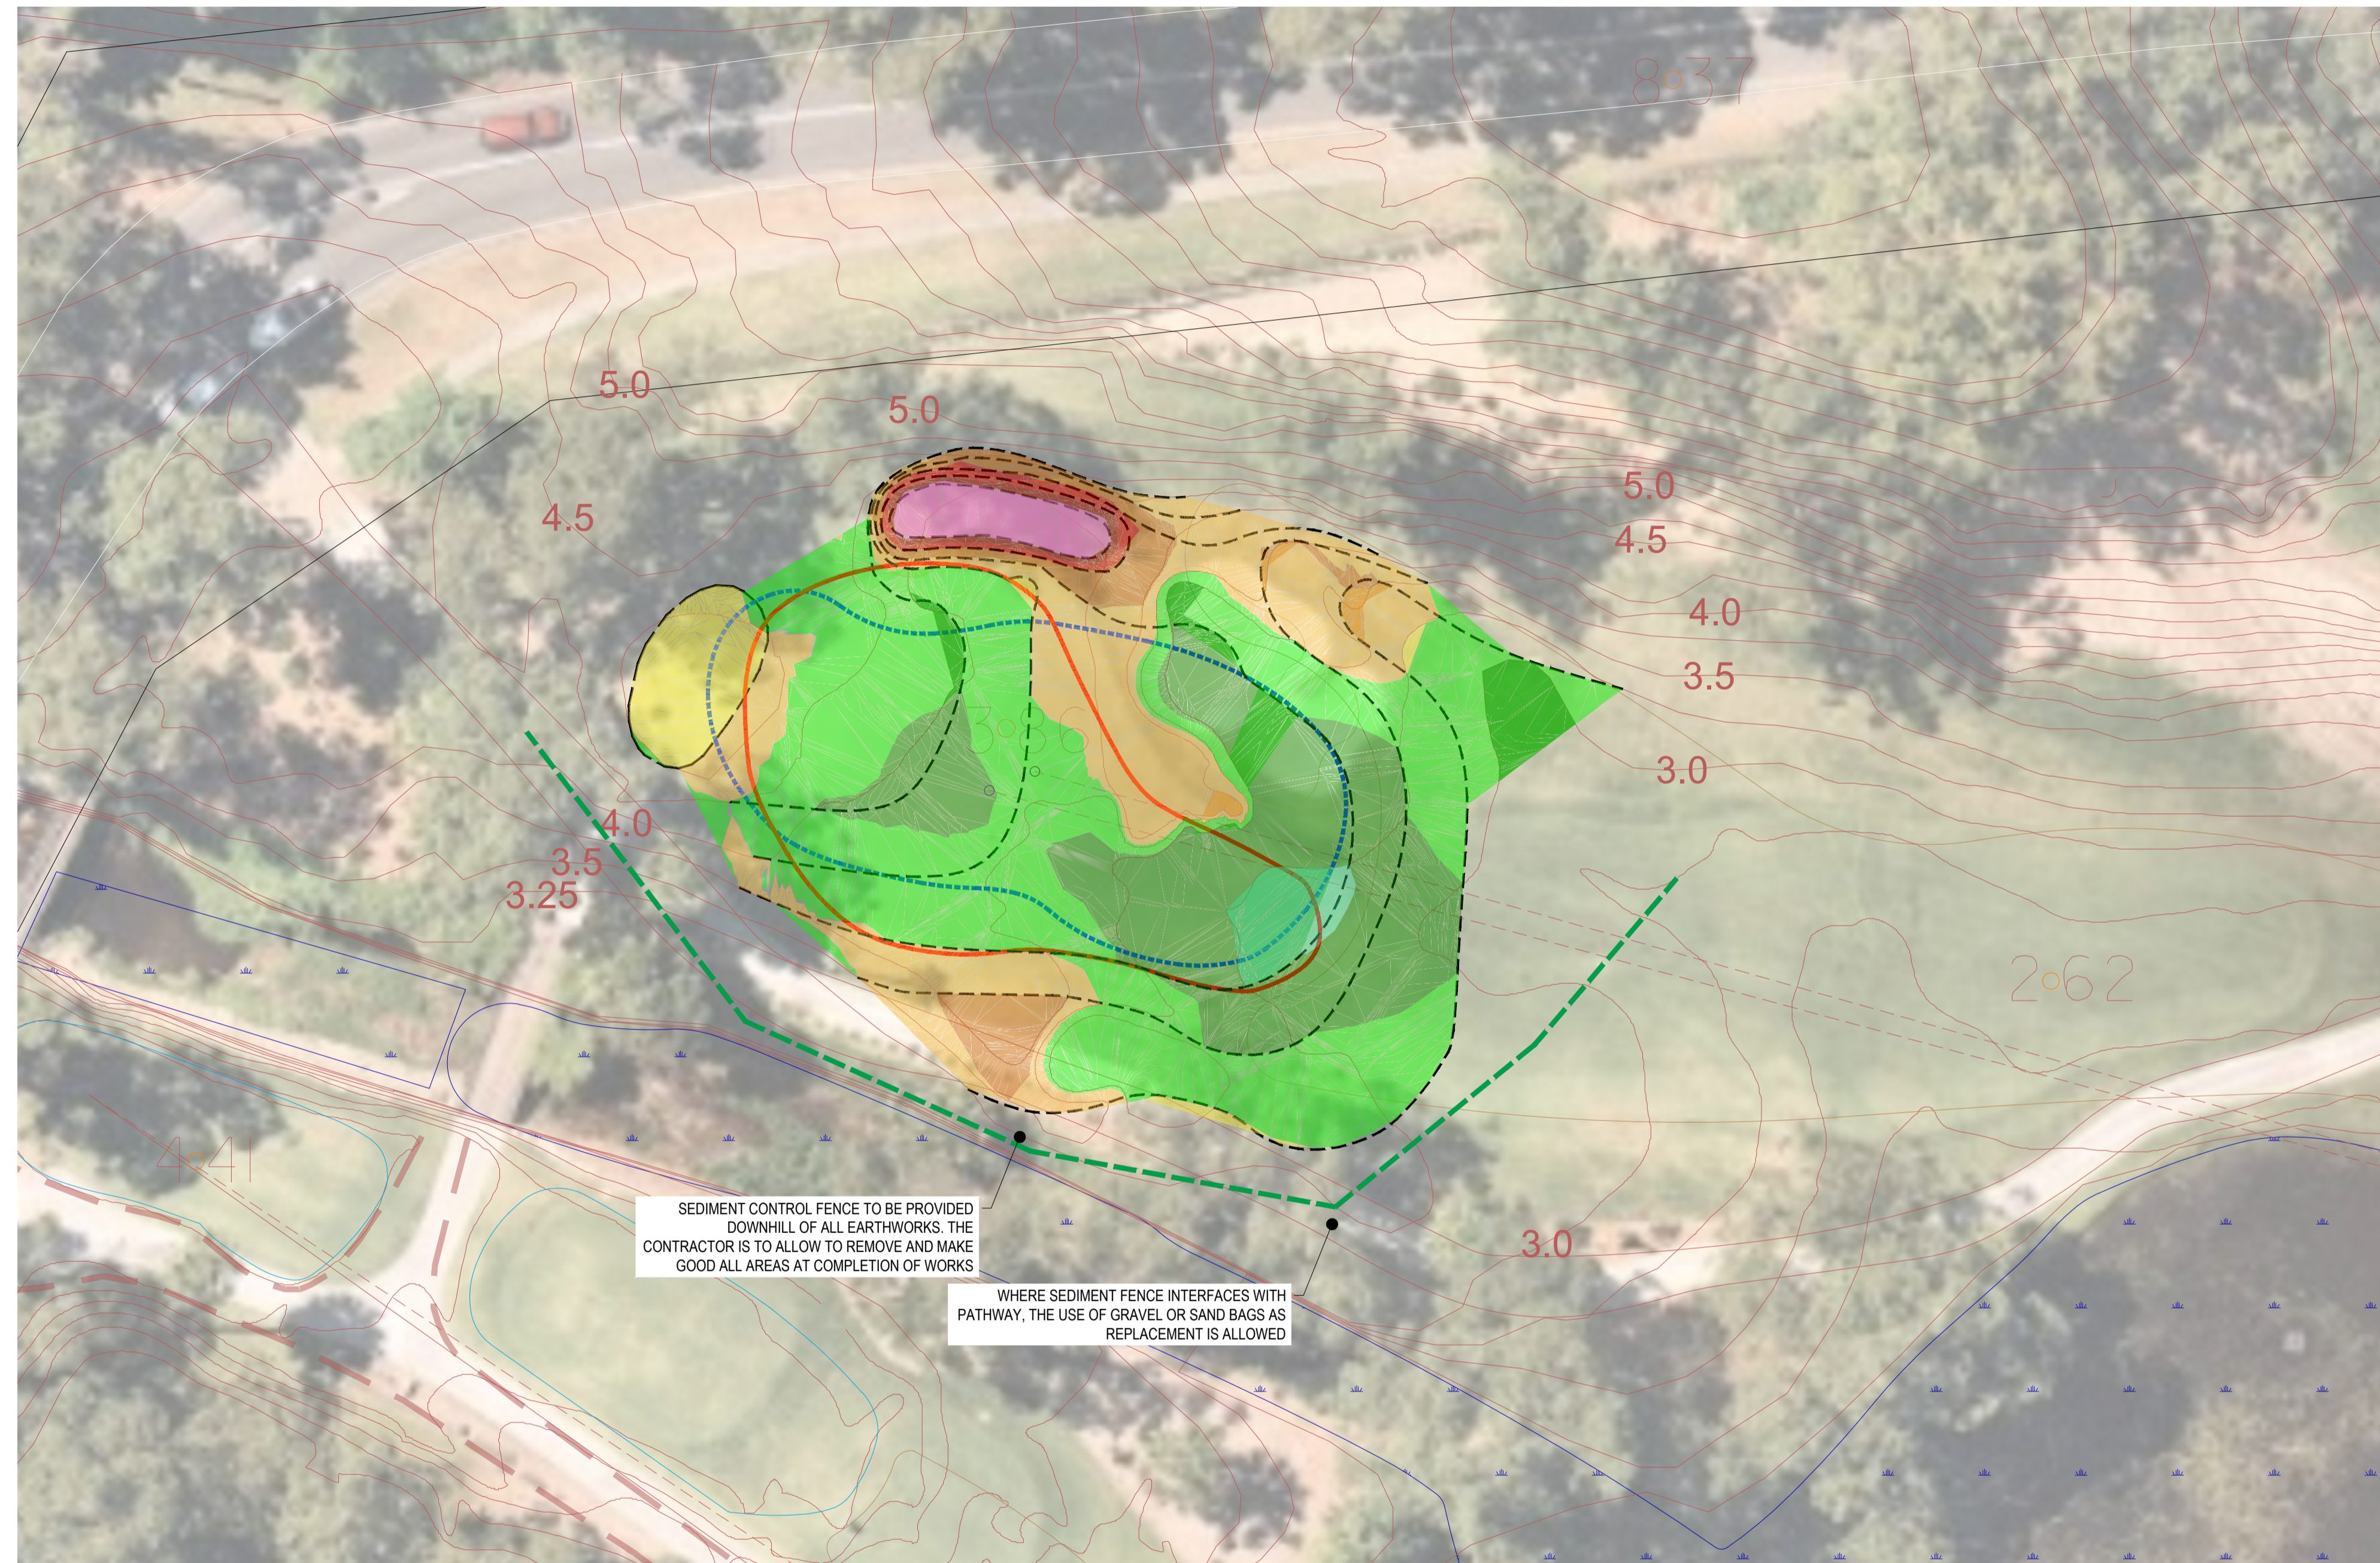
CUT & FILL LEGEND

FROM	TO
	-2.00 -1.75
	-1.75 -1.50
	-1.50 -1.25
	-1.25 -1.00
	-1.00 -0.75
	-0.75 -0.50
	-0.50 -0.25
	-0.25 -0.001
	-0.000 0.000
	0.001 0.25
	0.25 0.50
	0.50 0.75
	0.75 1.00
	1.00 1.25
	1.25 1.50

CUT AND FILL VOLUMES

Assessment Surfaces	Volumes m3	Hole											TOTAL m3	
		1st	2nd	3rd	4th	5th	6th	7th	8th	10th	11th	12th		13th
Final Surface v Existing Surface	Cut	26	40	102	1230	35	1026	103	193	5	1060	0	6	3826
	Fill	461	149	188	3	199	38	125	44	549	7	470	432	2665
	Balance	435	109	86	-1227	164	-988	22	-149	544	-1053	470	426	-1161

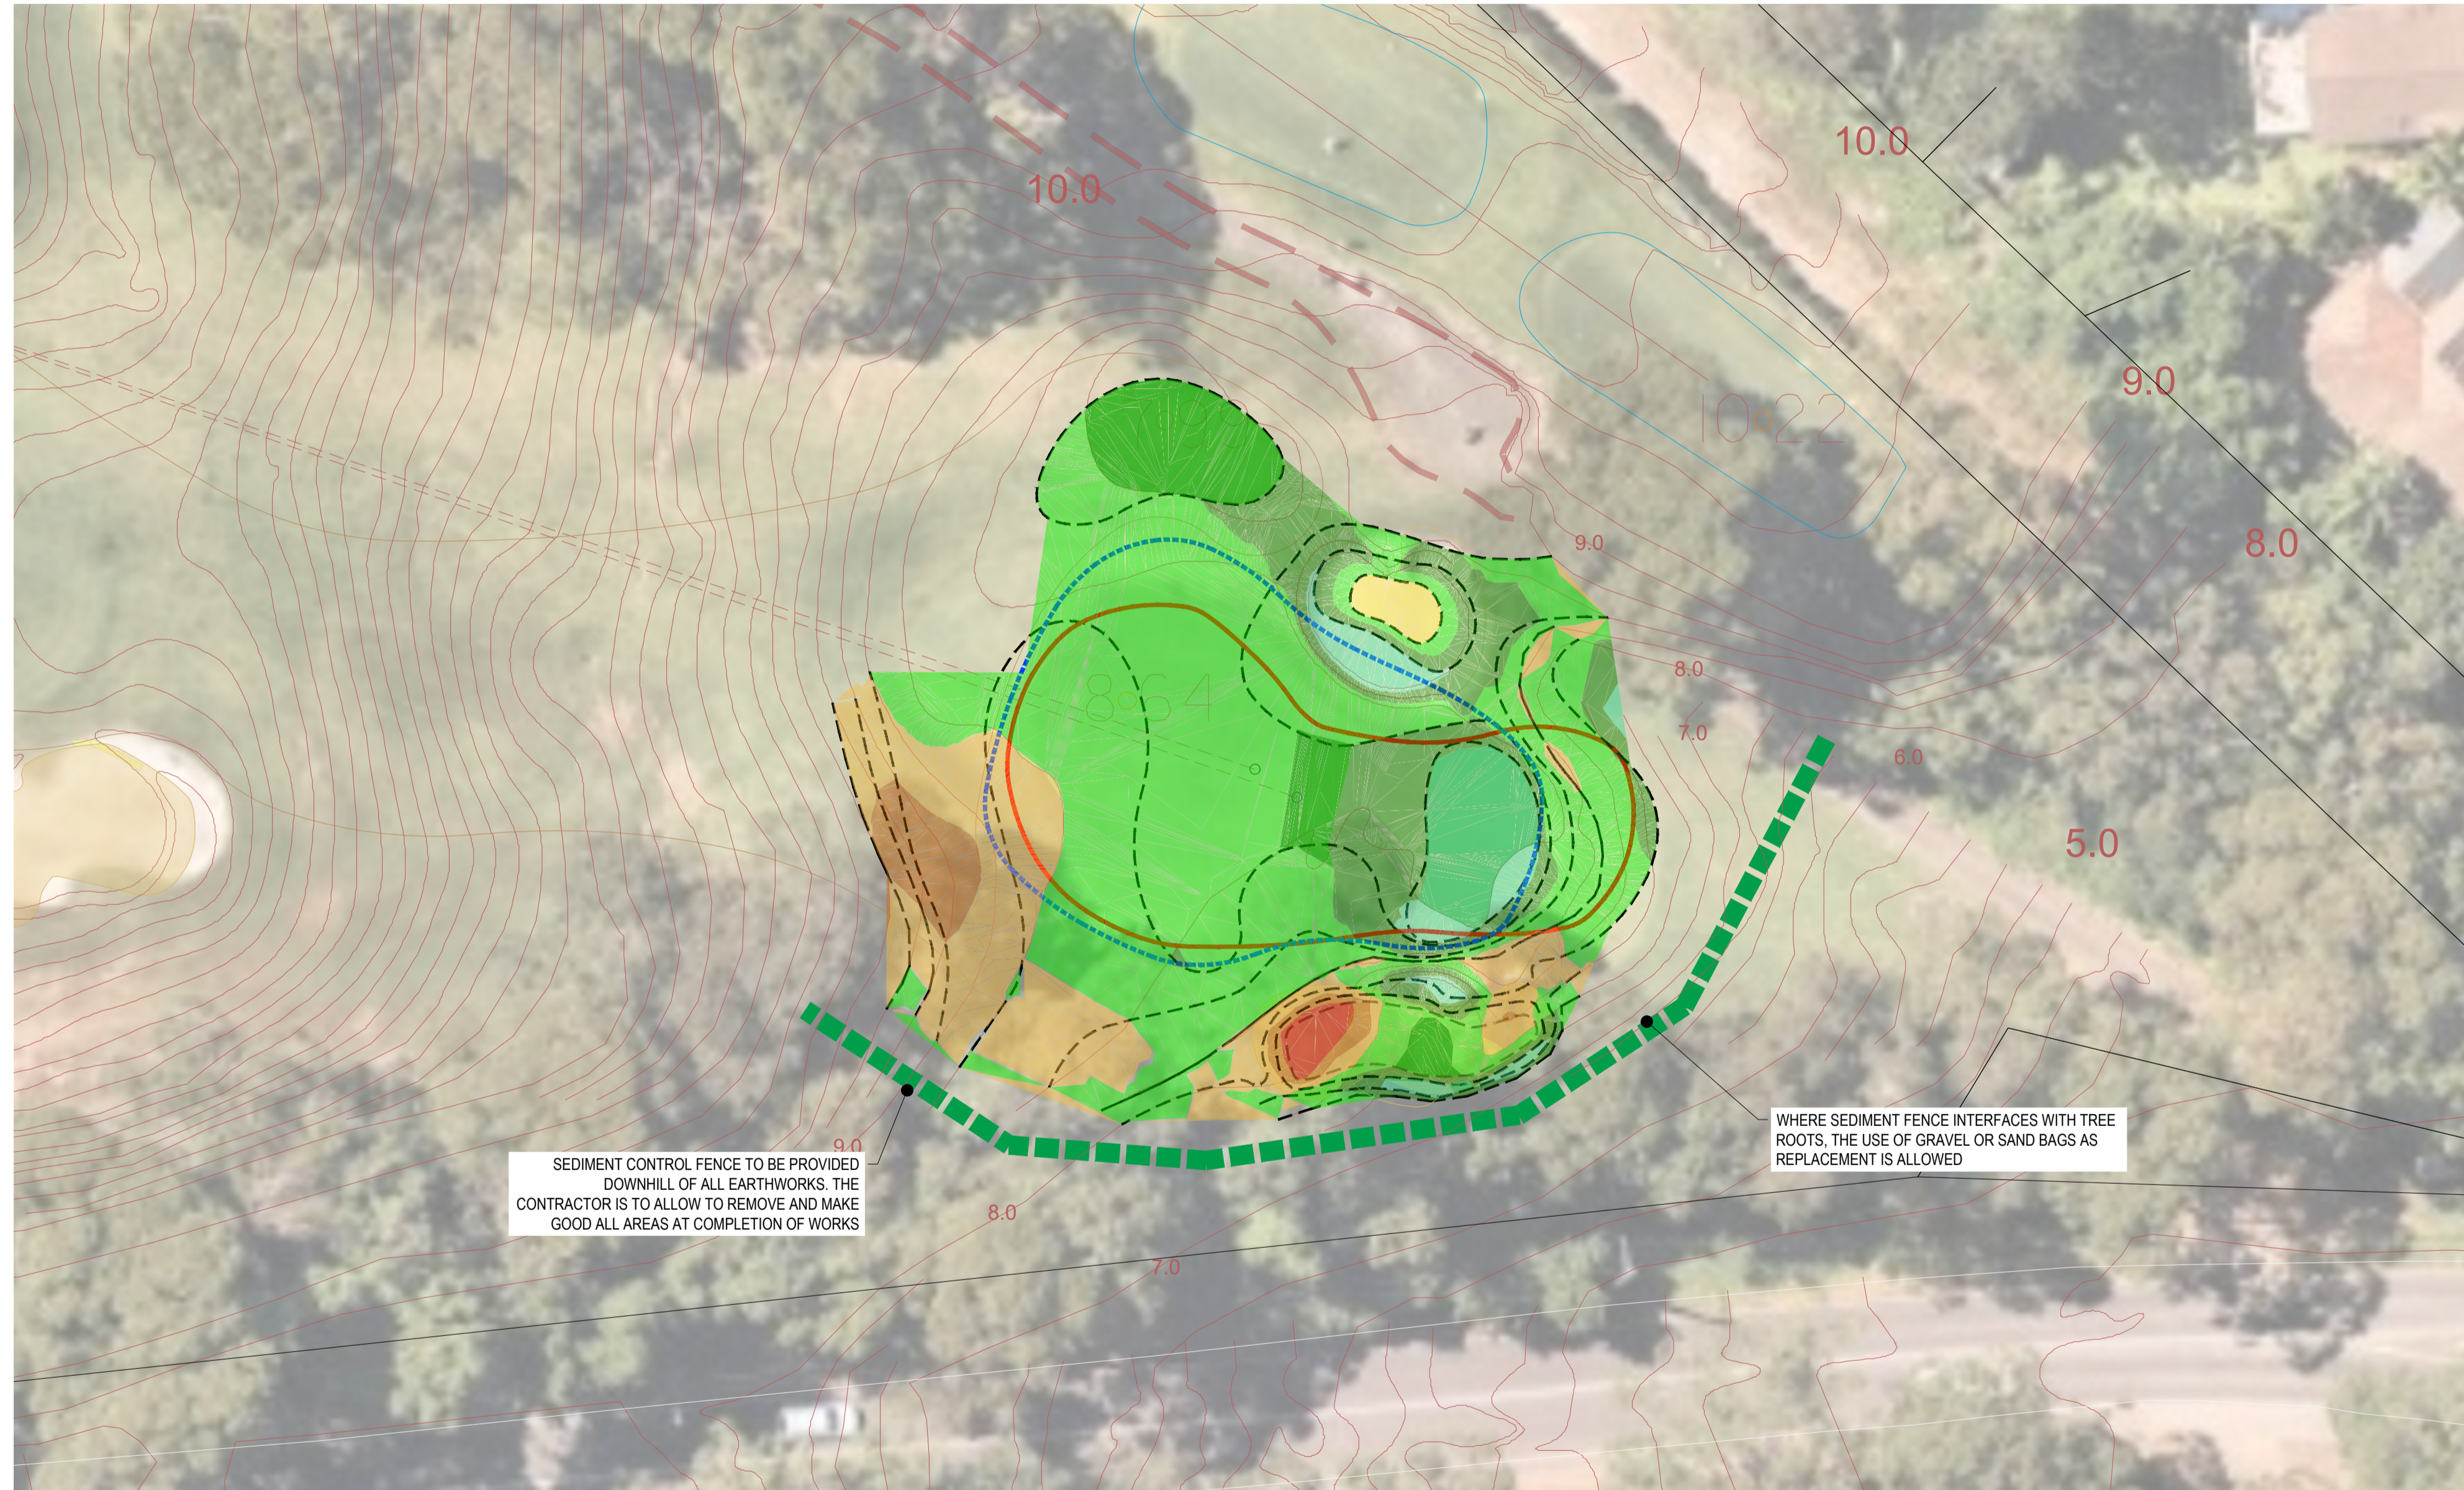
CUT & FILL LEGEND

FROM	TO
	-2.00 -1.75
	-1.75 -1.50
	-1.50 -1.25
	-1.25 -1.00
	-1.00 -0.75
	-0.75 -0.50
	-0.50 -0.25
	-0.25 -0.001
	-0.000 0.000
	0.001 0.25
	0.25 0.50
	0.50 0.75
	0.75 1.00
	1.00 1.25
	1.25 1.50

CUT AND FILL VOLUMES

Assessment Surfaces	Volumes m3	Hole											TOTAL m3	
		1st	2nd	3rd	4th	5th	6th	7th	8th	10th	11th	12th		13th
Final Surface v Existing Surface	Cut	26	40	102	1230	35	1026	103	193	5	1060	0	6	3826
	Fill	461	149	188	3	199	38	125	44	549	7	470	432	2665
	Balance	435	109	86	-1227	164	-988	22	-149	544	-1053	470	426	-1161

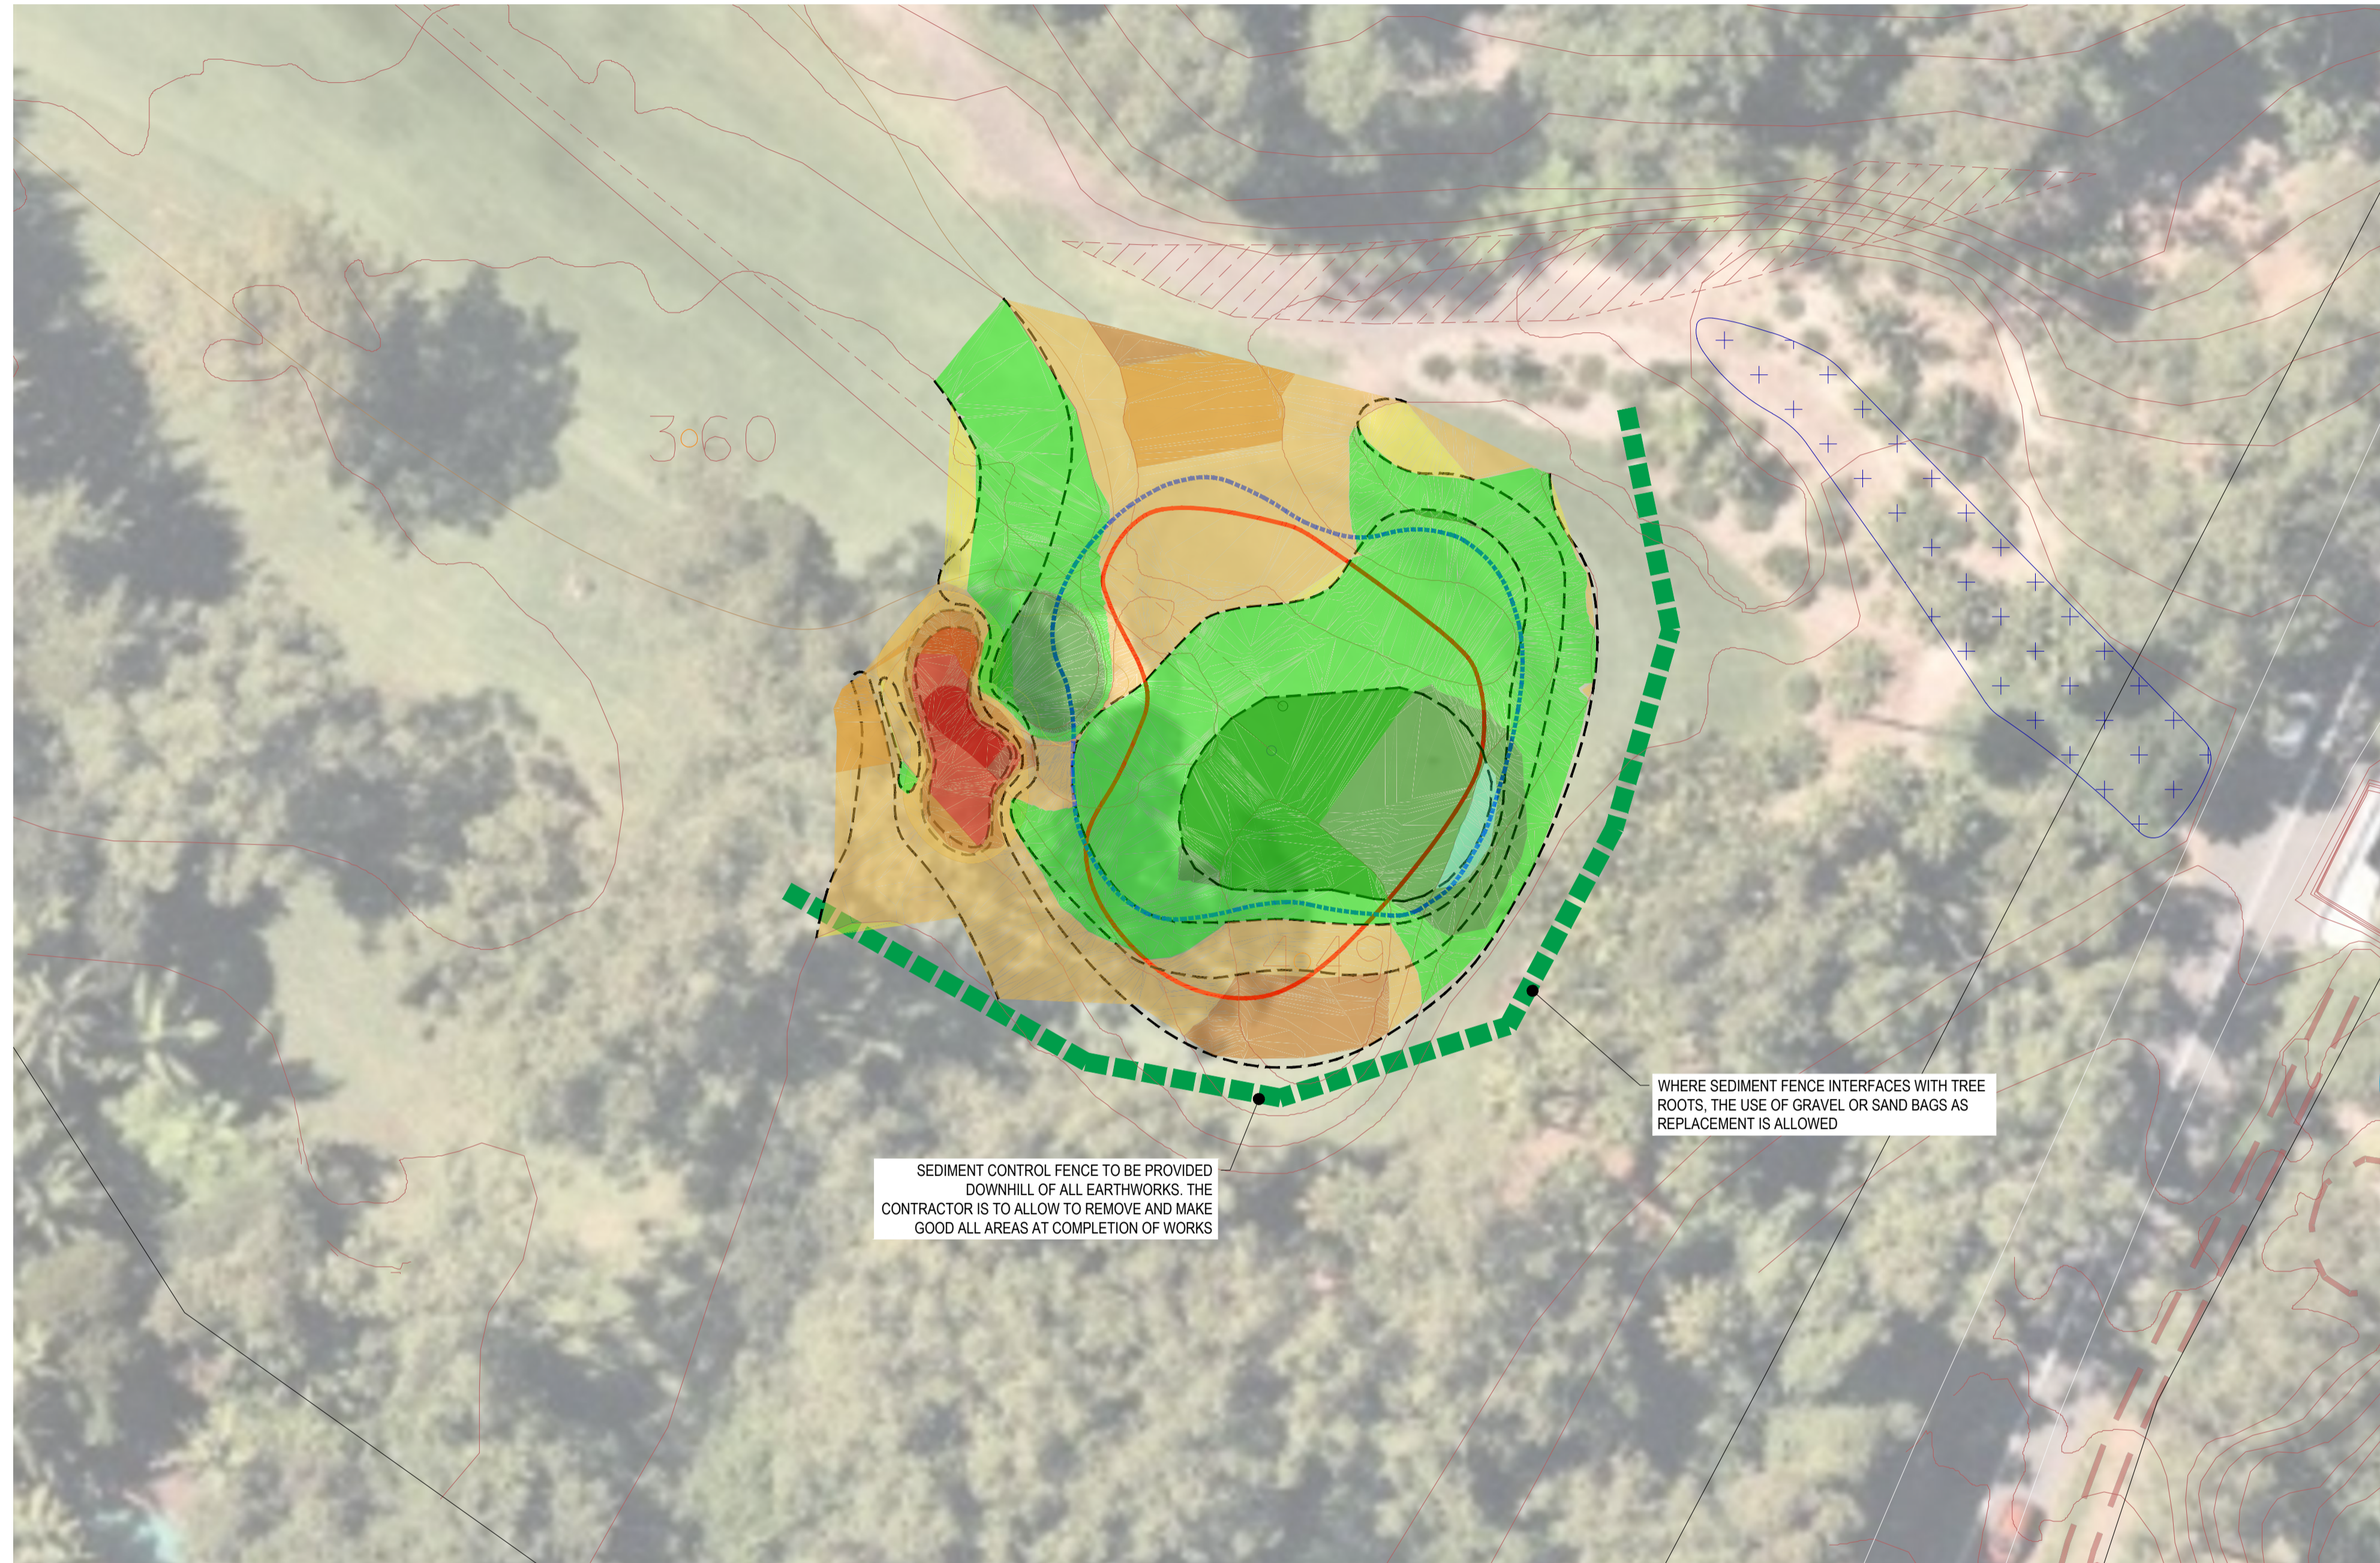
CUT & FILL LEGEND

FROM	TO
	-2.00 -1.75
	-1.75 -1.50
	-1.50 -1.25
	-1.25 -1.00
	-1.00 -0.75
	-0.75 -0.50
	-0.50 -0.25
	-0.25 -0.001
	-0.000 0.000
	0.001 0.25
	0.25 0.50
	0.50 0.75
	0.75 1.00
	1.00 1.25
	1.25 1.50

CUT AND FILL VOLUMES

Assessment Surfaces	Volumes m3	Hole											TOTAL m3	
		1st	2nd	3rd	4th	5th	6th	7th	8th	10th	11th	12th		13th
Final Surface	Cut	26	40	102	1230	35	1026	103	193	5	1060	0	6	3826
v	Fill	461	149	188	3	199	38	125	44	549	7	470	432	2665
Existing Surface	Balance	435	109	86	-1227	164	-988	22	-149	544	-1053	470	426	-1161
