Bayview Golf Club

Acid Sulfate Soil Management Plan:
Green Renovation Works
Bayview Golf Course, Cabbage Tree
Road, Bayview, NSW

P2309440JR03V01

April 2023

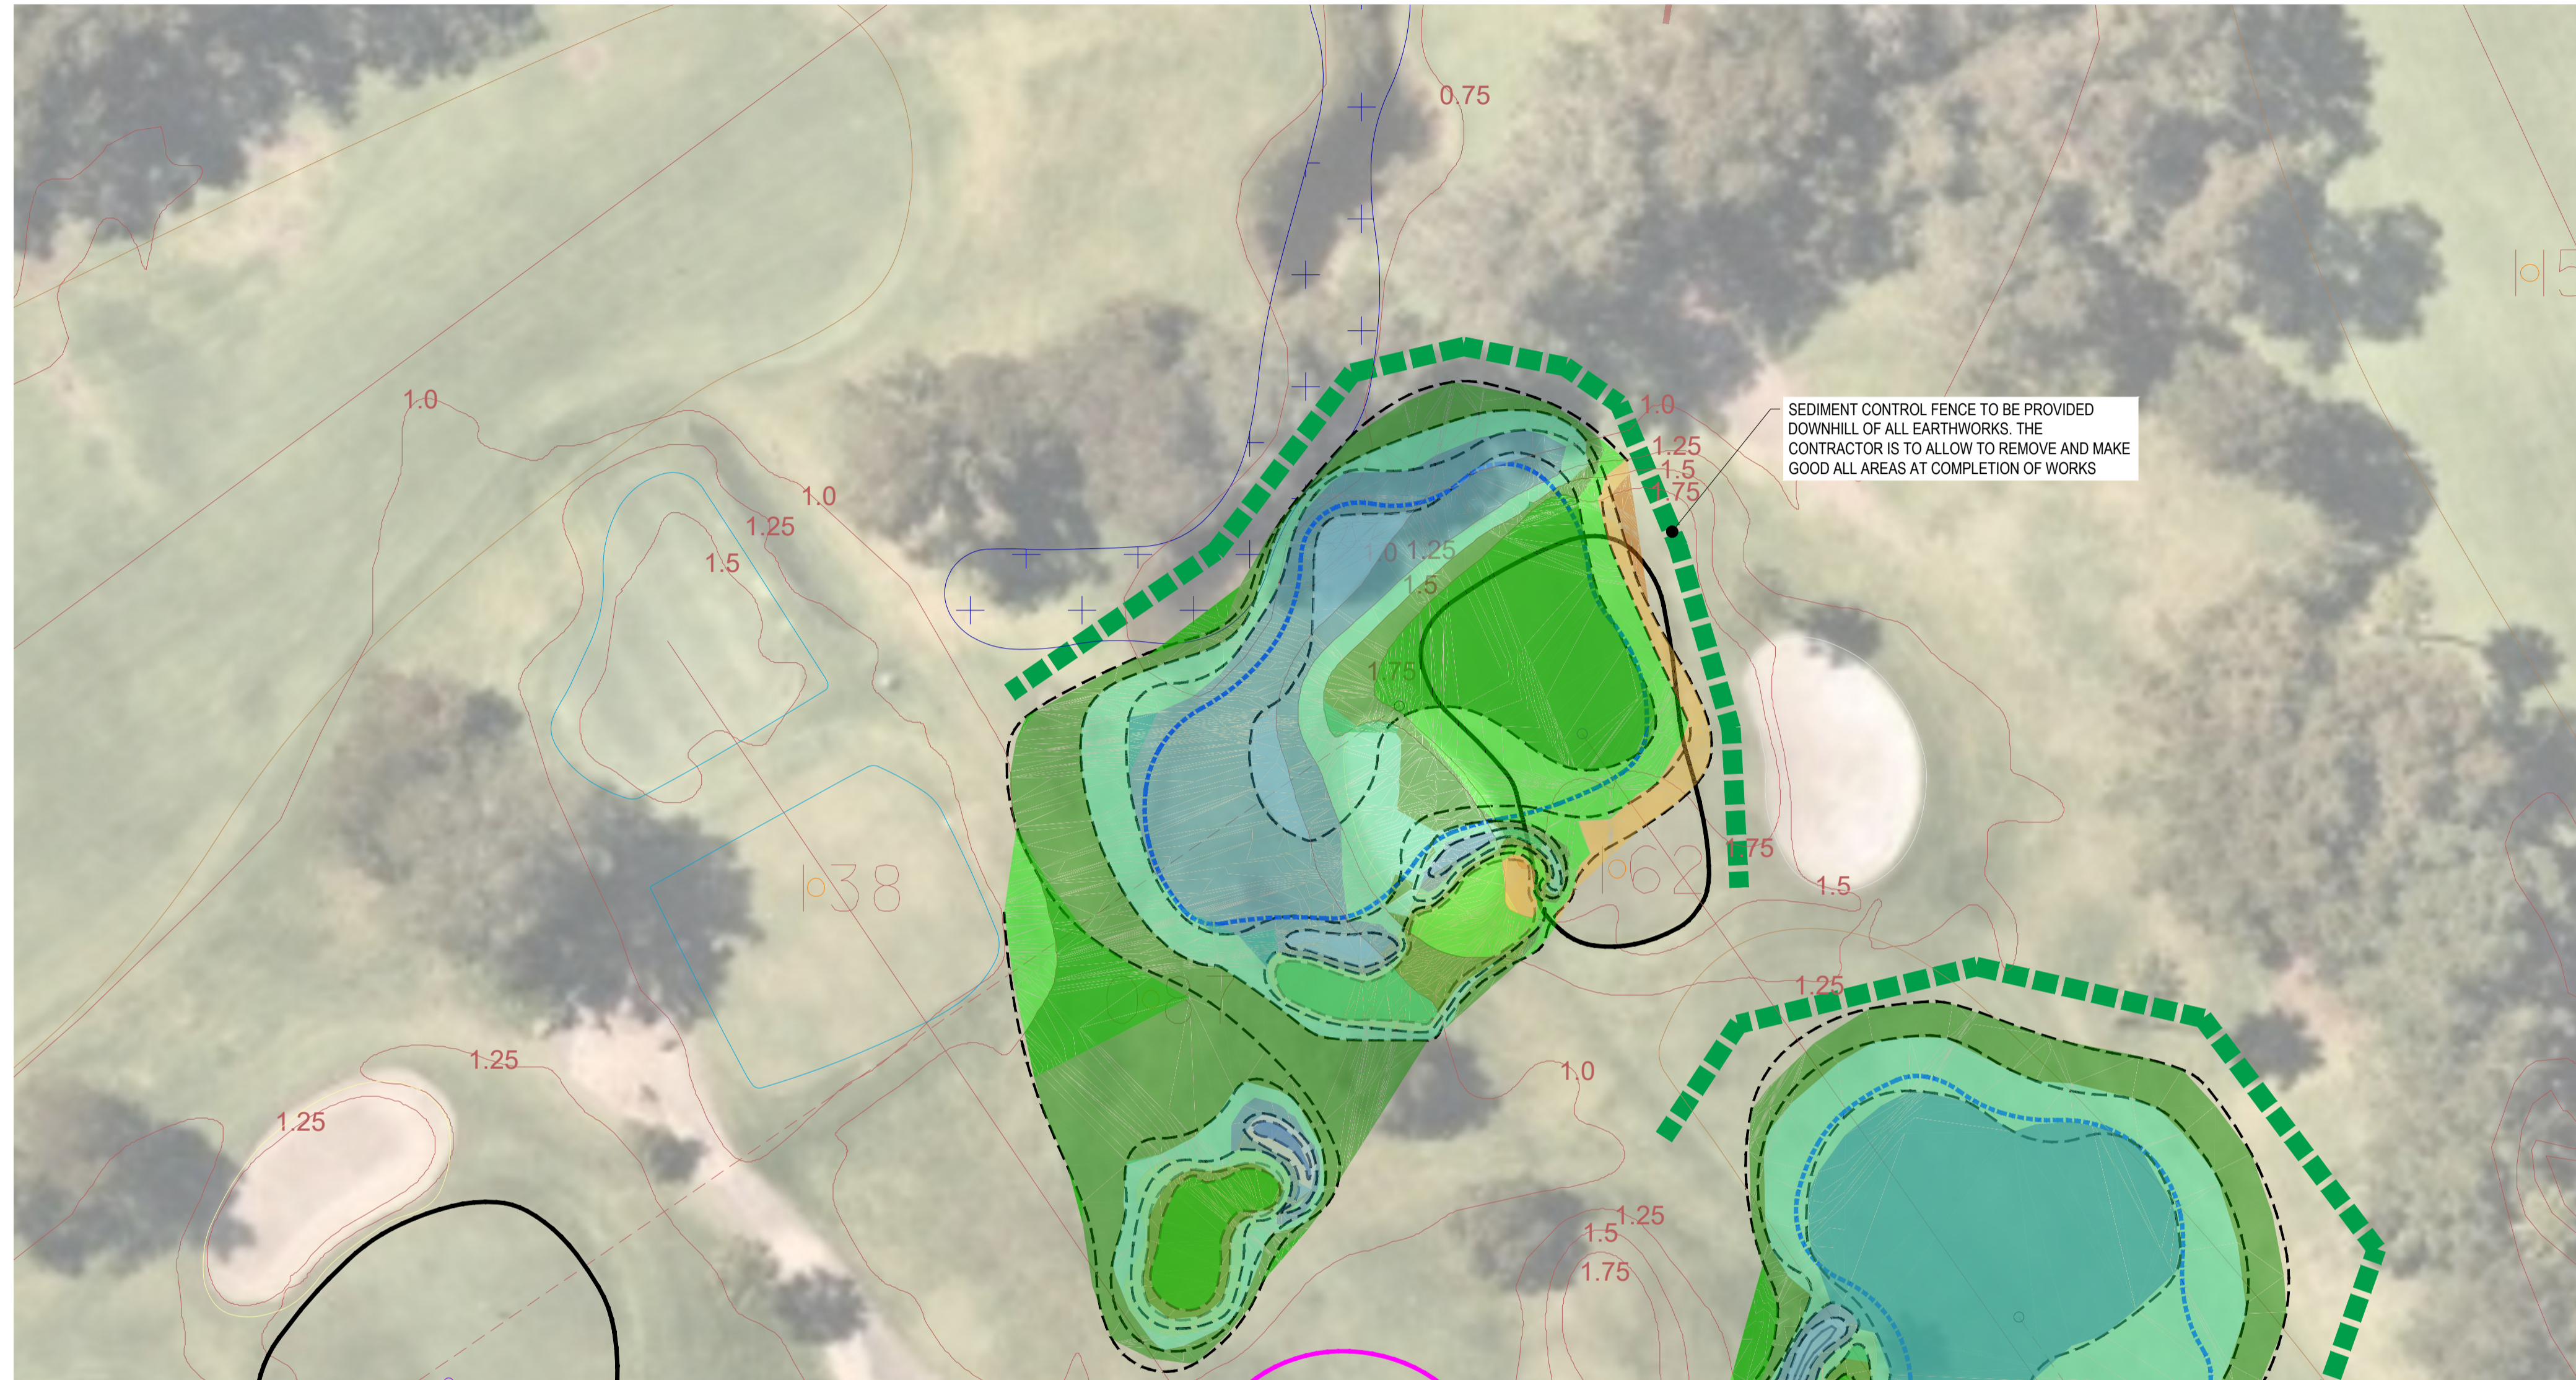
CUT & FILL LEGEND

FROM	TO
	-2.00	-1.75
	-1.75	-1.50
	-1.50	-1.25
	-1.25	-1.00
	-1.00	-0.75
	-0.75	-0.50
	-0.50	-0.25
	-0.25	-0.001
	-0.001	0.000
	0.001	0.25
	0.25	0.50
	0.50	0.75
	0.75	1.00
	1.00	1.25
	1.25	1.50

CUT AND FILL VOLUMES

Assessment Surfaces	Volumes m3	Hole											TOTAL m3	
		1st	2nd	3rd	4th	5th	6th	7th	8th	10th	11th	12th		13th
Final Surface v Existing Surface	Cut	26	40	102	1230	35	1026	103	193	5	1060	0	6	3826
	Fill	461	149	188	3	199	38	125	44	549	7	470	432	2665
	Balance	435	109	86	-1227	164	-988	22	-149	544	-1053	470	426	-1161

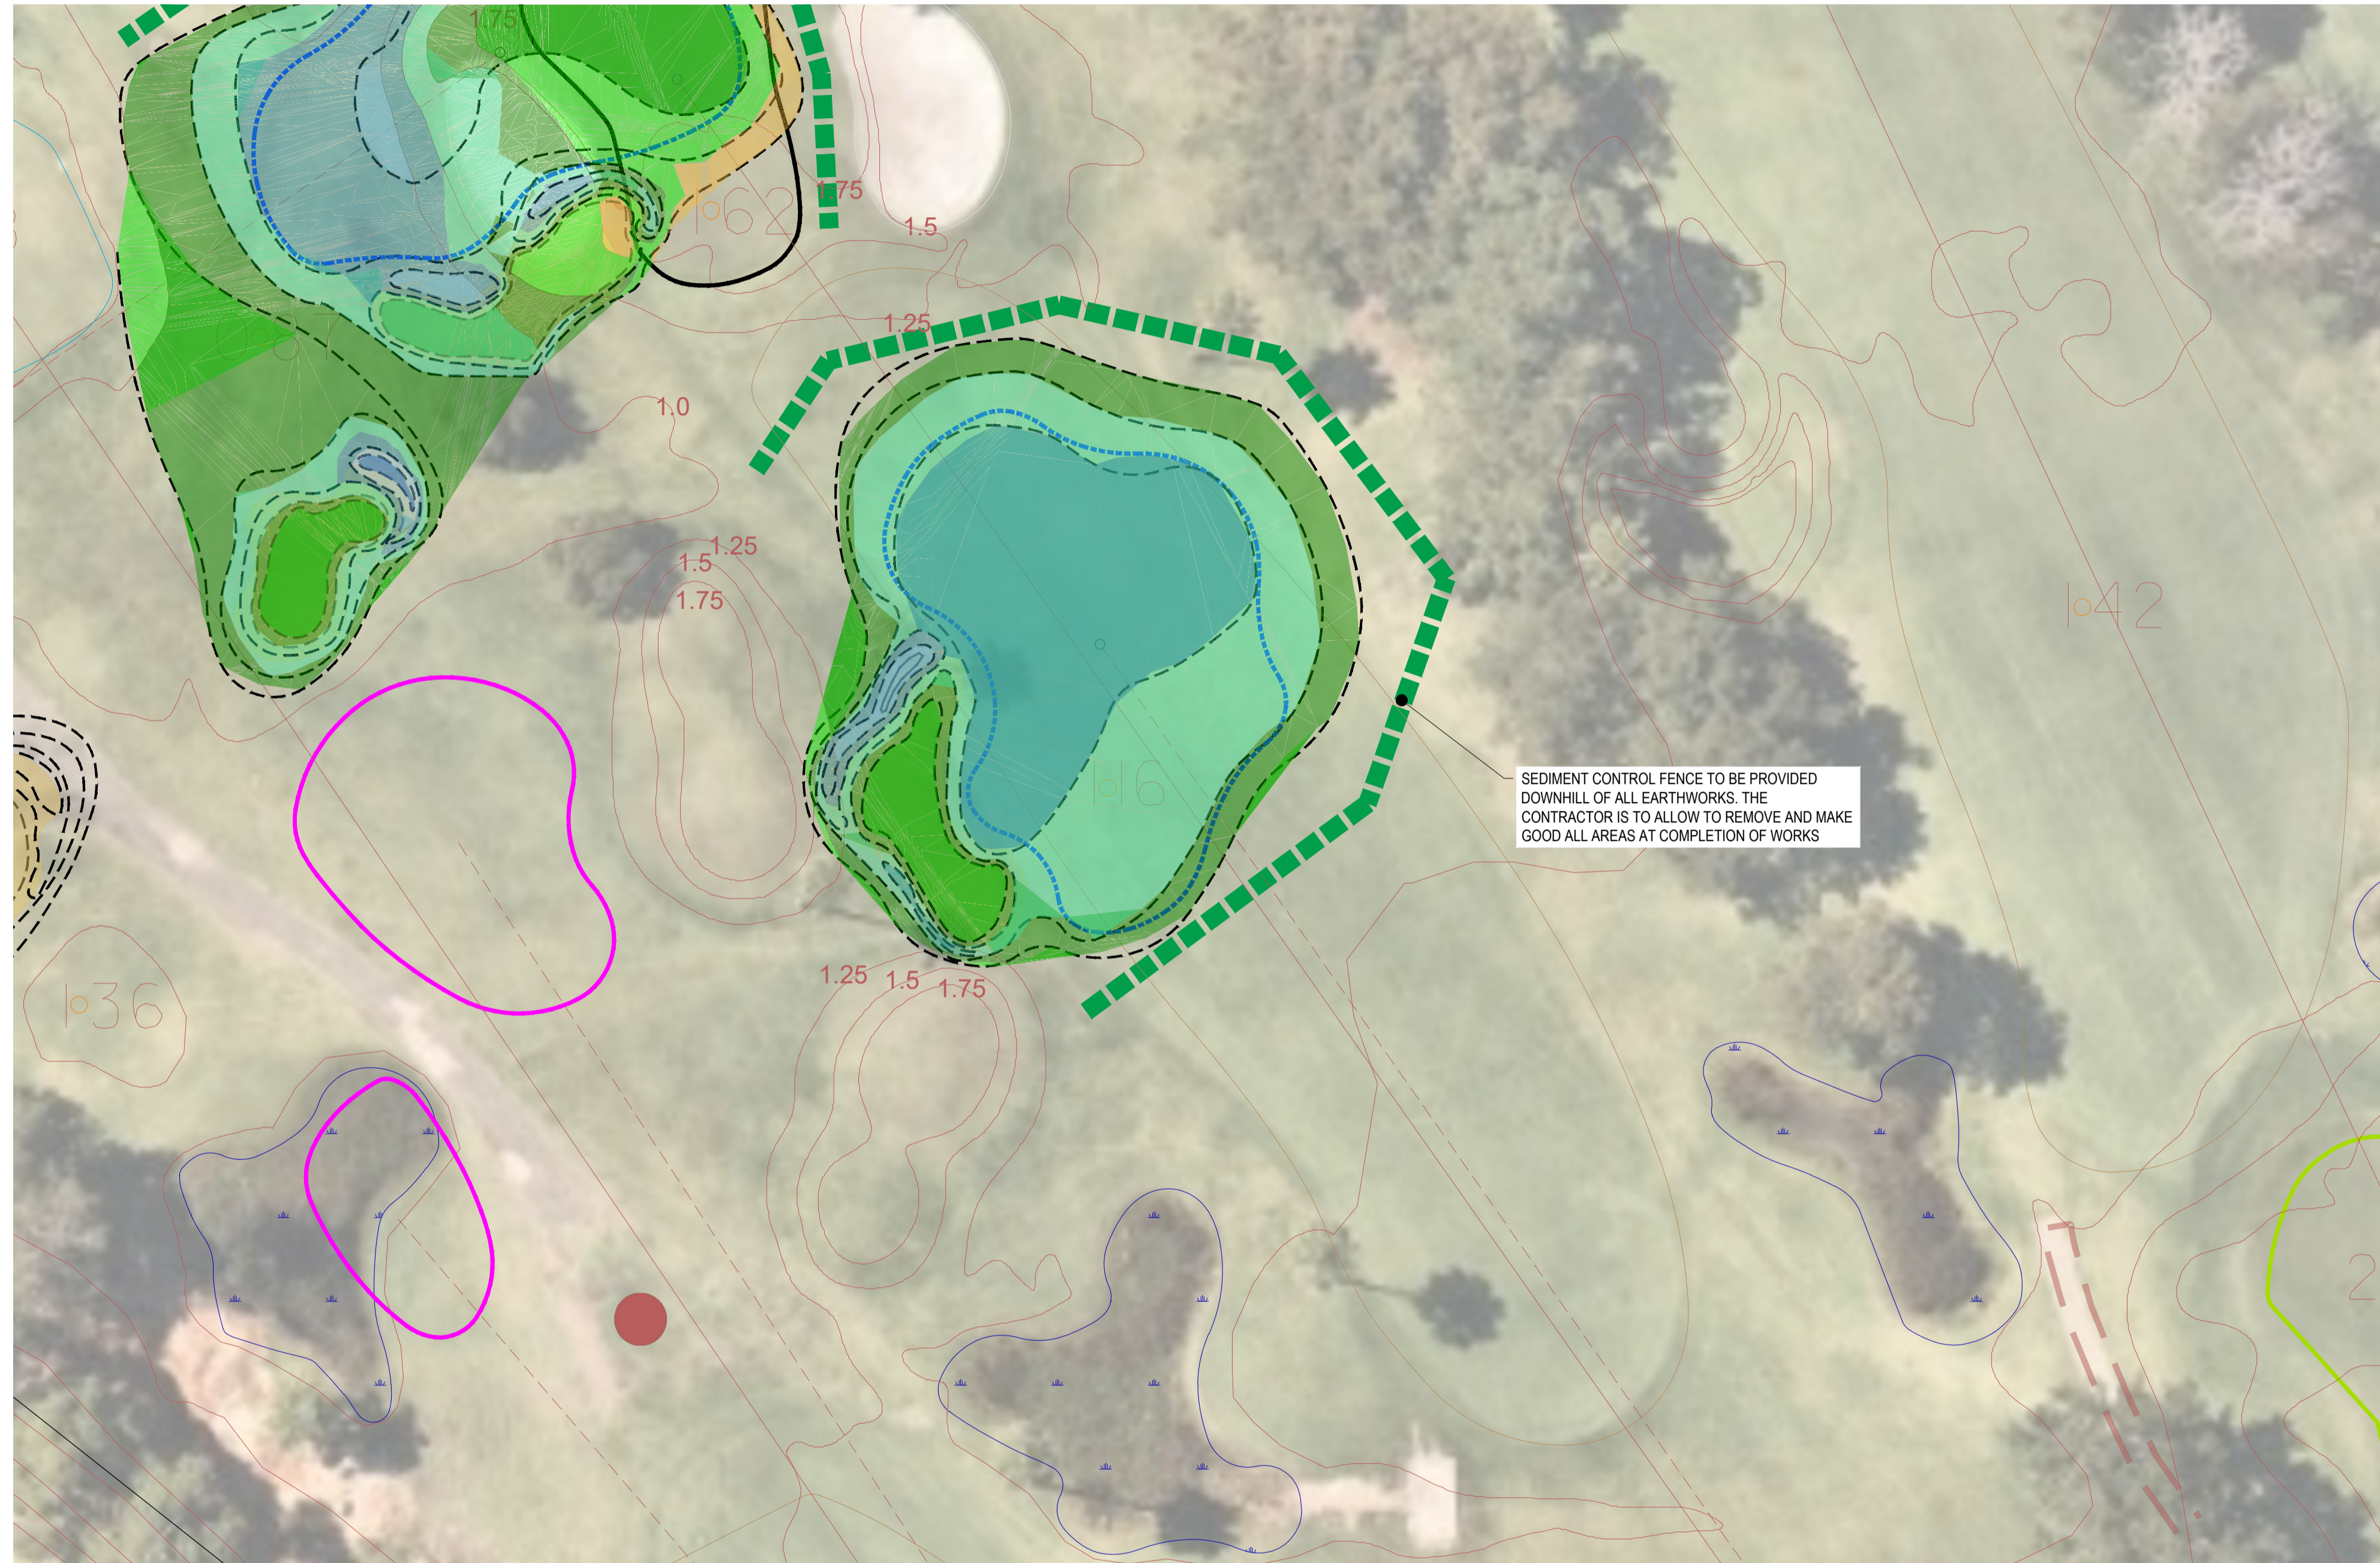
CUT & FILL LEGEND

FROM	TO
	-2.00	-1.75
	-1.75	-1.50
	-1.50	-1.25
	-1.25	-1.00
	-1.00	-0.75
	-0.75	-0.50
	-0.50	-0.25
	-0.25	-0.001
	-0.001	0.000
	0.001	0.25
	0.25	0.50
	0.50	0.75
	0.75	1.00
	1.00	1.25
	1.25	1.50

CUT AND FILL VOLUMES

Assessment Surfaces	Volumes m3	Hole											TOTAL m3	
		1st	2nd	3rd	4th	5th	6th	7th	8th	10th	11th	12th		13th
Final Surface	Cut	26	40	102	1230	35	1026	103	193	5	1060	0	6	3826
v	Fill	461	149	188	3	199	38	125	44	549	7	470	432	2665
Existing Surface	Balance	435	109	86	-1227	164	-988	22	-149	544	-1053	470	426	-1161

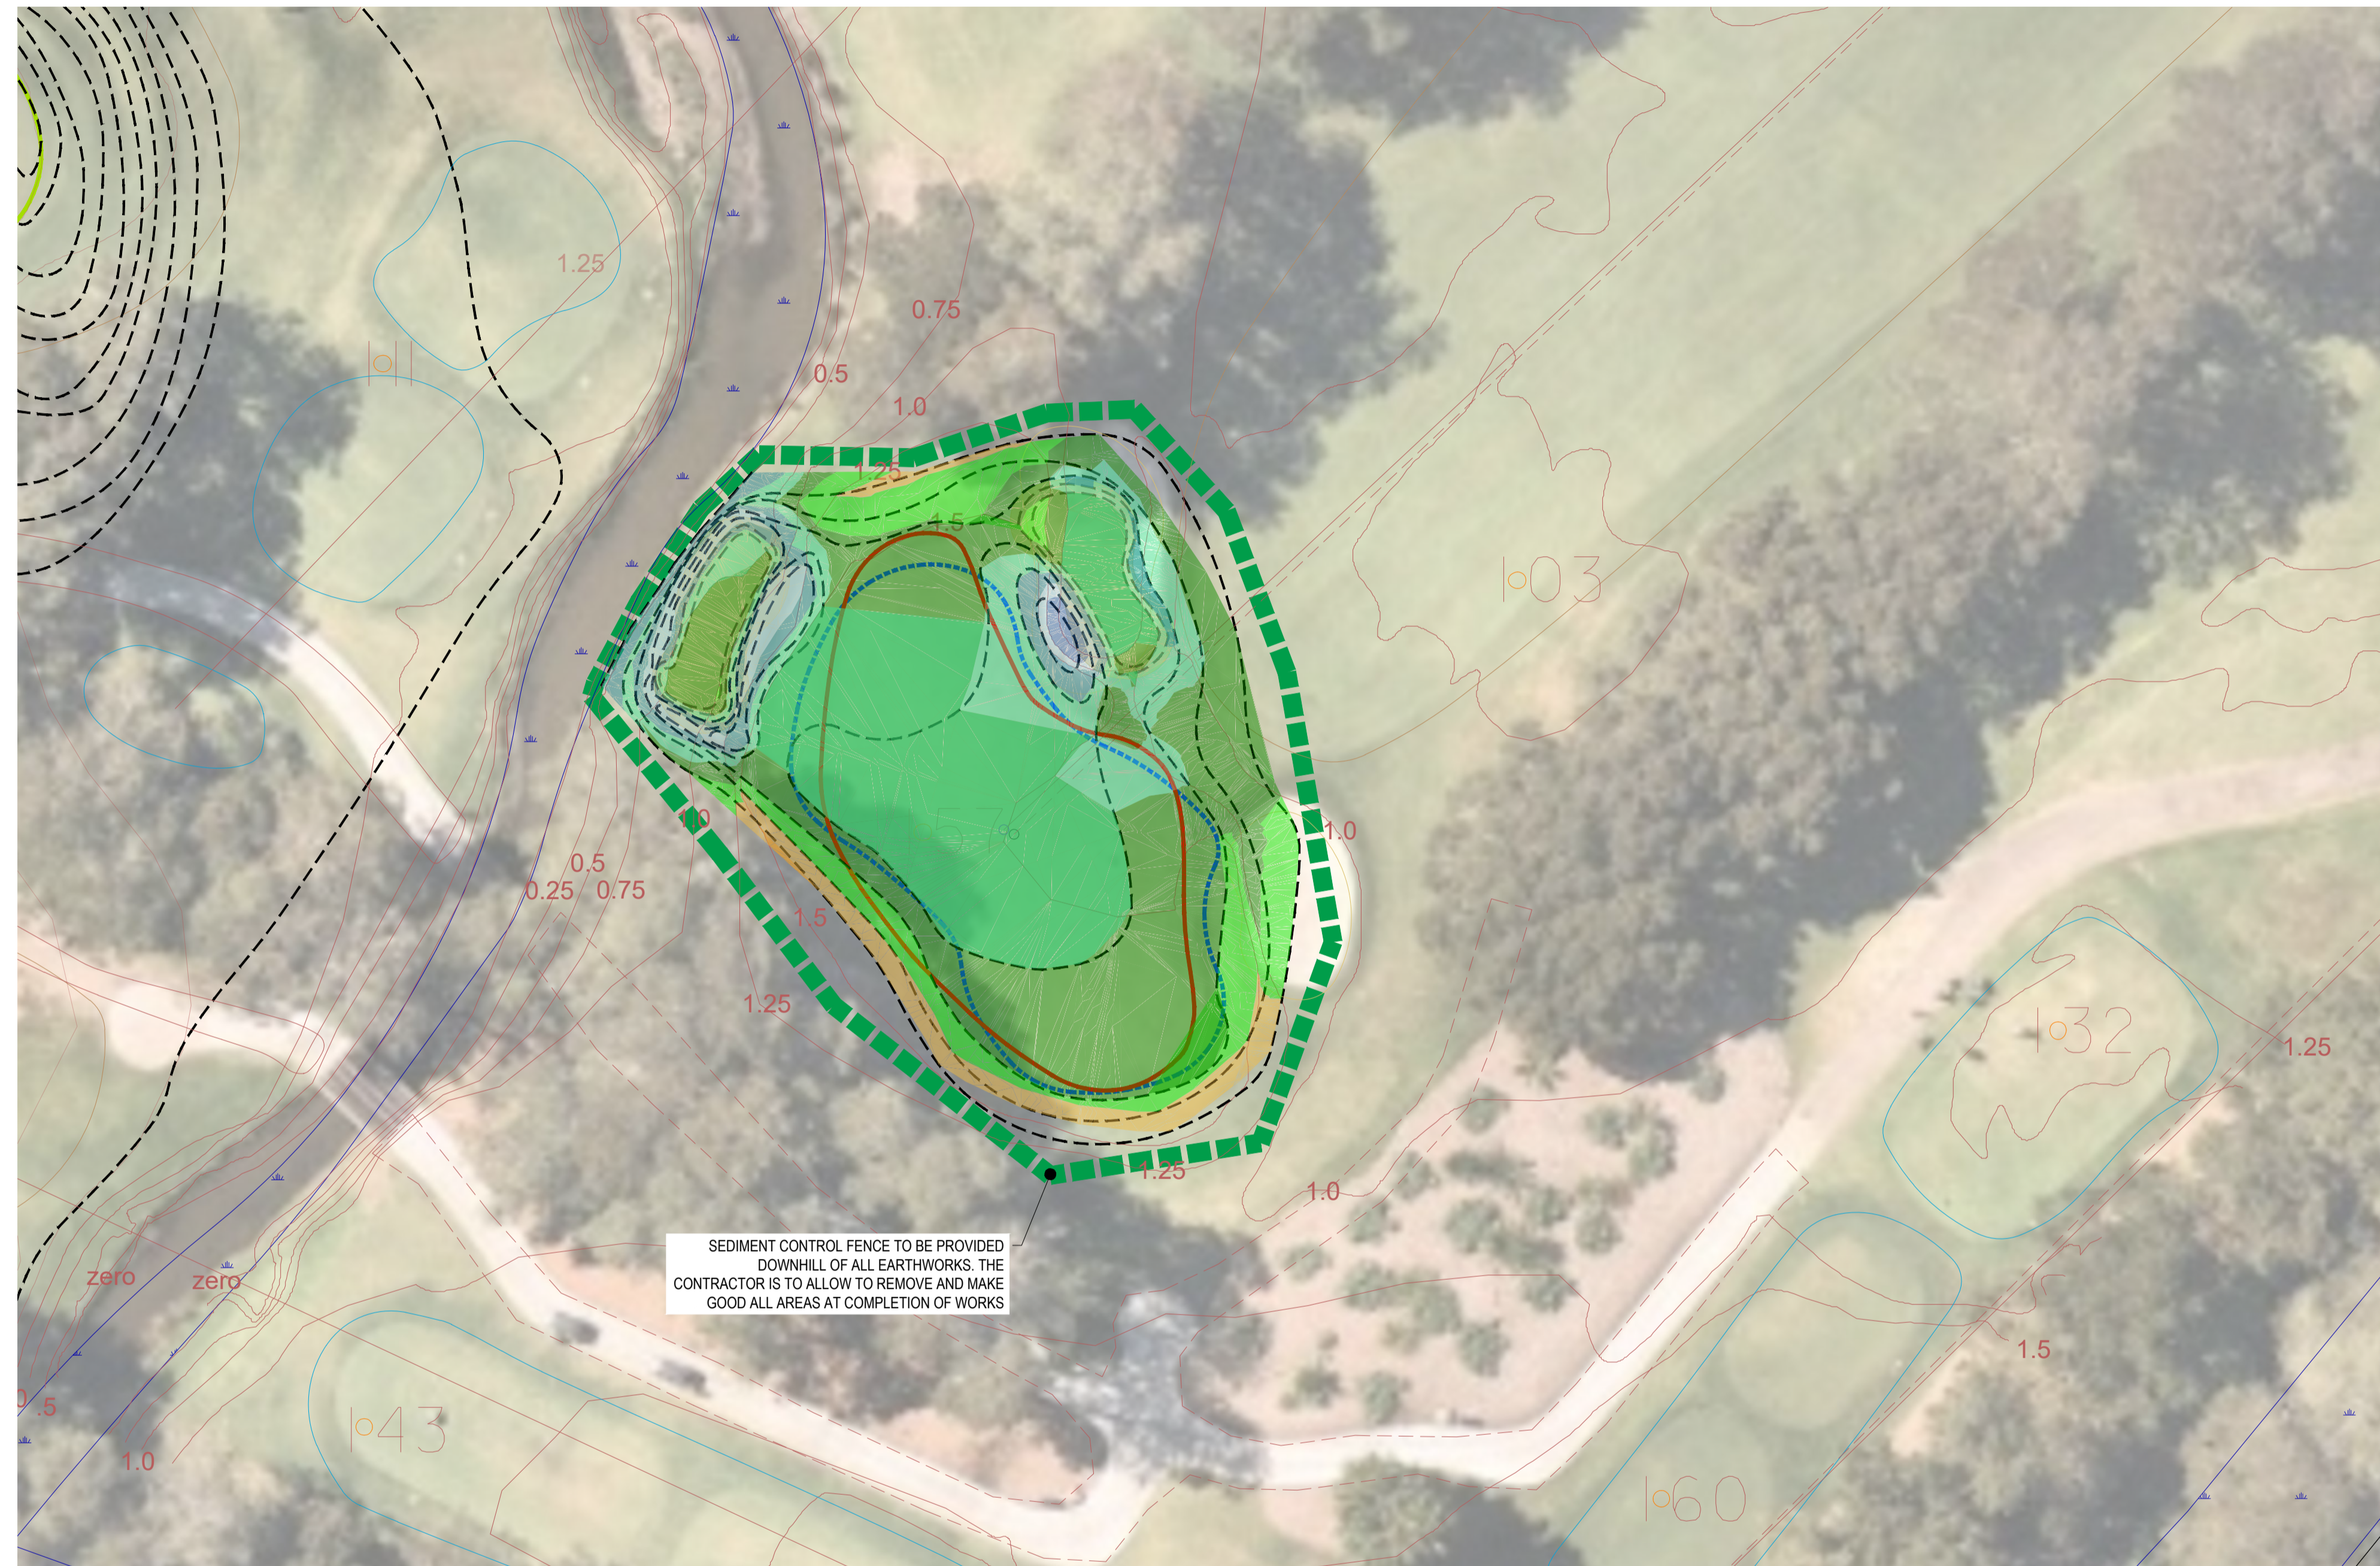
CUT AND FILL VOLUMES

Assessment Surfaces	Volumes m3	Hole												TOTAL m3
		1st	2nd	3rd	4th	5th	6th	7th	8th	10th	11th	12th	13th	
Final Surface v Existing Surface	Cut	26	40	102	1230	35	1026	103	193	5	1060	0	6	3826
	Fill	461	149	188	3	199	38	125	44	549	7	470	432	2665
	Balance	435	109	86	-1227	164	-988	22	-149	544	-1053	470	426	-1161
