## AS2870-2011 SITE CLASSIFICATION

Homestead Homes builders

Lot 1, No 54 Rangers Retreat Road  
French Forest NSW

**Class P**

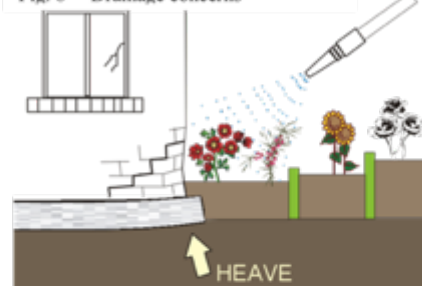
Fig. 8 Drainage concerns

- Excessive watering or under-watering of gardens.
- Watering systems that are overused or discharge water too close to building walls (Fig. 8)
- Constructing terraces, retaining walls or garden walls without good drainage. (Fig. 10)
