Preliminary Geotechnical Assessment

Project: Alterations & Additions
82 Anzac Avenue, Collaroy NSW

Ref: AG 24519
21 November 2024

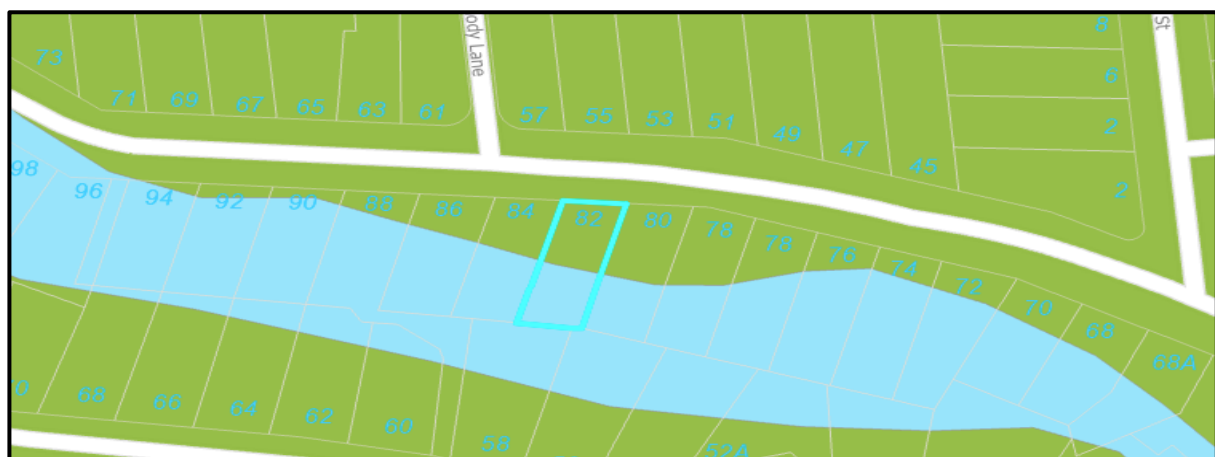
Figure 1. Warringah Landslip Risk Map:
82 Anzac Avenue, Collaroy NSW (© NBC Maps)

LEGEND
Warringah Landslip Risk Map
Area A - Slope less than 5 degrees
Area B - Flanking Slopes from 5 to 25 degrees
Area C - Slopes more than 25 degrees
Area D - Collaroy Plateau Area Flanking Slopes 5 to 15 degrees
Area E - Collaroy Plateau Area Slopes more than 15 degrees

The site is mapped as **Area D & E** subject to specific landslip risk/geotechnical hazard mapping with reference to the Warringah (WLEP) Landslip Risk Map, Northern Beaches Council (**Image 1**).

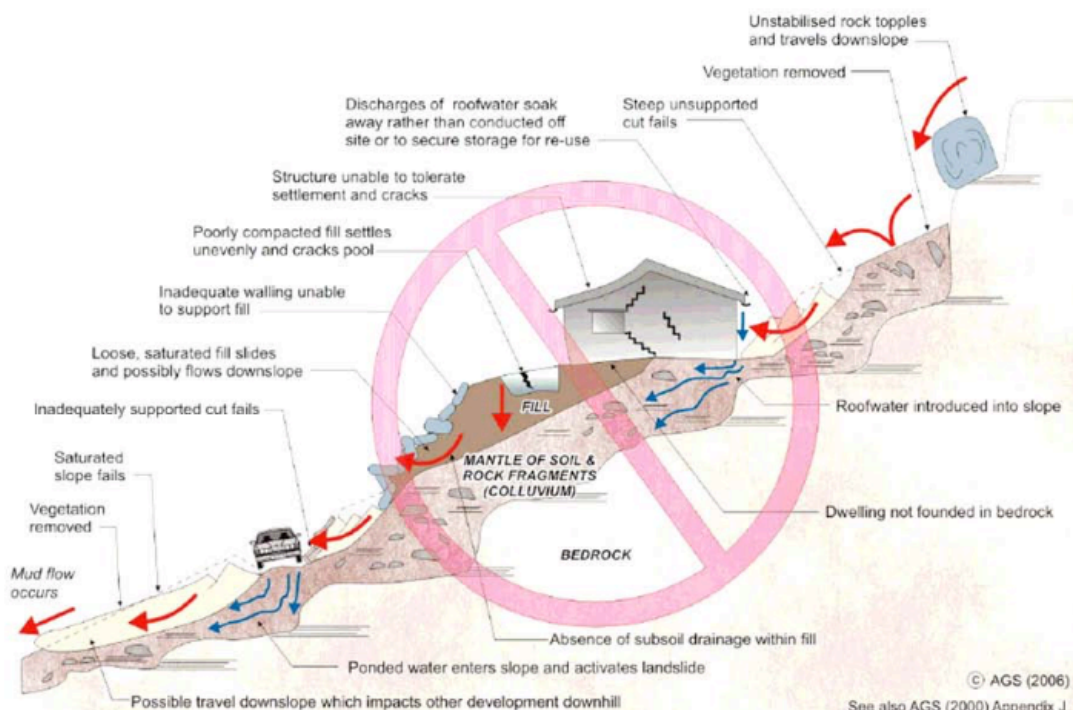
EXAMPLES OF **POOR** HILLSIDE PRACTICE
