Preliminary Geotechnical Assessment

Project: Alterations & Additions
31 Duke Street, Forestville NSW

Ref: AG 24439
24 October 2024

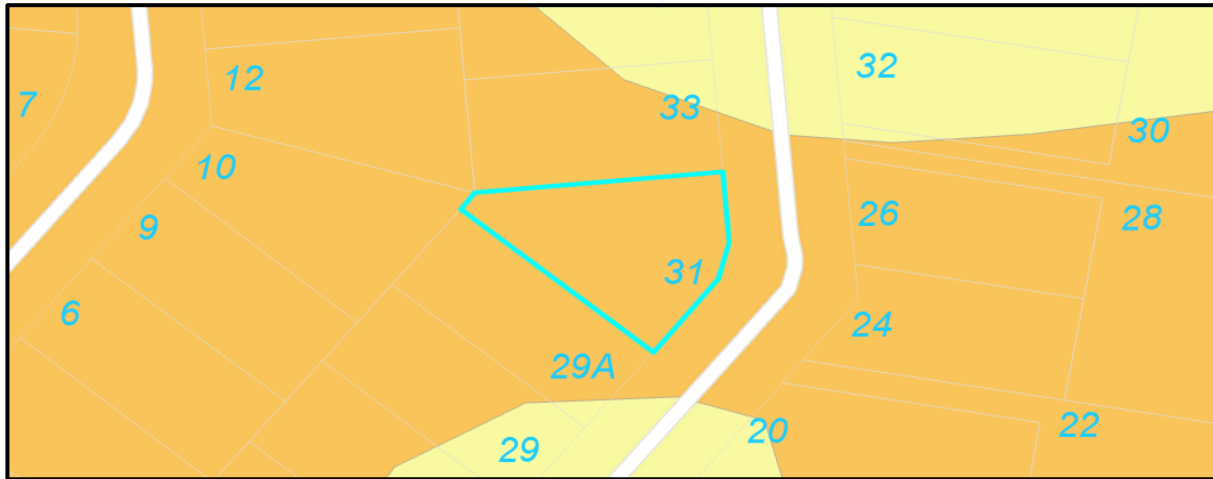
Figure 1. Warringah Landslip Risk Map:
31 Duke Street, Forestville (© NBC Maps)

LEGEND
Warringah Landslip Risk Map
 Area A - Slope less than 5 degrees
 Area B - Flanking Slopes from 5 to 25 degrees
 Area C - Slopes more than 25 degrees
 Area D - Collaroy Plateau Area Flanking Slopes 5 to 15 degrees
 Area E - Collaroy Plateau Area Slopes more than 15 degrees

The site is mapped as **Area B** subject to specific landslip risk/geotechnical hazard mapping with reference to the Warringah (WLEP) Landslip Risk Map, Northern Beaches Council (**Image 1**).

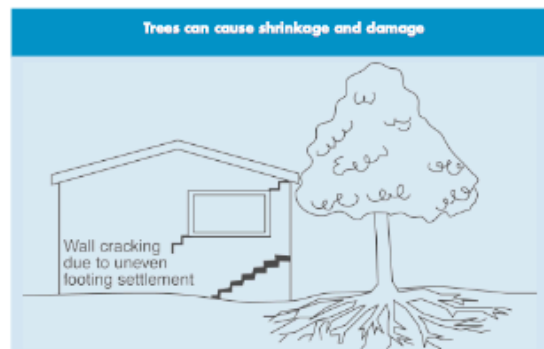
As the moisture absorption process completes its journey to the innermost areas of the building, the internal footings will rise. If the spread of moisture is roughly even, it may be that the symptoms will temporarily disappear, but it is more likely that swelling will be uneven, creating a difference rather than a disappearance in symptoms. In buildings with timber flooring supported by bearers and joists, the isolated piers will rise more easily than the strip footings or piers under walls, creating noticeable doming of flooring.

As the weather pattern changes and the soil begins to dry out, the external footings will be first affected, beginning with the locations where the sun's effect is strongest. This has the effect of lowering the external footings. The doming is accentuated and cracking reduces or disappears where it occurred because of dishing, but other cracks open up. The roof lines may become convex.
