## Preliminary Geotechnical Assessment

For Alterations and Additions at  
9B Beach Road, Newport, NSW

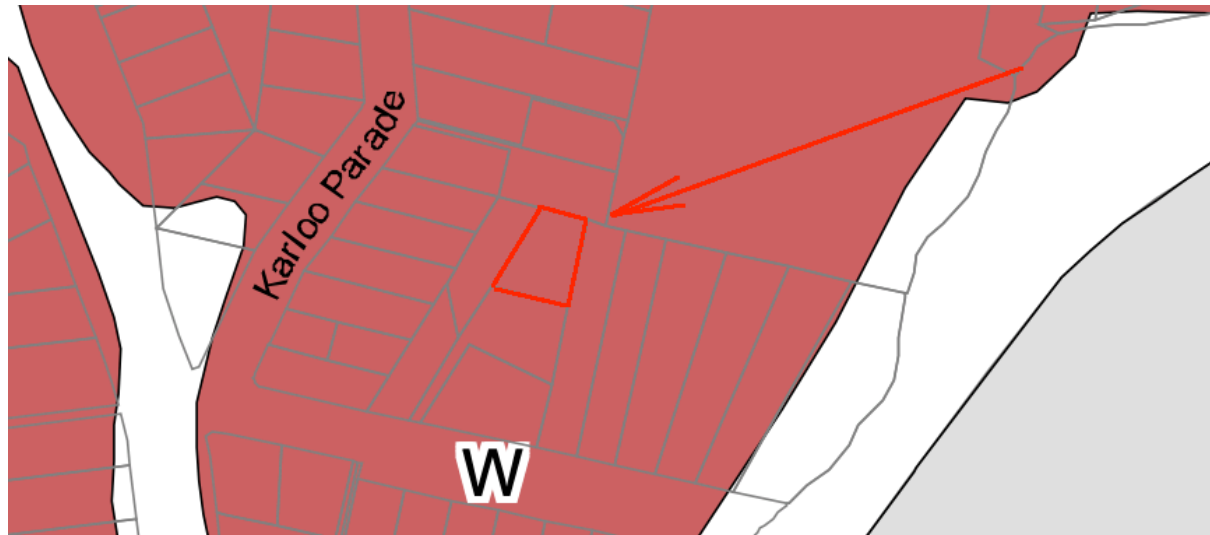
The property is classified Geotechnical Hazard H1 (W) with reference to Northern Beaches Council PLEP Geotechnical Hazard Map Sheet GTH\_011 (PLEP Geotechnical Hazard Map **Image 1** below).

**Geotechnical Hazard**

W Geotechnical Hazard H1

AE Geotechnical Hazard H2
