27th March, 2020 – AG 19088B
49 Forest Way, Frenchs Forest NSW

UPDATED PLANS LETTER

Geotechnical Assessment

Project: Seniors Housing Development
49 Forest Way, Frenchs Forest, NSW.

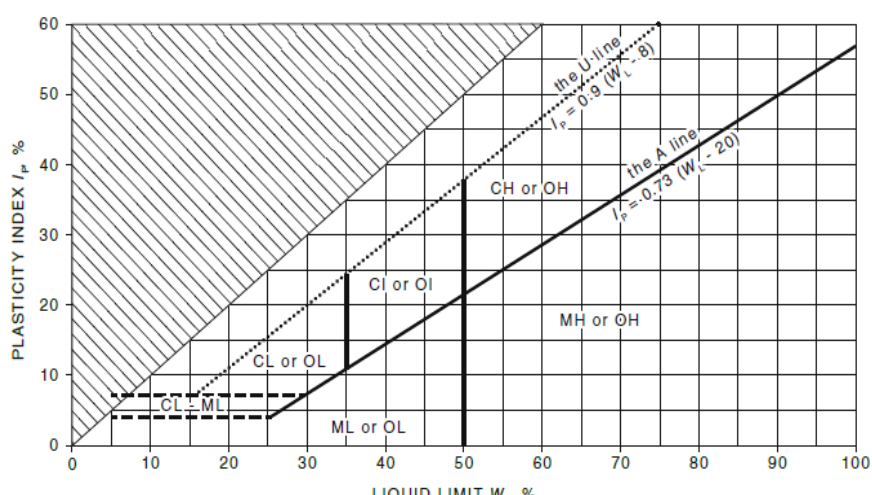
</div> <p>NOTE: The U line is an approximate upper bound for most natural soils. Data which plot above the U line may represent unusual/problem soil behaviour, or unreliable data and should be considered carefully.</p> <p>FIGURE 5 MODIFIED CASAGRANDE CHART FOR CLASSIFYING SILTS AND CLAYS ACCORDING TO THEIR BEHAVIOUR</p> <p>© AS2870-2017</p>				
CL and CI					
OL					
MH					
CH					
OH					
PT
