## **Geotechnical Assessment**

**Project:** Alterations and Additions  
131 Gondola Road, North Narrabeen NSW

**REF: AG 20035**  
25<sup>th</sup> February, 2020

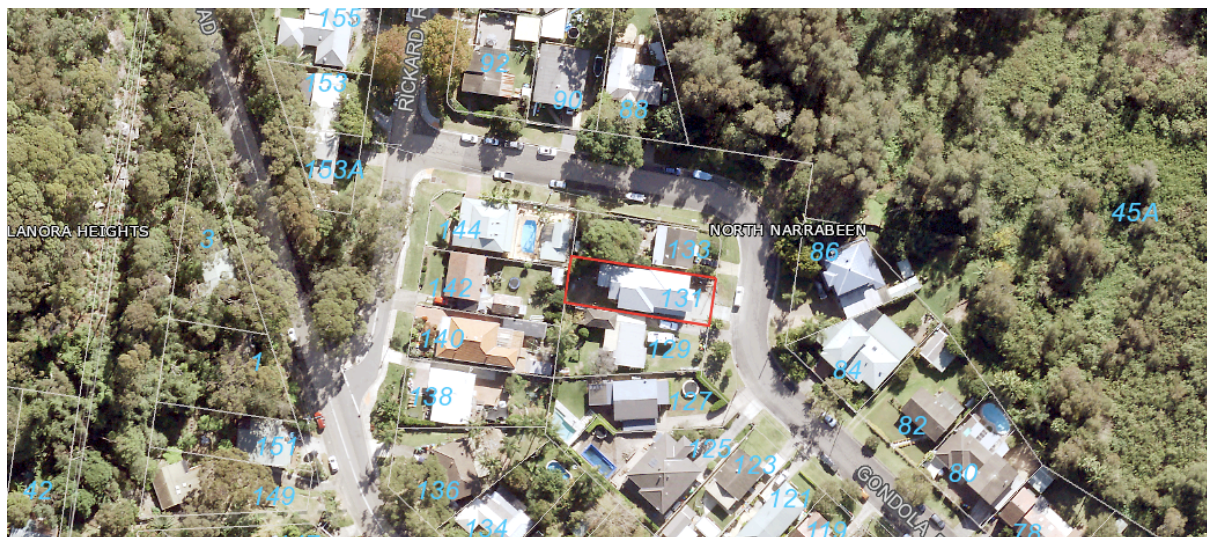
**Image 1:** Site location – 131 Gondola Road, North Narrabeen NSW – Red Polygon (© NBC Maps)

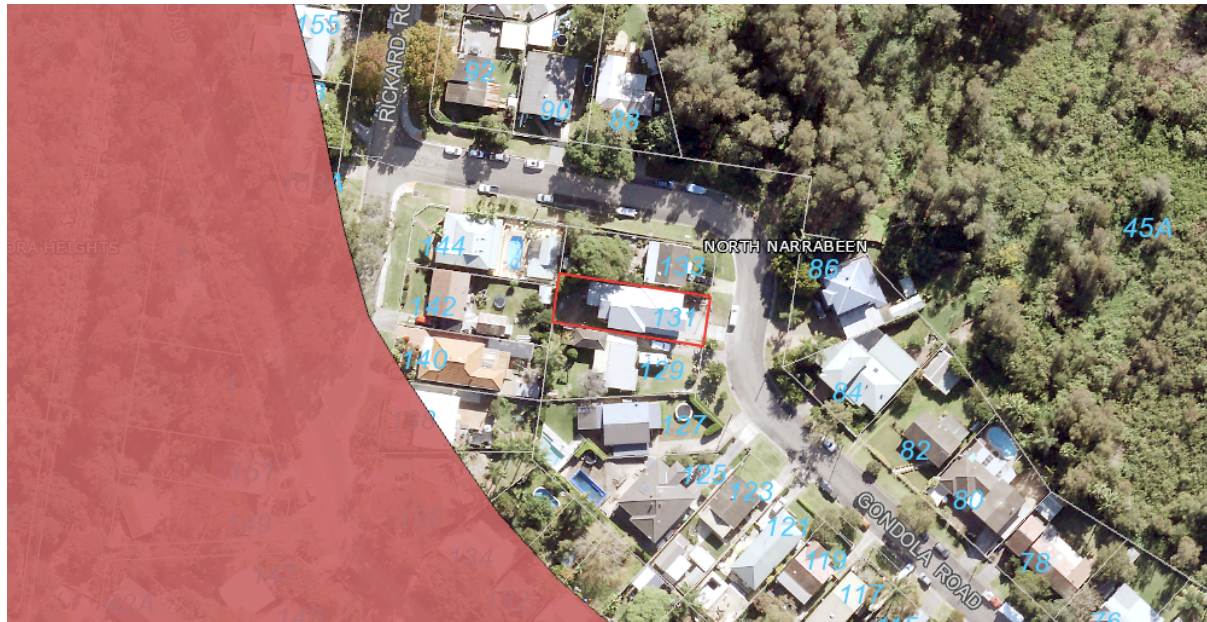
<b>W</b>	Geotechnical Hazard H1
<b>AE</b>	Geotechnical Hazard H2

**Image 2:** 131 Gondola Road, North Narrabeen NSW – **Geotechnical Hazard Map**– Red polygon (PLEP 2014)

- No evidence of significant soil creep, tension cracks or other indicators of slope instability were identified at the time of our inspection.
- The existing structure displayed no evidence of significant cracking or settlement that could be attributed to slope instability.
- The property is not mapped as a Geotechnical Hazard Zone in Northern Beaches Council PLEP Geotechnical Hazard Map (PLEP Geotechnical Hazard Map **Image 2** below).

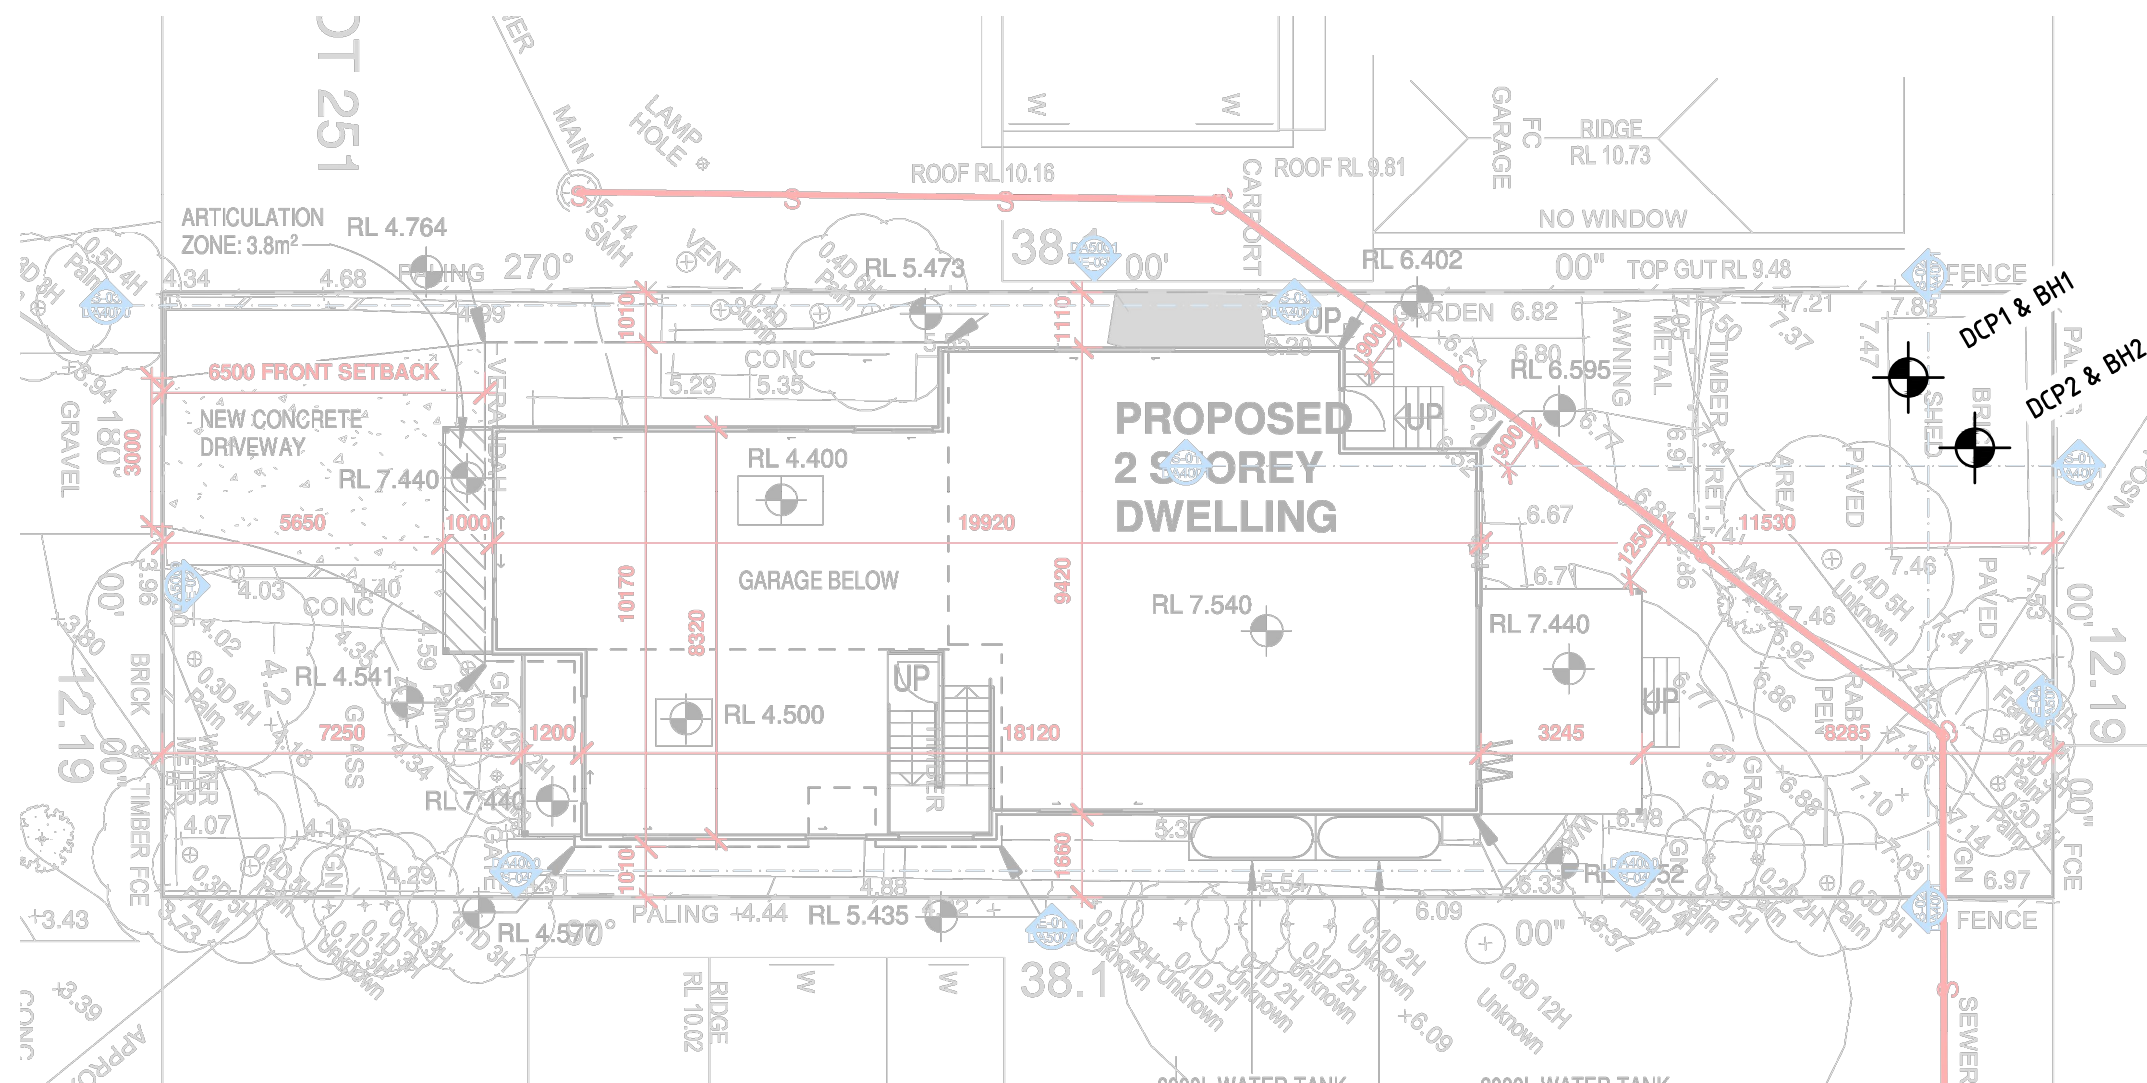
## DCP & BOREHOLE LOCATIONS

### SITE PLAN/EXISTING UNSUPPORTED EXCAVATION

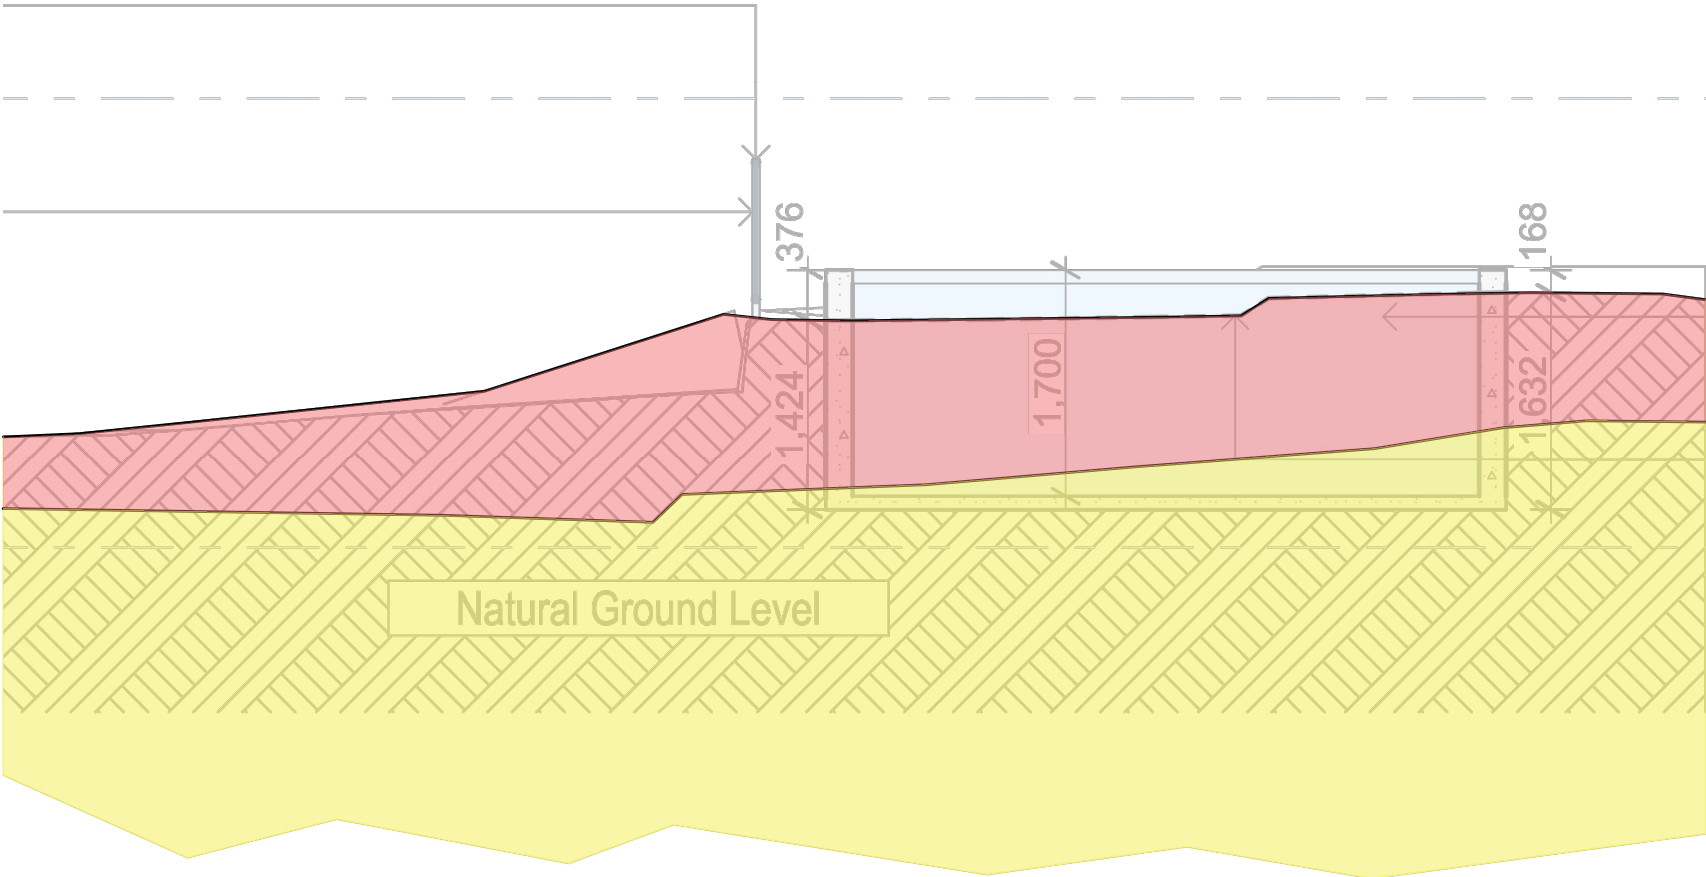
INTERPRETED SUBSURFACE SECTION ONLY.  
ACTUAL GROUND CONDITIONS MAY VARY.

**INFERRED GEOLOGICAL SECTION**  
SCALE NTS
