Ref: SRE/628/MV/20/PG

RE: PRELIMINARY GEOTECHNICAL ASSESSMENT FOR PROPOSED ALTERATION AND ADDITIONS AT 11 MILDRED AVENUE, MANLY VALE, NSW 2093 - PRELIMINARY GEOTECHNICAL ASSESSMENT

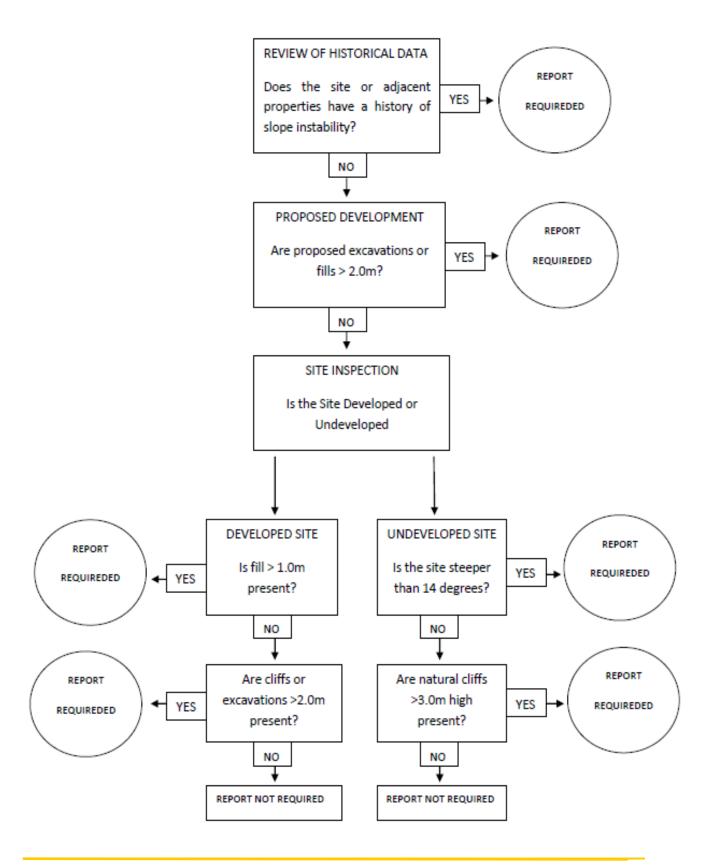
APPENDIX 1

CHECKLIST FLOW CHART FOR COUNCIL'S ASSESSMENT OF SITE CONDITIONS AND NEED FOR GEOTECHNICAL REPORT IN LANDSLIP RISK CLASSES B AND D

Further to the analyses of the Council Checklist Flowchart, attached on the *Appendix 1* and this preliminary geotechnical assessment for the proposed new addition and alteration at 11 Mildred Avenue, it is recommended to carry a further geotechnical site inspection by a competent professional geotechnical engineer.
