30 November 2020  
79B Lauderdale Avenue, Fairlight NSW

### **GEOTECHNICAL ASSESSMENT ADDENDUM LETTER**

Preliminary Geotechnical Assessment for 79B Lauderdale Avenue, Fairlight NSW

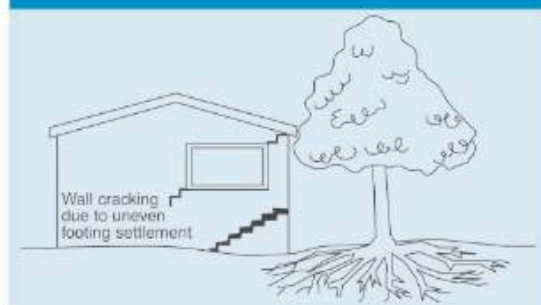
#### Trees can cause shrinkage and damage

As the weather pattern changes and the soil begins to dry out, the external footings will be first affected, beginning with the locations where the sun's effect is strongest. This has the effect of lowering the external footings. The doming is accentuated and cracking reduces or disappears where it occurred because of dishing, but other cracks open up. The roof lines may become convex.
