## **REPORT ON GEOTECHNICAL SITE INVESTIGATION**

### **PROPOSED NEW DEVELOPMENT**

**38 PARK STREET & 1795-1797 & 1793 PITTWATER ROAD,  
MONA VALE, NSW**

**Project No.: 2019-132.1**

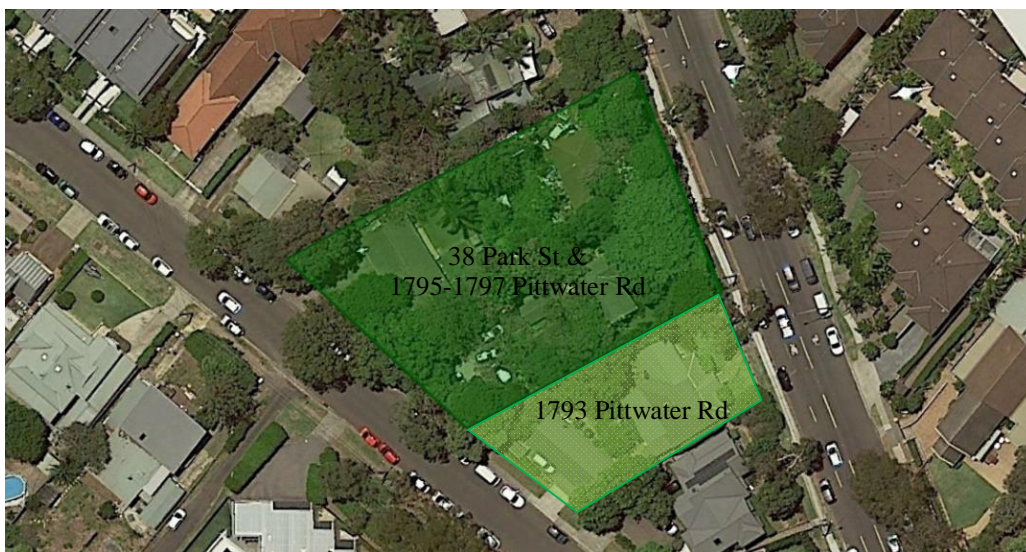
*Photograph: 1 – Aerial photo of site and surrounds.*

The site contains four properties with four one and two storey brick and weatherboard residences, which are located at the centre of each property with lawns and mature trees up to approximately 20m in height surrounding.

The ground surface of the site displays a gentle dip towards the east from a high of approximately RL14.3 at the northwest corner to a low of approximately RL9.8 at the southeast corner. The existing residential buildings appear approximately 70 years old. An inspection of the existing dwellings and the properties identified no obvious geotechnical problems.

An aerial photograph of the site and its surrounds is provided below, as sourced from Google Earth data, as Photograph 1.

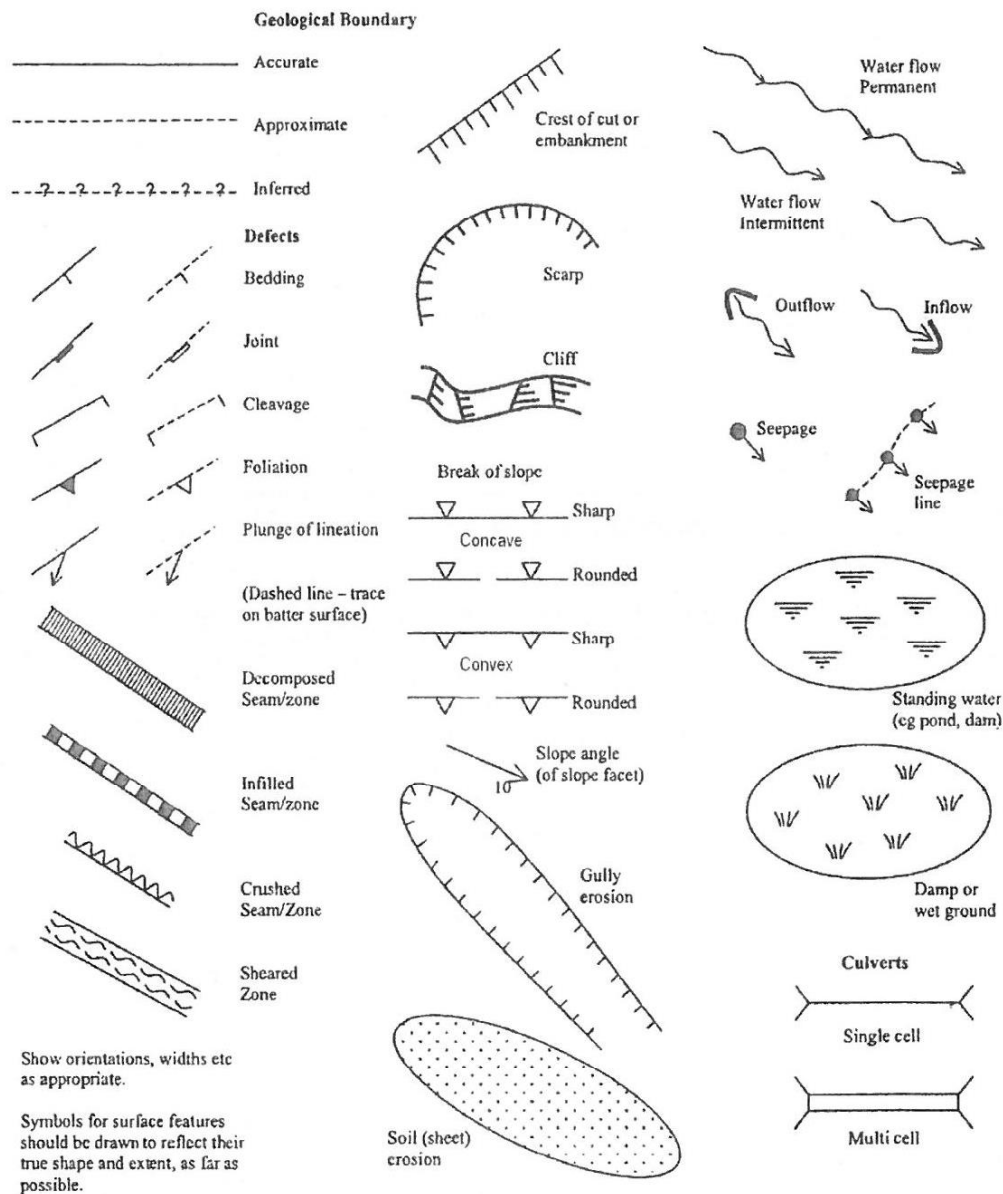
## APPENDIX E - GEOLOGICAL AND GEOMORPHOLOGICAL MAPPING SYMBOLS AND TERMINOLOGY

Examples of Mapping Symbols (after Guide to Slope Risk Analysis Version 3.1 November 2001, Roads and Traffic Authority of New South Wales).

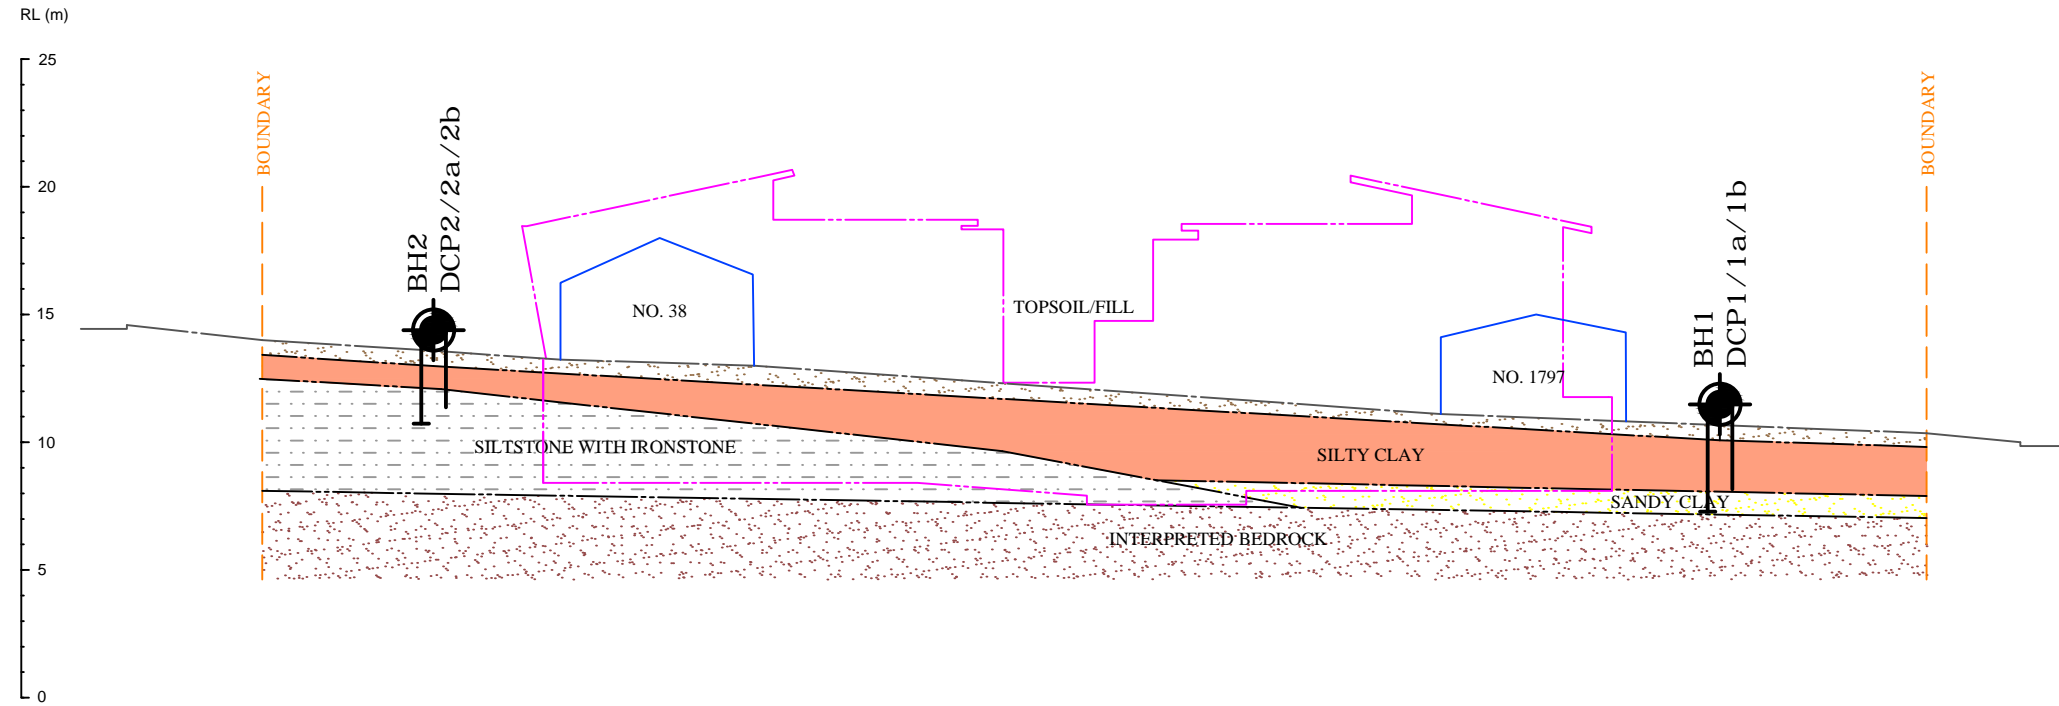
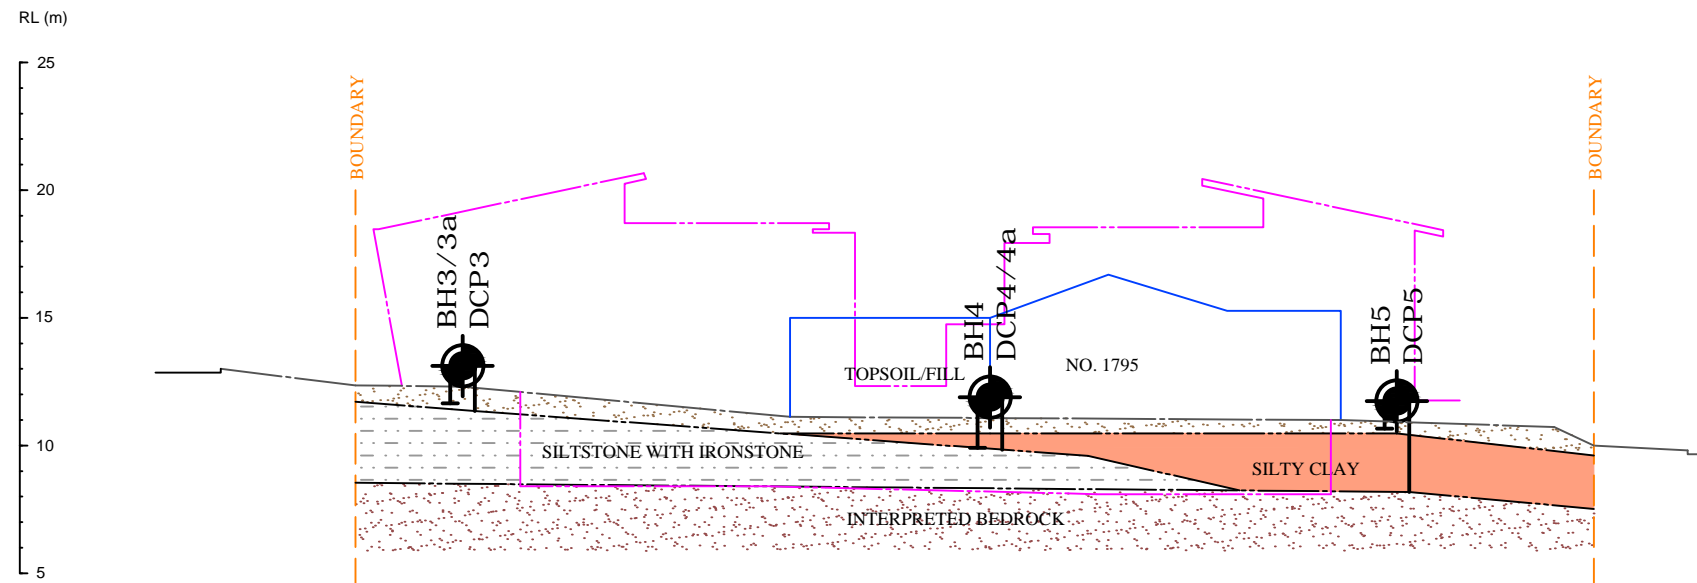
**NB. FOR LOCATION OF SECTION A-A', PLEASE REFER TO FIGURE 1. SITE PLAN AND TEST LOCATIONS**

Explanatory notes are included in Appendix: 1. Mapping information and test locations are shown on Figure: 1 and 3, along with detailed log sheets in Appendix: 2. A geological model/section is provided as Figure: 2 and 4, Appendix: 2.

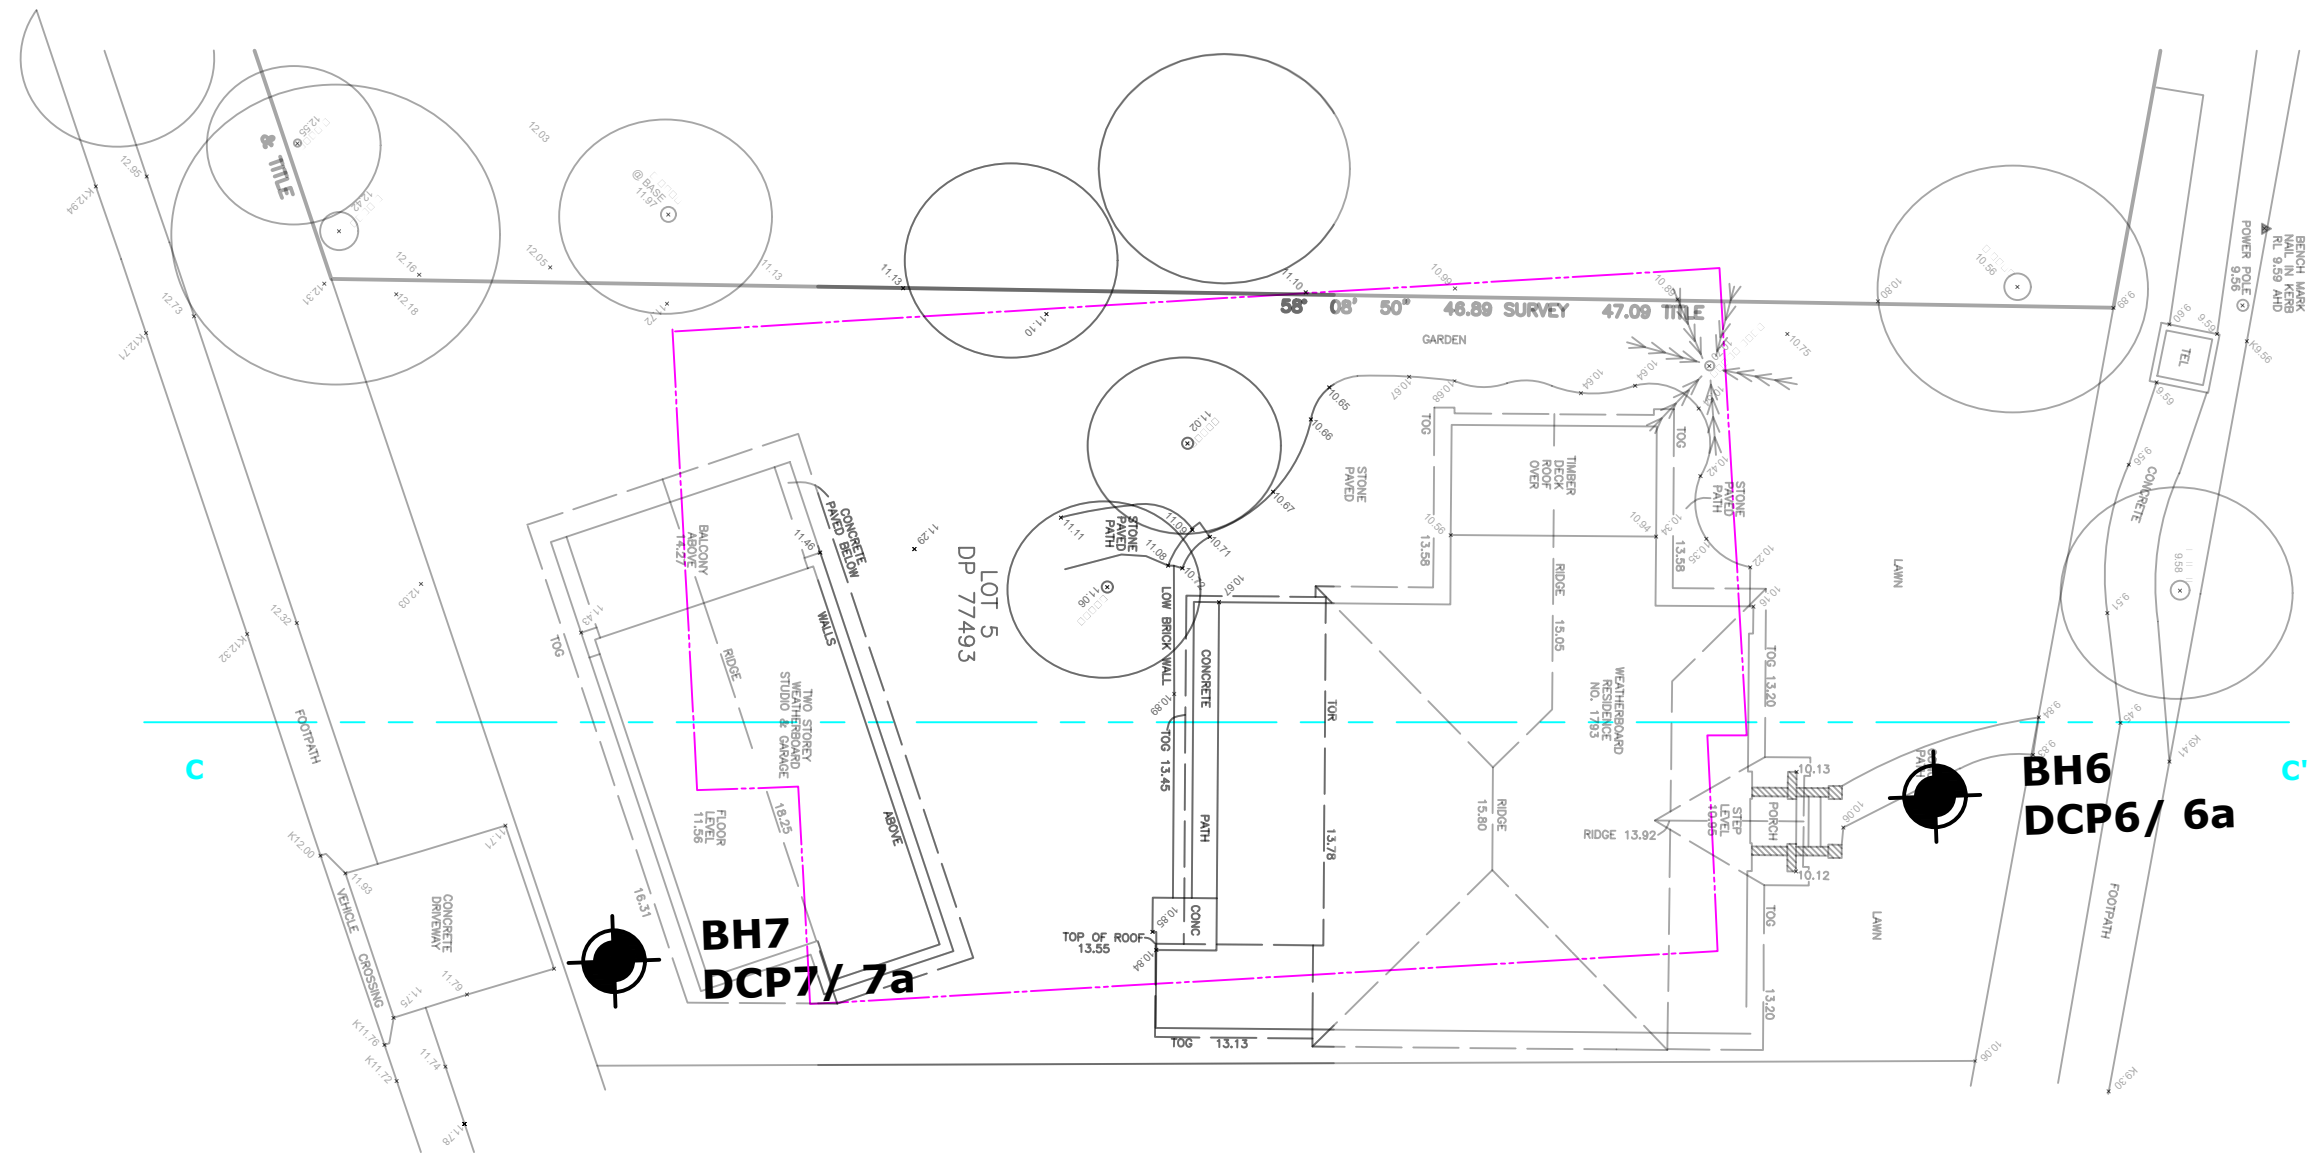
ADDRESS:  
38 Park Street & 1795-1797 Pittwater Road,  
Mona Vale

SCALE: 1:200

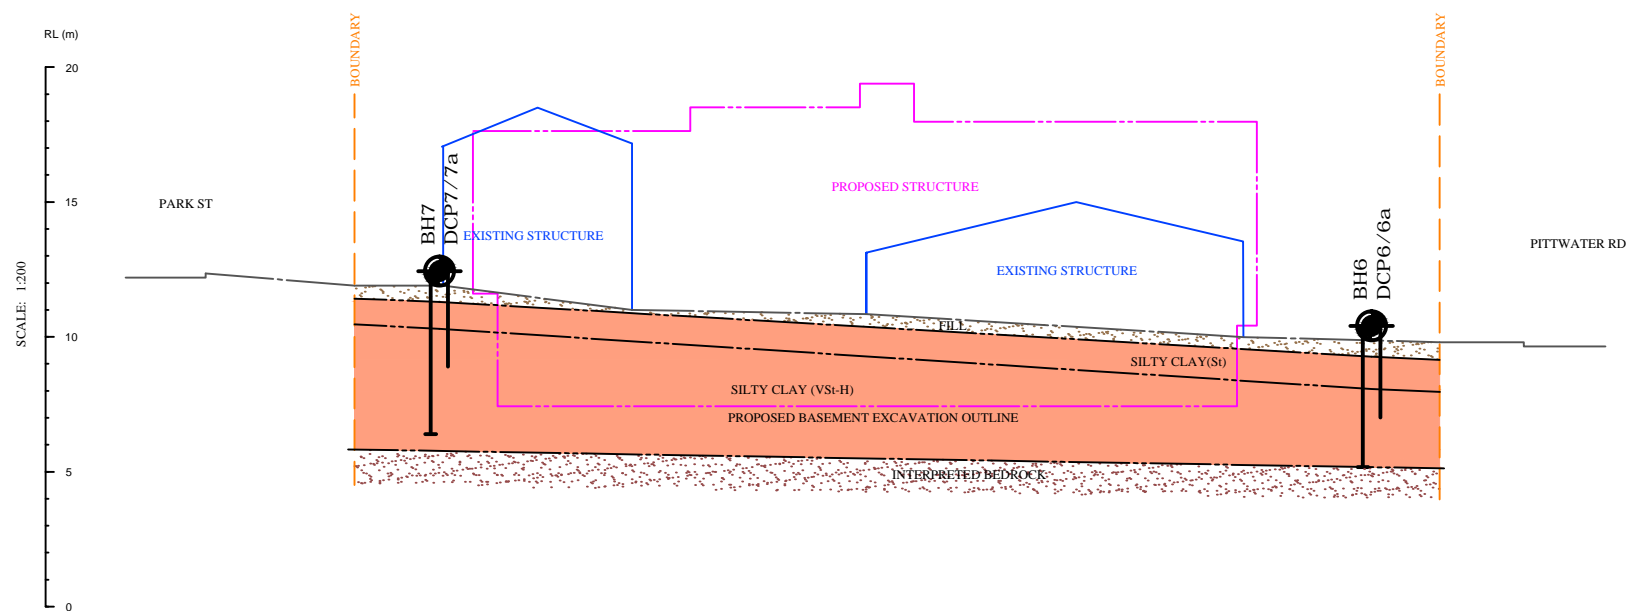
**NB. FOR LOCATION OF SECTION C-C', PLEASE REFER TO FIGURE 1. SITE PLAN AND TEST LOCATIONS**
