AS2870-2011 SITE CLASSIFICATION

Lot 1 No 5 Iraga Place
Forestville NSW

AS2870 Site Classification

Class P

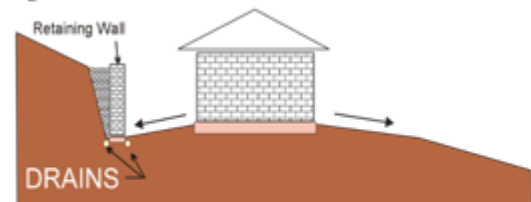
Fig. 5 Well Drained Sites

- Constructing sheds or outdoor roofed areas without connecting the roof drainage to storm water lines.
- Constructing paving around the building without sufficient slope away from the building. (In sandy soils and low and moderate "reactivity" clays, a slope of 1:40 up to 1 metre away from the building is adequate. In highly reactive clays a slope of 1:20 works better. In large paved areas a drain and collection pit may be necessary). (Fig. 5 & 18)

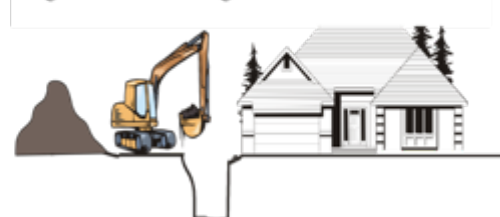
Fig. 11 De-stabilizing house foundations

- Ensuring that excavations are well supported or are dug to avoid collapses. (Fig. 11)
- Constructing well-compacted and retained 'soil aprons' around the building to stop erosion.

- Special considerations if any excavations are to be dug near adjoining structures. (Fig. 11)
- Sloping the soil and paths away from the building by the minimum amount required by the building regulations to prevent water flowing towards the building foundations. (Fig. 10 & 18)

- Running machinery over shallow drain pipes may break them causing leaks and subsequent foundation movements.
- Any excavations close to building footings can cause them to sink by disturbing the foundation material or by drying the foundation clay. (Fig 11)
