## **Geotechnical Investigation Report**

Proposed Development at:

26 Ralston Road

G21118-1-Rev A

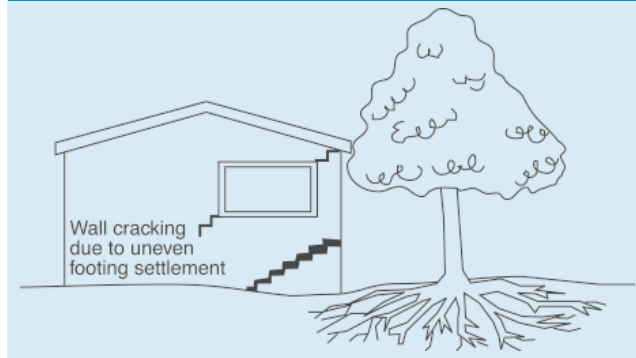
Trees can cause shrinkage and damage

As the weather pattern changes and the soil begins to dry out, the external footings will be first affected, beginning with the locations where the sun's effect is strongest. This has the effect of lowering the external footings. The doming is accentuated and cracking reduces or disappears where it occurred because of dishing, but other cracks open up. The roof lines may become convex.
