Ref: SRE/818/CL/21

**RE: PRELIMINARY GEOTECHNICAL ASSESSMENT FOR PROPOSED ADDITIONS & ALTERATIONS AT 9 SUFFOLK AVENUE, COLLARROY NSW 2097 - PRELIMINARY GEOTECHNICAL REPORT**

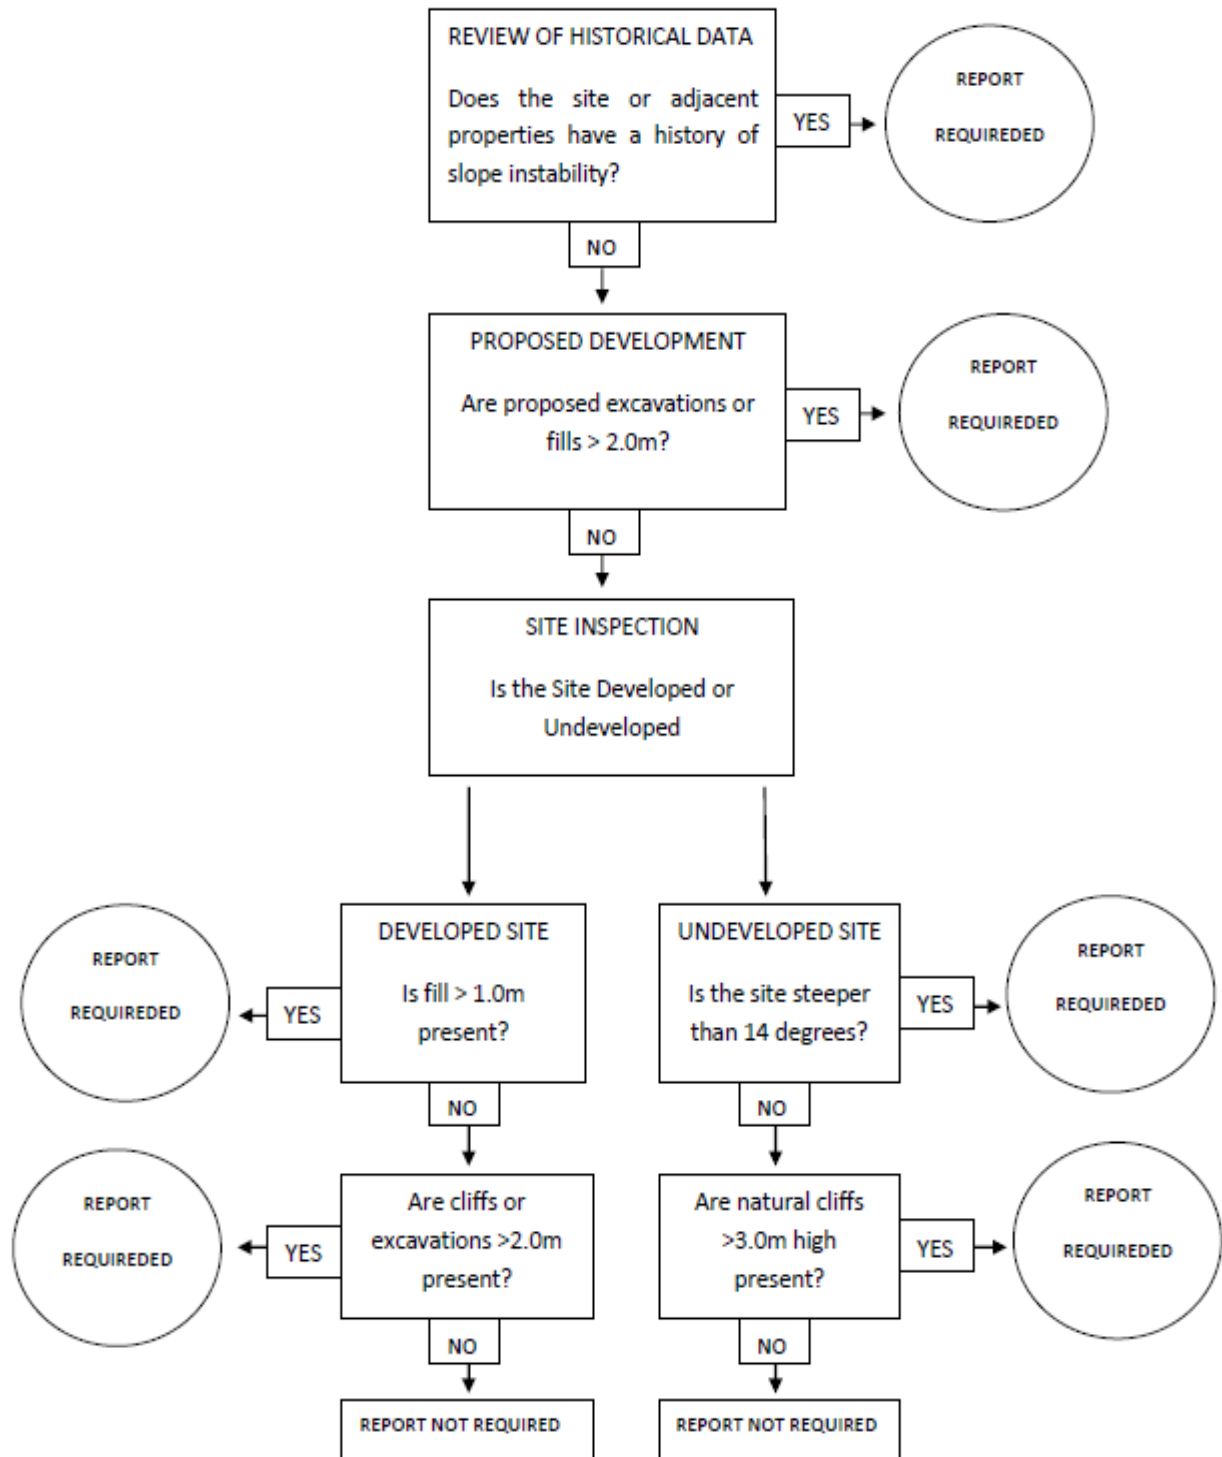
### CHECKLIST FLOW CHART FOR COUNCIL'S ASSESSMENT OF SITE CONDITIONS AND NEED FOR GEOTECHNICAL REPORT IN LANDSLIP RISK CLASSES B AND D

**Appendix 1 – Checklist Flow Chart for Council's Assessment of Site Conditions and Need for Geotechnical Report in Landslip Risk Classes B and D**
