PRELIMINARY GEOTECHNICAL ASSESSMENT: **28 Woodbine Street, North Balgowlah**

1.0	LANDSLIP RISK CLASS (<i>Highlight indicates Landslip Risk Class of property</i>)
<input type="checkbox"/>	A - Geotechnical Report not normally required
<input checked="" type="checkbox"/>	B - Geotechnical Engineer (Under Council Guidelines) to decide if Geotechnical Report is required
<input type="checkbox"/>	C - Geotechnical Report is required
<input type="checkbox"/>	D - Geotechnical Engineer (Under Council Guidelines) to decide if Geotechnical Report is required
<input type="checkbox"/>	E - Geotechnical Report required

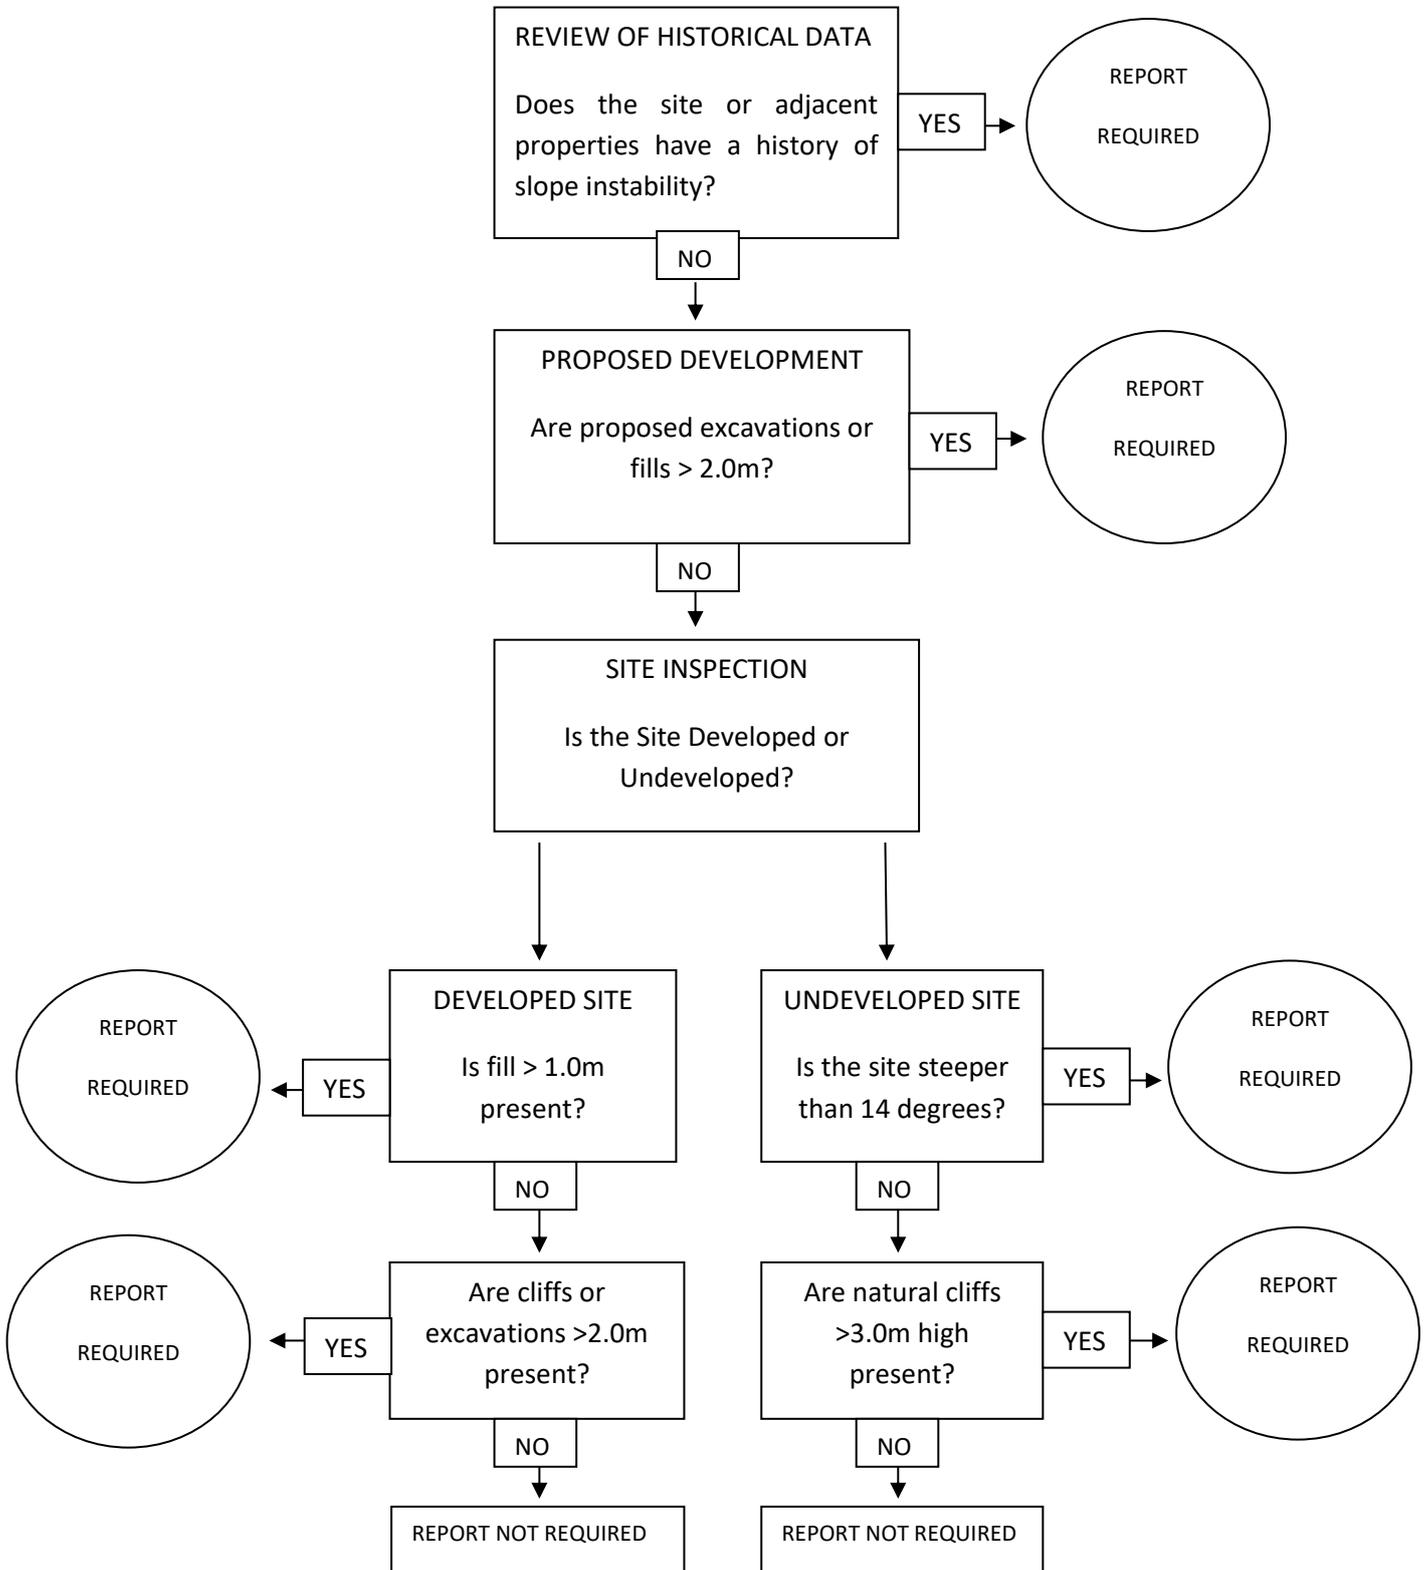
Preliminary Assessment Flow Chart – Northern Beaches Council (Warringah)

The proposed development and site conditions were considered and applied to the Council Flow Chart.
