Preliminary Geotechnical Assessment

Project: Alterations & Additions
293 Sydney Road, Balgowlah NSW

Ref: AG 25023
22 January 2025

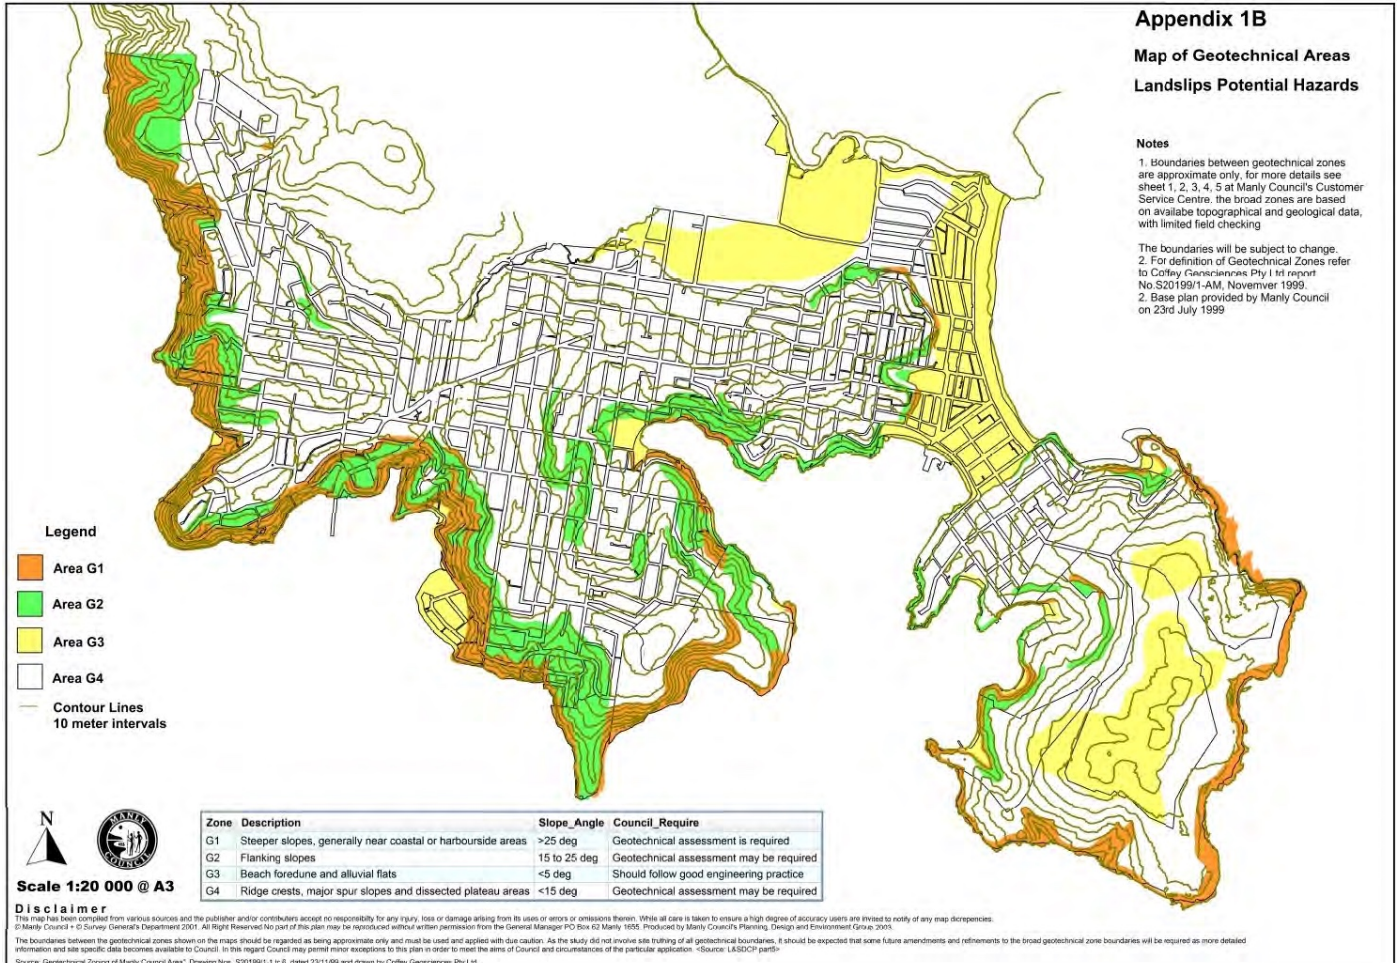
1. Boundaries between geotechnical zones are approximate only, for more details see sheet 1, 2, 3, 4, 5 at Manly Council's Customer Service Centre, the broad zones are based on available topographical and geological data, with limited field checking.

2. The boundaries will be subject to change. For definition of Geotechnical Zones refer to Coffey Geosciences Pty Ltd report No S20199/11-AM, November 1999.
3. Base plan provided by Manly Council on 23rd July 1999.

The site is mapped as **G4** landslide risk/geotechnical hazard with reference to Schedule 1 – Map C – Potential Geotechnical Landslip Hazard Areas, Manly DCP, Northern Beaches Council (**Appendix B**).
