## **PRELIMINARY GEOTECHNICAL ASSESSMENT**

**WARRIEWOOD VALLEY SECTOR 3 REZONING  
MACPHERSON STREET, WARRIEWOOD**

**Prepared for  
MIRVAC HOMES (NSW) PTY LTD**

**Project 37274  
December 2004**

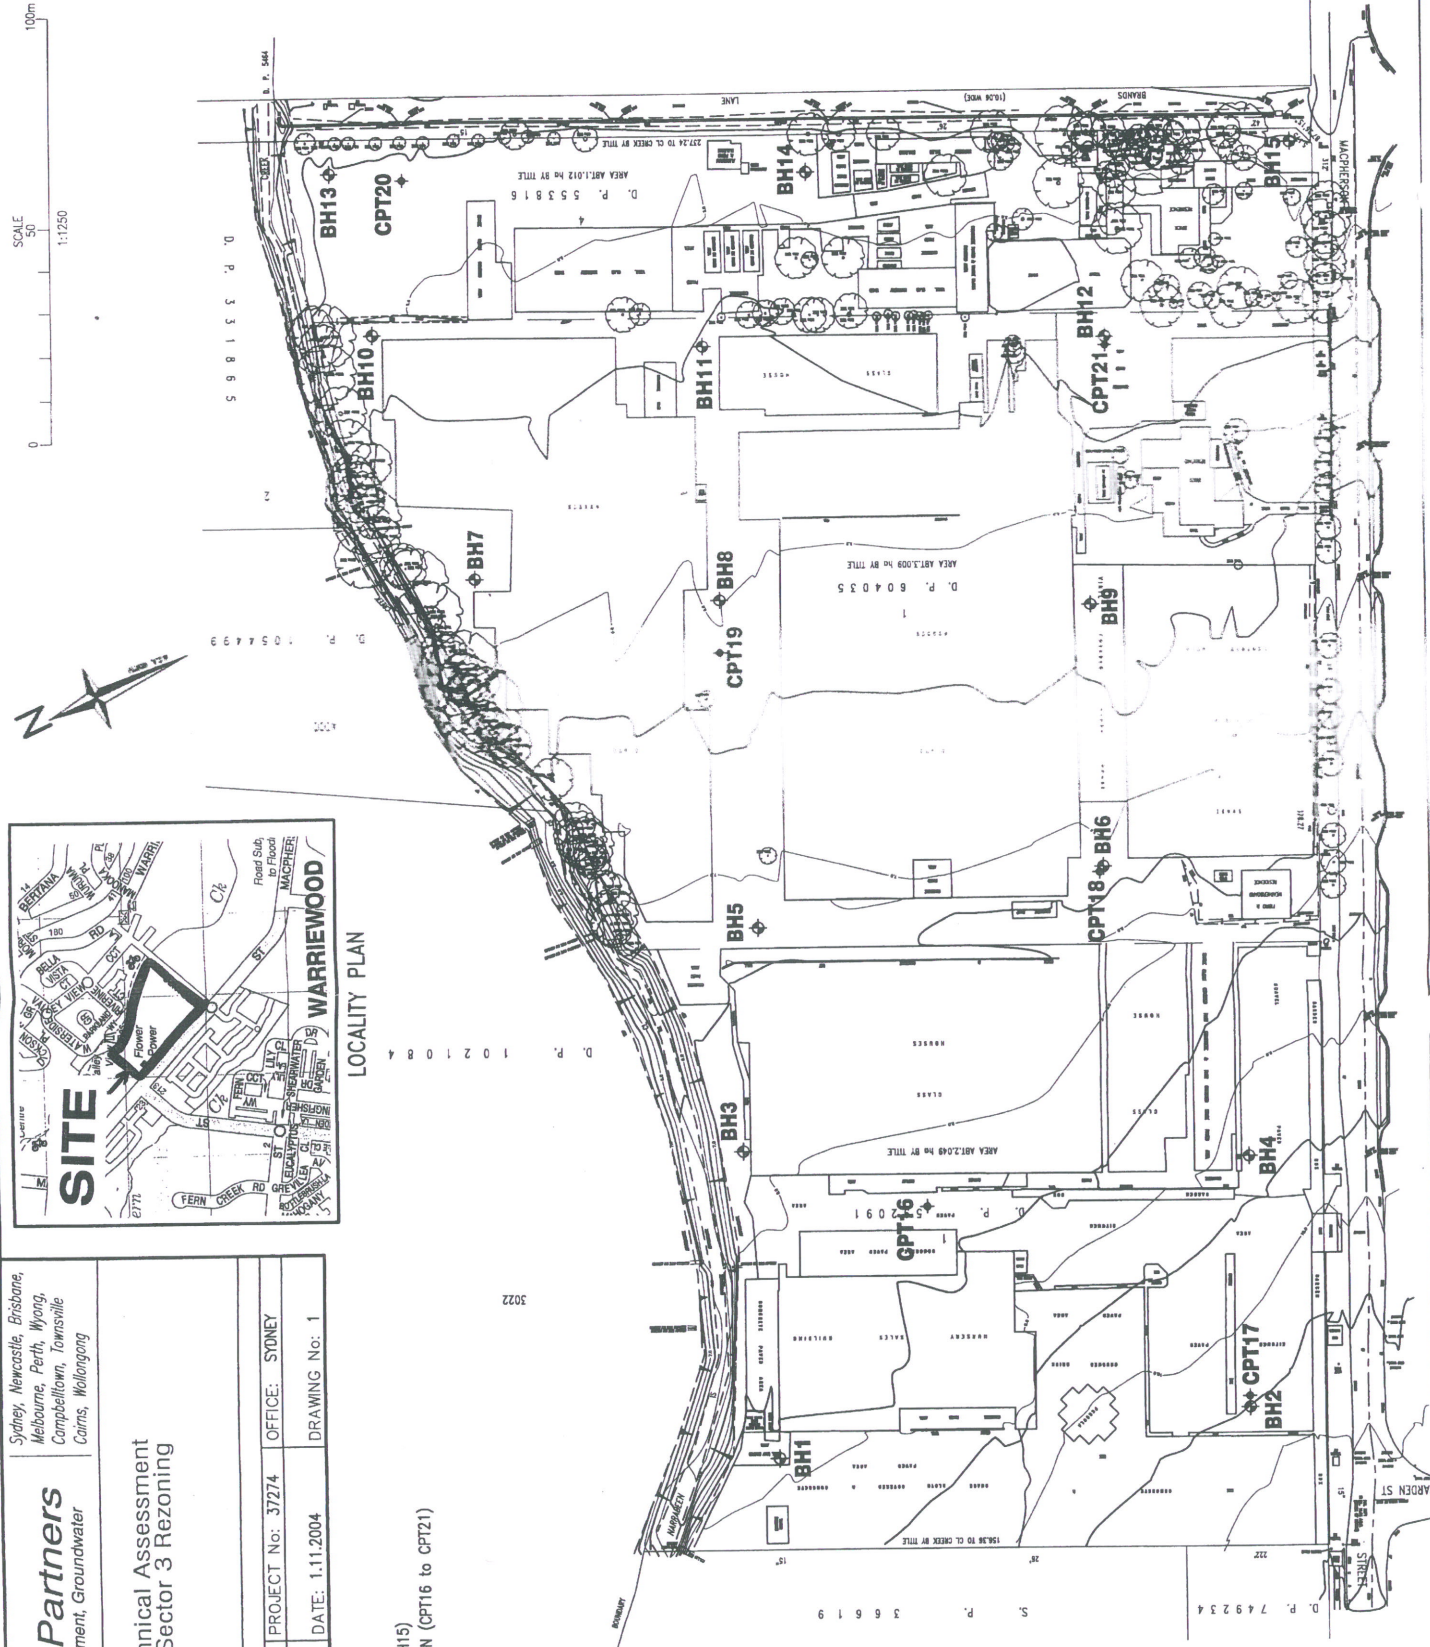
- ◆ TEST BORE LOCATION (BH1 to BH15)
- ◆ CONE PENETRATION TEST LOCATION (CPT16 to CPT21)

APPENDIX A: Notes Relating to this Report  
Results of Field Work  
Drawing 1
