Geotechnical Assessment

Project: Refurbishment to Existing Waterfront Structures
25-33 Robertson Road, Scotland Island NSW

For Proposed Refurbishment to Existing Waterfront Structures at
25-33 Robertson Road, Scotland Island NSW

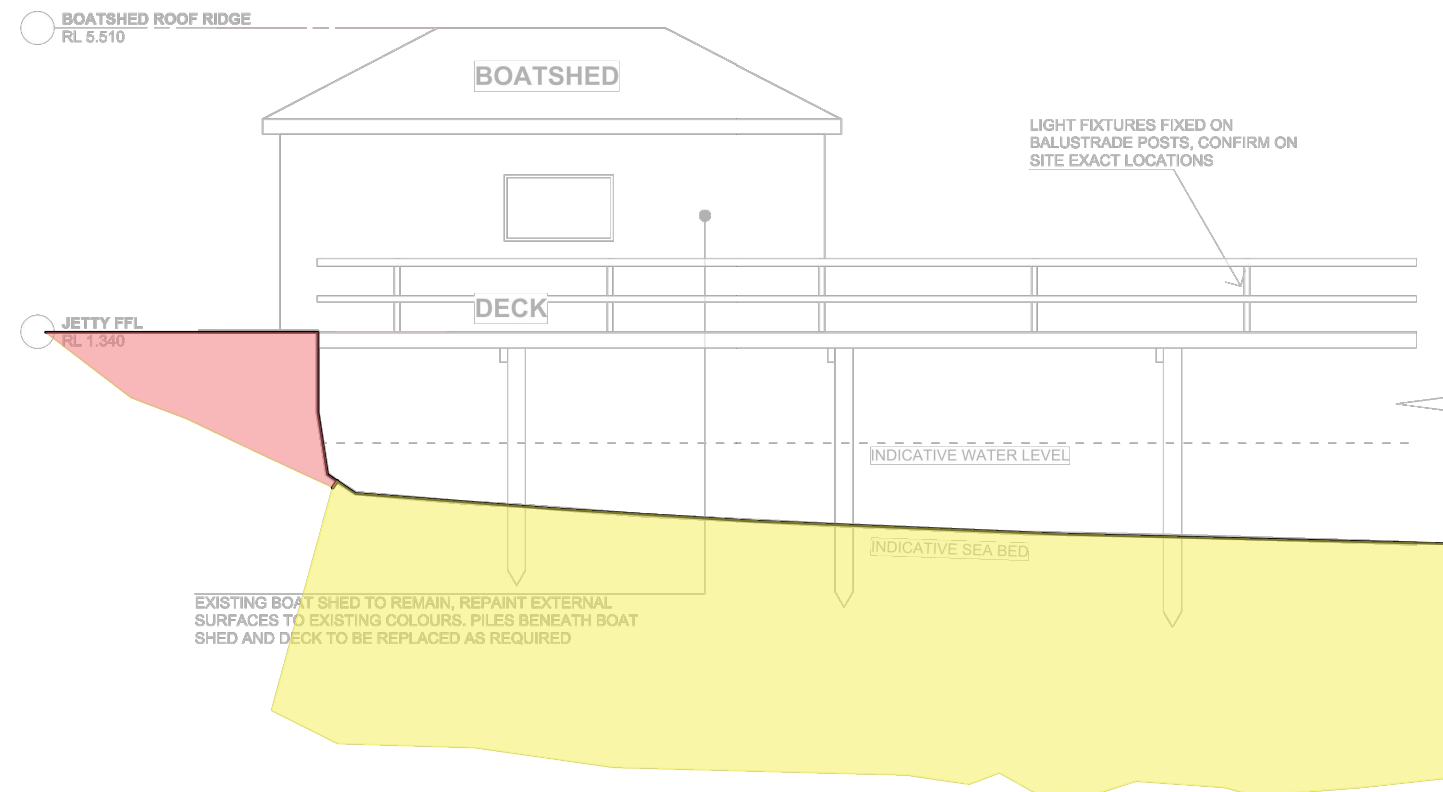
INFERRED GEOLOGICAL SECTION
SCALE NTS

INTERPRETED SUBSURFACE SECTION ONLY.
ACTUAL GROUND CONDITIONS MAY VARY.

INFERRED GEOLOGICAL TYPE SECTION

The soil profile consists of marine sands overlying weathered bedrock. Based on our observations and the results of testing onsite, we would expect competent weathered shale/low strength sandstone bedrock to be found beyond 4200mm from current surface levels across the area of the proposed works.
