30 Mactier Street, Narrabeen

Geotechnical Comments for New DA.

PRELIMINARY GEOTECHNICAL ASSESSMENT:

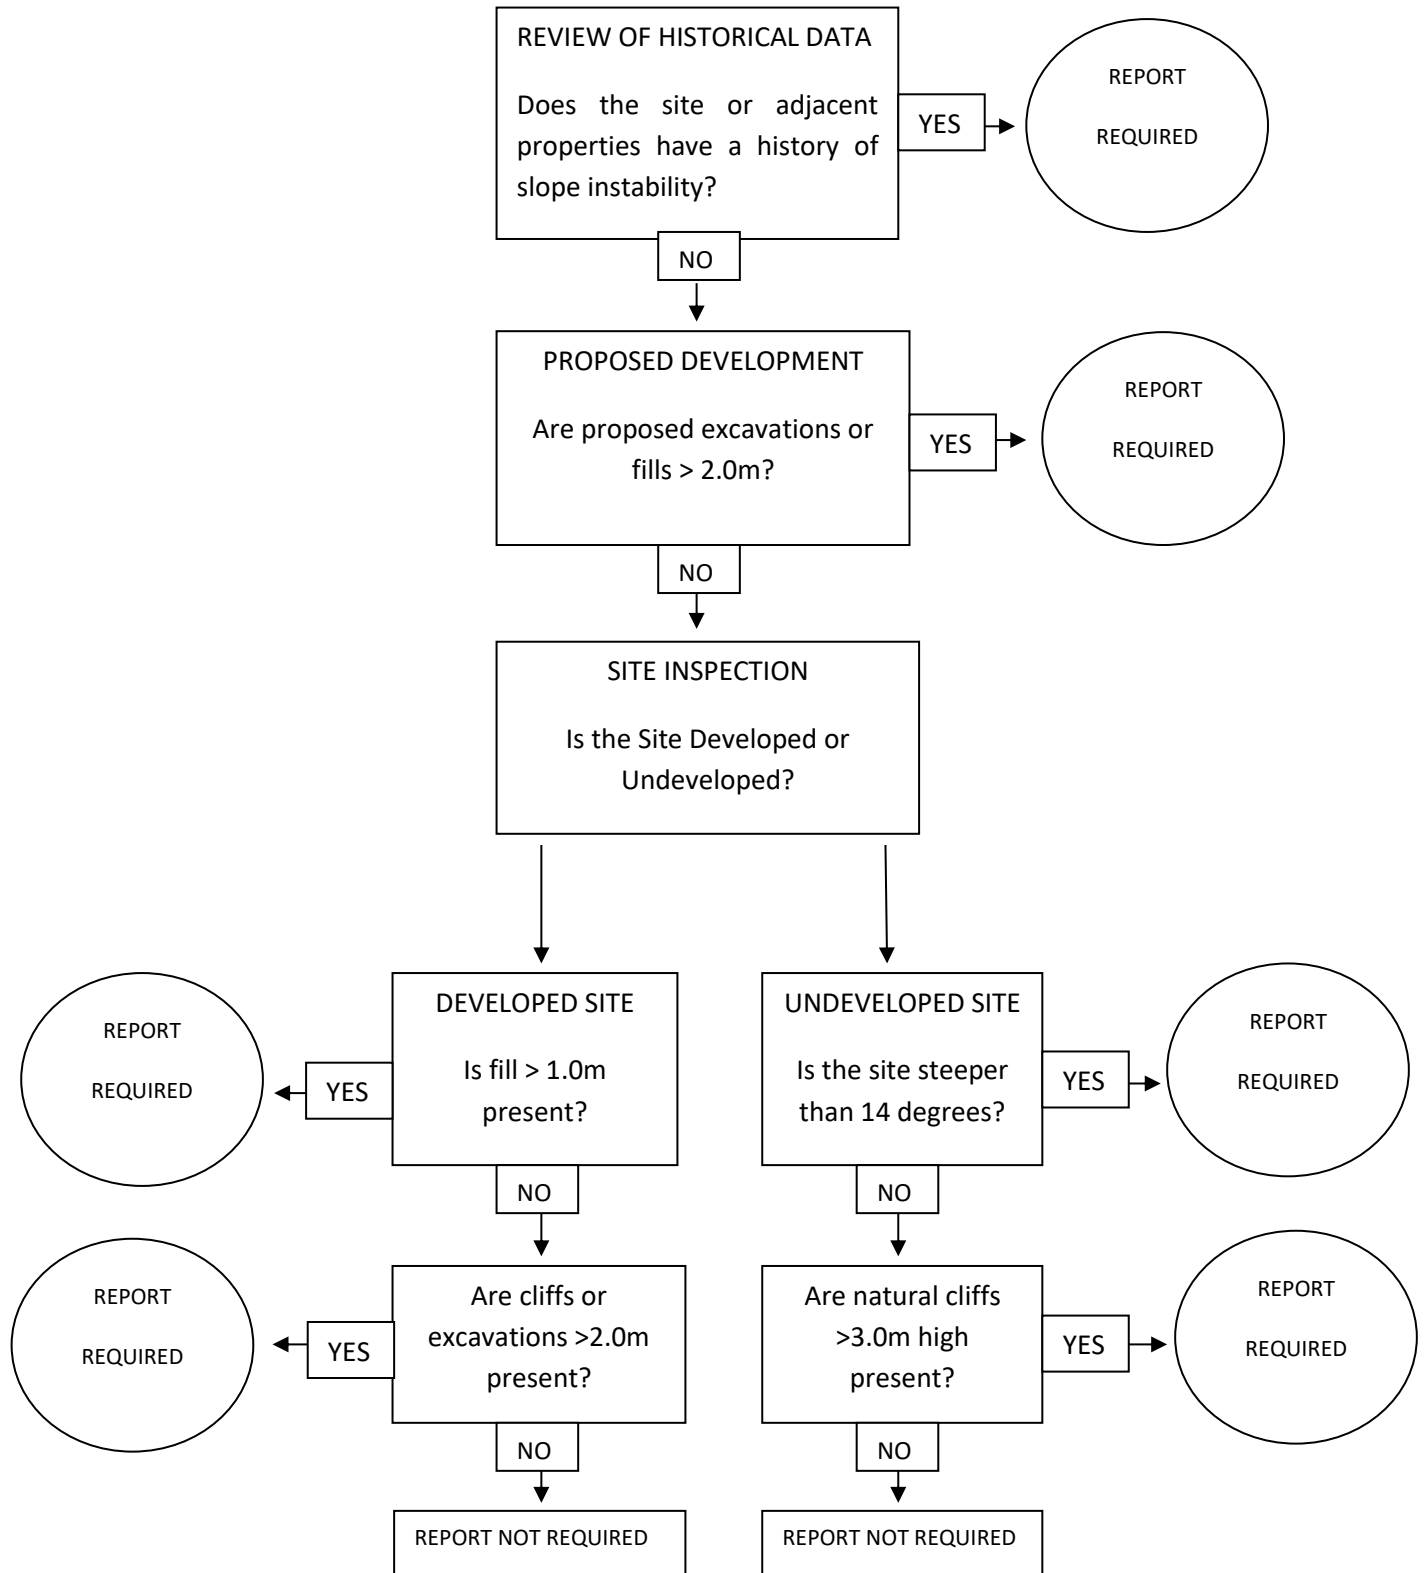
Preliminary Assessment Flow Chart – Northern Beaches Council (Warringah)

The proposed development and site conditions were considered and applied to the Council Flow Chart.
