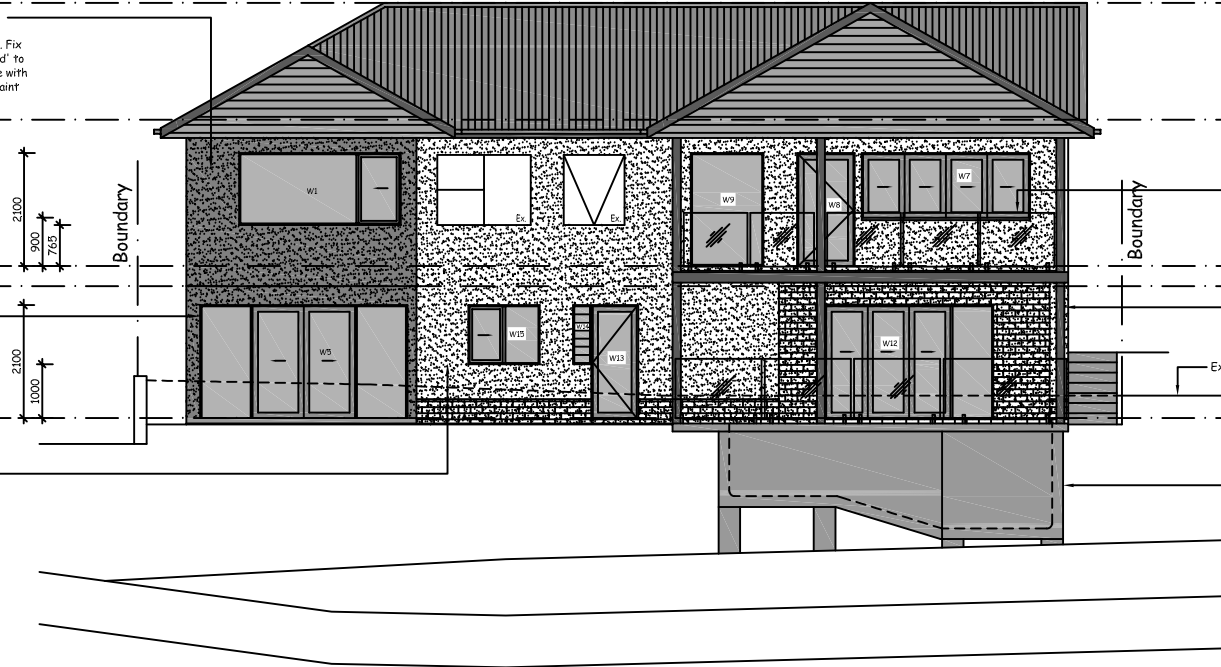
NORTH WEST ELEVATION

50mm EIFS cladding or similar. All external timber framed walls to be wrapped in a breathable membrane. Fix EIFS to battens to provide 'air void' to prevent condensation in accordance with manufacturers recommendations. Paint finish as selected by owners.

Powder coated aluminium framed windows & doors to owners selection, (refer Residence schedule on Drg. N2 or Granny Flat schedule on Drg. N3).

A cement render finish is to be applied to all external exposed brickwork. Render is to have a painted finish as selected by owners.

New 1.0m high balustrade as selected by owners to NCC requirements

125 x 125 Square timber posts as confirmed by Engineer.
