MARINE POLLUTION RESEARCH PTY LTD

AQUATIC ECOLOGY ASSESSMENT
PROPOSED SHARED JETTY 1742 & 1744 PITTWATER ROAD BAYVIEW AND
NEW BOATSHED, RAMP AND SEAWALL REPLACEMENT AT NO. 1744

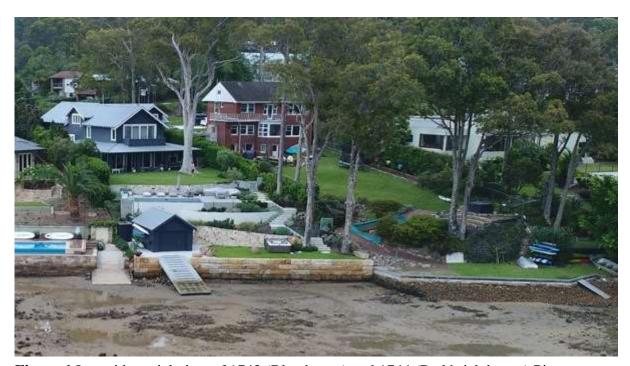
Figure 1 Low tide aerial view of 1742 (Blue house) and 1744 (Red brick house) Pittwater Road, Bayview.

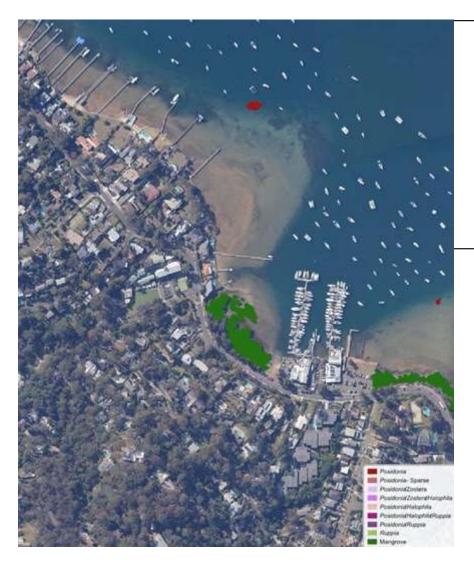
Figure 2 Portion of DPI Fisheries' Estuarine Vegetation Pittwater Map 37 showing marine vegetation located in relation to the subject property.

With respect to expected marine vegetation, **Figure 2** shows a portion of the DPI Fisheries Estuary Vegetation Map No 37 for Pittwater with the shared jetty location indicated. The latest 2019 mapping indicated only a small amount of *Posidonia* seagrass (Red) with no *Zostera* seagrass, where the 2005 mapping had an inner *Zostera* seagrass bed (light blue)

from about 140 to 180m offshore and a *Posidonia* seagrass bed (Red) in deeper waters from about 230 to 250m offshore from the subject property. *Posidonia australis* in Pittwater is listed as an *Endangered Population* under the NSW *Fisheries Management Act 1994 (FMA)* and as a *Threatened Ecological Community* under the Commonwealth *Environment Protection and Biodiversity Conservation Act 1999 (EPBC Act)*. There are no mangrove stands or saltmarsh areas indicated in the immediate vicinity of the property and the closest mature mangroves are located more than 200m to the south-east. Mangroves are protected under the FMA. There are no aquaculture or commercial fishing activities (hauling or meshing) in the locality (EPA 1992).

- To ensure minimum disturbance of seabed sediments during mobilisation, these operations will have to be done at a high tide, and the pushing vessel must be operated in such a manner as to minimise sediment disturbance or disturbance to the rocky reef or off-shore seagrass as identified in **Figures 2 and 4**.
- The barge will also need to be manoeuvred and then held in place for construction and possible piling operations and this would be either done using barge-mounted push in spuds, or by using barge mounted winches and wire connected to pre-placed mooring blocks. These manoeuvres should also be timed with the tides to minimise seabed disturbance.
- Placement of mooring spuds or mooring blocks must be undertaken in such a manner

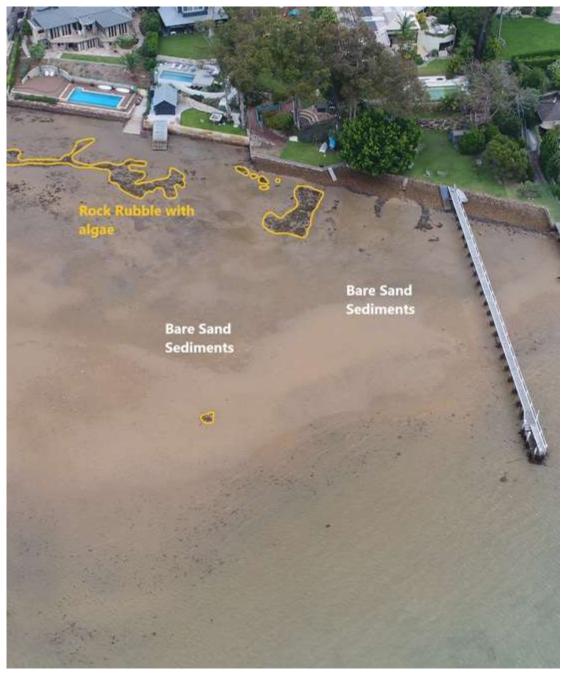
Figure 4 Aquatic Habitats at and around the subject property foreshore. From the aerial photograph, it is clear that portions of these rock + algae (yellow) can be smothered or exposed, as sand drifts move around seasonally.

The results of the aquatic habitat survey are shown on **Figure 4** above. There are two main aquatic habitats at the site, intertidal sediment habitat and rock rubble habitat:

- The sediment habitat comprises a mosaic of soft silty-sand patches inshore overlain with mobile and firm sand drift sections offshore (**Figures 4 and 5**).

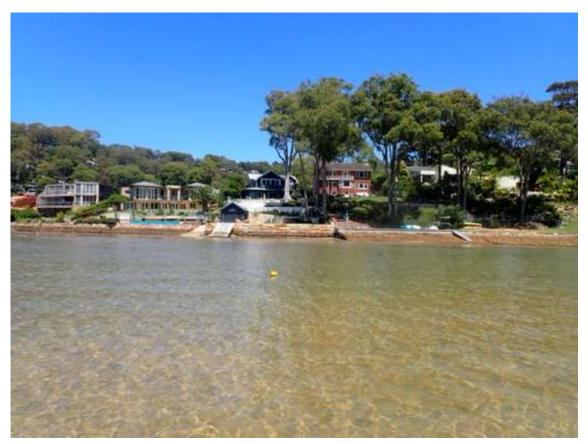
Figure 5 View inshore over the intertidal sand flat offshore from properties 1742 and 1744. 1742-44 Pittwater Rd Bayview Jetty Aq Ecol MPR1322 Marine Pollution Research Pty Ltd

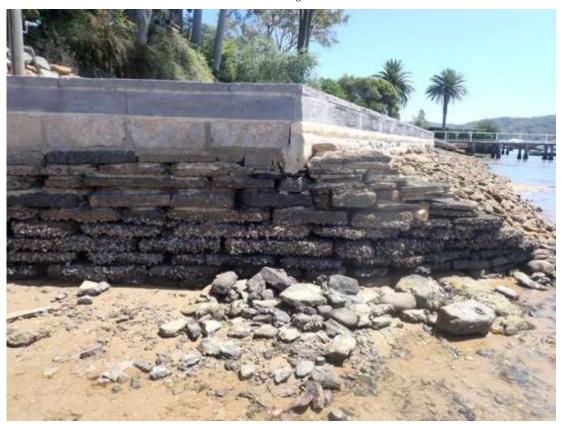
Figure 6 View of common boundary between the two properties showing block sandstone seawall along the north-east edge of No 1744 property to be replaced and placed river cobbles lining the front edge of the seawall (to be retained).

- The rock habitat includes the intertidal surfaces of rock walls along the common boundary (**Figure 6**), finer gravel plus rock fragments generally along the foot of the subject property seawall (**Figure 6**) and exposed and fragmented basement rock habitat offshore from the property seawalls in the lower intertidal. These latter reef fragments support an intertidal assemblage based around the brown algae *Hormosira* (Neptune's Necklace) and Oysters (**Figure 7**).

- Whilst the lower sections of the sandstone rock wall at the site supports oysters and a variety of gastropod molluses, the fine gravel and rock fragment habitat at the toe of the wall (**Figure 6**) did not support many oysters and also had less molluses, probably owing to the constant smothering and uncovering of this habitat by sand drifts.

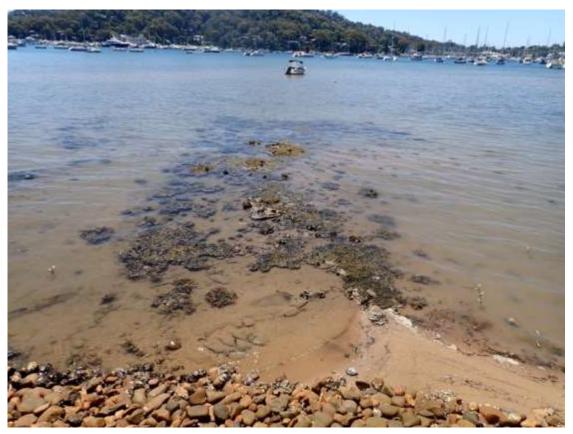
Figure 7 View offshore from property 1744 of the rock/rock rubble with attached oysters and Neptune's necklace located west of the proposed ramp.

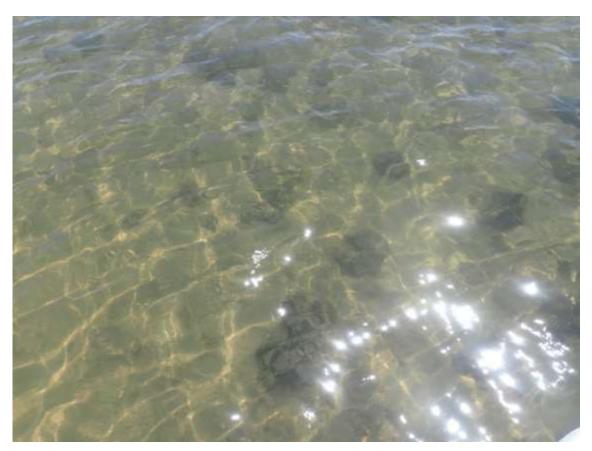
Figure 8 Shallow sub-tidal rock rubble, far offshore from site with attached *Padina sp*.

- There were small amounts of scattered shallow sub-tidal rock rubble well offshore which supported *Padina sp.* (**Figure 8**).
- Three grey mangrove seedlings were observed inshore along the seawall at 1744 west of the proposed ramp location (**Figure 9**).

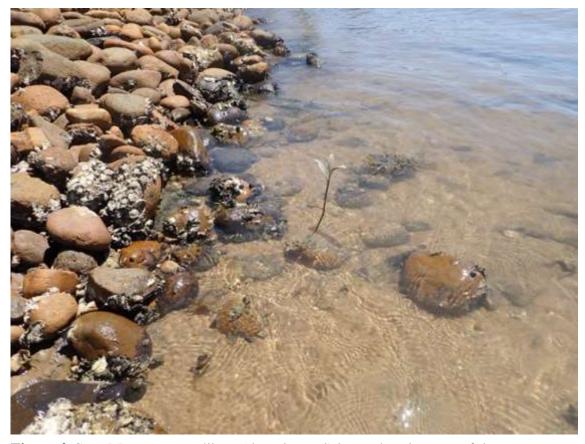
Figure 9 Grey Mangrove seedlings (three in total) located to the west of the ramp proposal.

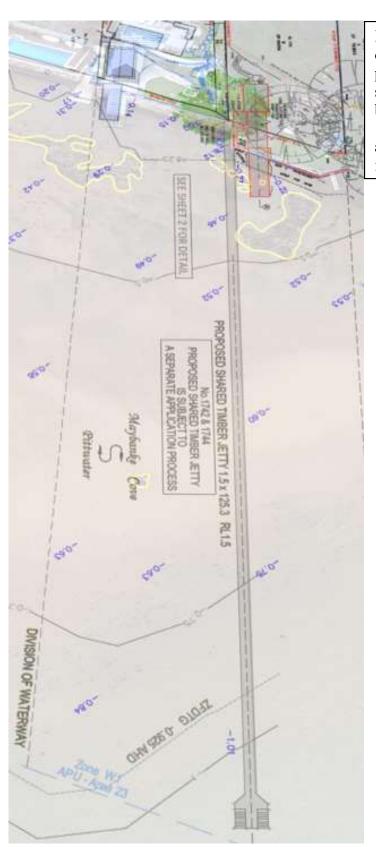
Figure 10 Approximate overlay of the proposed shared Jetty for property 1742 and 1744 (Grey shade) plus the ramp, seawall and boatshed proposal for property 1744 (Red outline). Exposed rock and rock and rock rubble habitat is outlined in yellow.
