Preliminary Geotechnical Assessment

Project: Alterations & Additions
24 White Street, Balgowlah NSW

Ref: AG 25029
29 January 2025

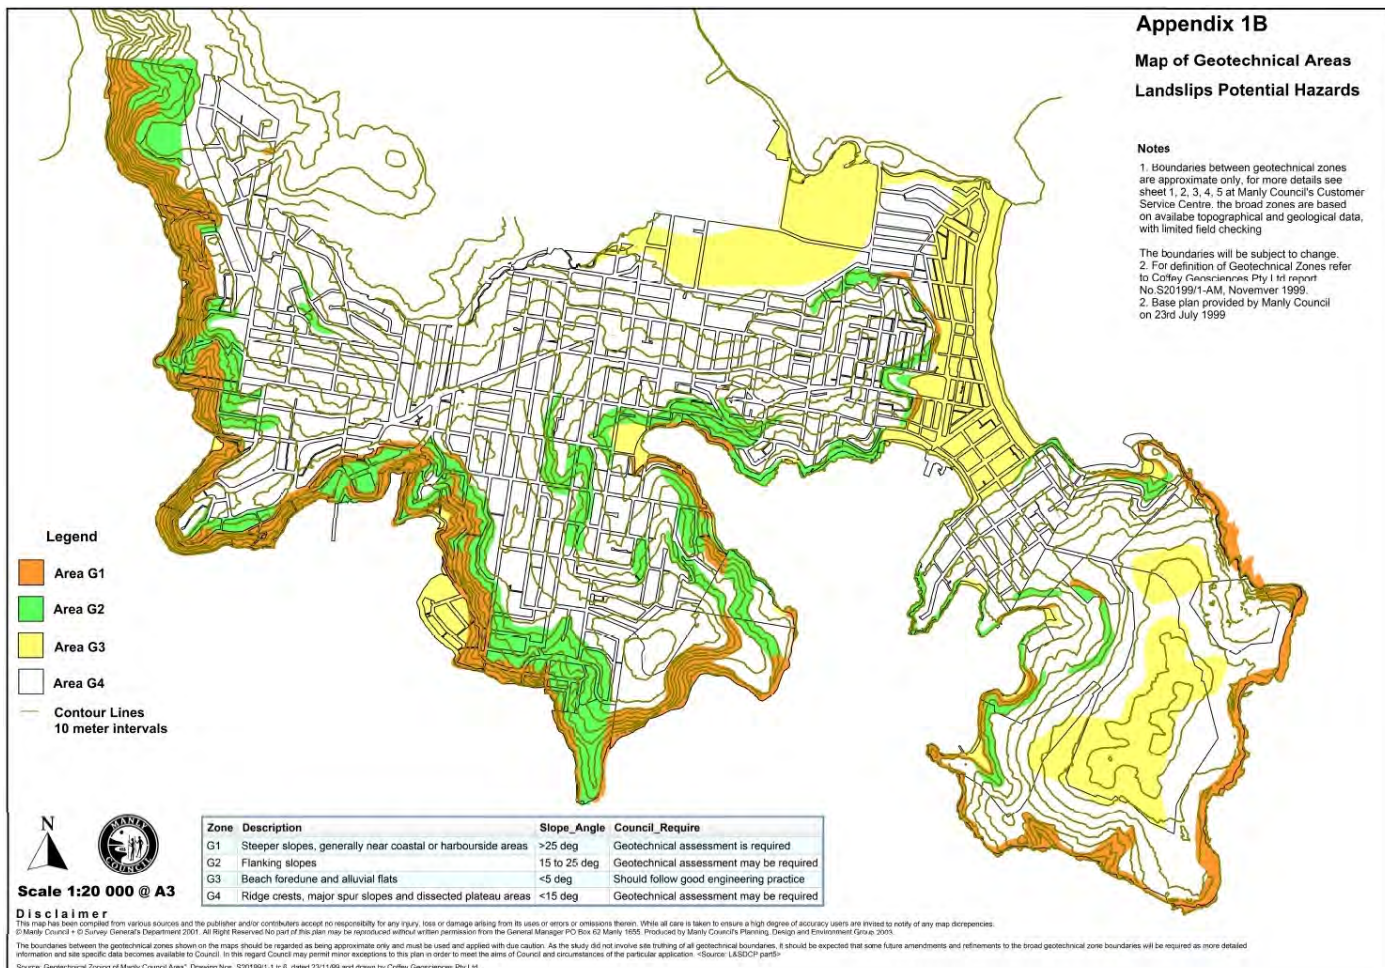
Schedule 1 – Map C – Potential Geotechnical Landslip Hazard Areas

Potential Geotechnical Landslip Hazard Areas
Northern Beaches Council | Manly DCP Schedule 1 Map C

The site is mapped as **G4** landslide risk/geotechnical hazard with reference to Schedule 1 – Map C – Potential Geotechnical Landslip Hazard Areas, Manly DCP, Northern Beaches Council (**Appendix B**).
