## AS2870-2011 SITE CLASSIFICATION

Icon Homes  
P O Box 311  
North RYde BC NSW

Lot 12 No 10 Baz Street Warriewood NSW

AS2870 Site Classification

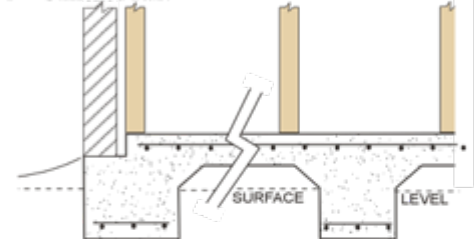
Fig. 1 Stiffened Raft

**Footings** (often incorrectly called foundations) are the "members" that support the building. They are commonly concrete slabs or timber floors supported by strips and stumps. (Fig 1, 2 & 3).

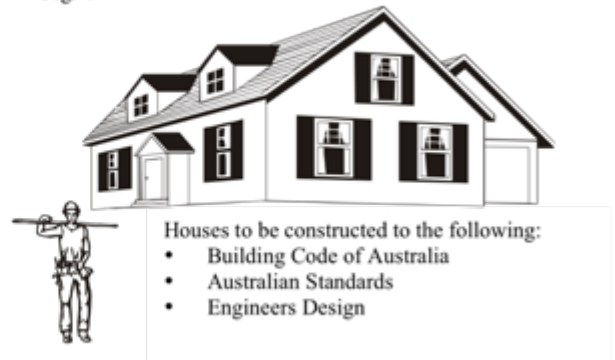
Fig. 4

In the construction of a building the builder needs to comply the Building Code of Australia, relevant Australian Standards, engineering specifications and contract documents. (Fig. 4) The following are important aspects the builder will need to address:

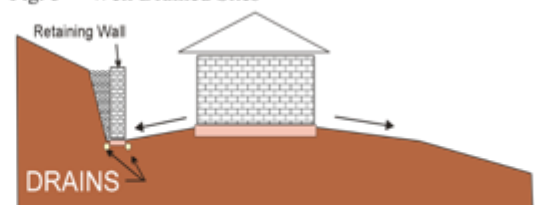
Fig. 5 Well Drained Sites

- Constructing sheds or outdoor roofed areas without connecting the roof drainage to storm water lines.
- Constructing paving around the building without sufficient slope away from the building. (In sandy soils and low and moderate "reactivity" clays, a slope of 1:40 up to 1 metre away from the building is adequate. In highly reactive clays a slope of 1:20 works better. In large paved areas a drain and collection pit may be necessary). (Fig. 5 & 18)

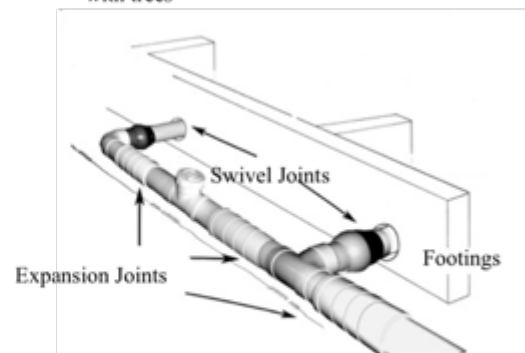
Fig. 6 Mechanical Flexible Couplings to reduce the potential of broken pipes in M/M-D, H1/H1-D, H2/H2-D & E /E-D sites plus all clay based sites with trees

- Constructing soil drains or moisture barriers in sloping sites to prevent stormwater adversely affecting the building foundations.
- In highly or extremely reactive clay sites Australian Standard 2870 – "Residential slabs and footings" requires *mechanical flexible couplings* for sub-surface drainage pipes and for above-ground connections from the downpipe to the storm water drains. These allow for the movement of the soil and minimise the risk of pipe joints breaking and creating leakage problems. (Fig.6).

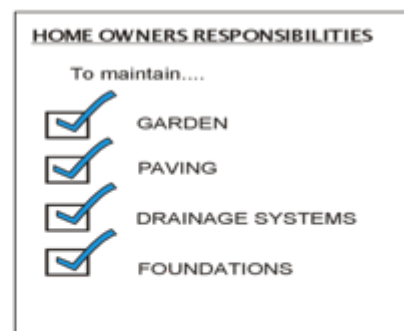
Fig.7

The home owner should read and become familiar with the Site Classification report provided prior to construction and the type of footing system used in the building. To comply with Australian Standard 2870 – "Residential slabs and footings", and achieve acceptable performance and safety during the design life of the house, the owners shall maintain the garden and foundation soil moistures, paving and drainage systems. (Fig. 7)

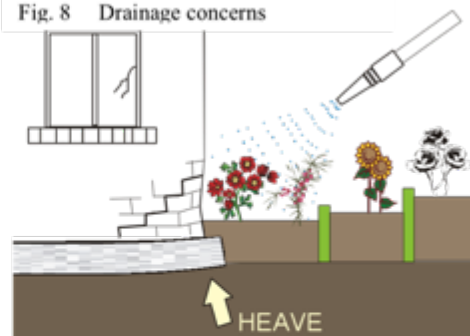
Fig. 8 Drainage concerns

- Excessive watering or under-watering of gardens.
- Watering systems that are overused or discharge water too close to building walls (Fig. 8)
- Constructing terraces, retaining walls or garden walls without good drainage. (Fig. 10)

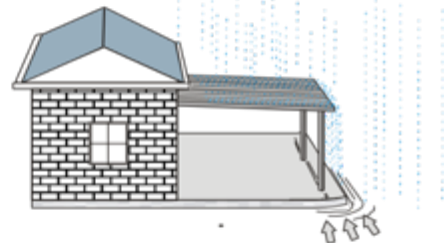
Fig. 9 Slab heave due to water ponding

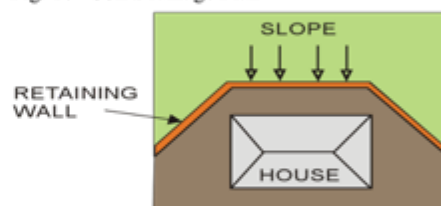
Fig. 10 Soil Drainage Plan

- Special considerations if any excavations are to be dug near adjoining structures. (Fig. 11)
- Sloping the soil and paths away from the building by the minimum amount required by the building regulations to prevent water flowing towards the building foundations. (Fig. 10 & 18)

- Australian Standard 2870, "Residential Slabs and Footings" requires soil drains and "normal" soil garden moisture in M, H1, H2, E, and P sites to be maintained by the owner. (Fig 10)

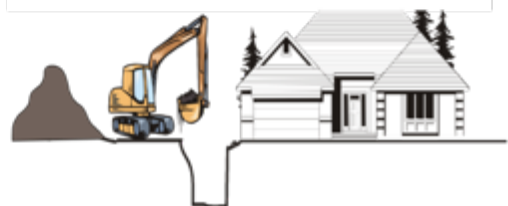
Fig. 11 De-stabilizing house foundations

- Ensuring that excavations are well supported or are dug to avoid collapses. (Fig. 11)
- Constructing well-compacted and retained 'soil aprons' around the building to stop erosion.

- Running machinery over shallow drain pipes may break them causing leaks and subsequent foundation movements.
- Any excavations close to building footings can cause them to sink by disturbing the foundation material or by drying the foundation clay. (Fig 11)

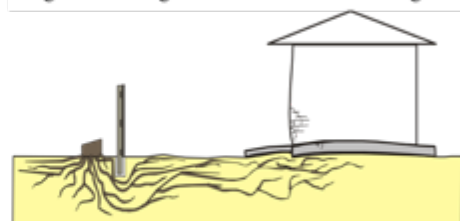
Fig. 12 Damage due to soil moisture changes

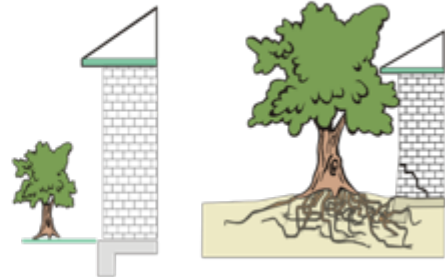
Fig. 13 Root Damage

Tree roots in sandy areas rarely cause any damage since sand does not shrink or swell, however if the root ball or large root is very close to a building it may grow and lift the footings of a light structure. (Fig. 13)
