## **Geotechnical Assessment**

**Project:** New Pool  
20 Palm Beach Road, Palm Beach, NSW.

**REF: AG 19104**  
1<sup>st</sup> July, 2019

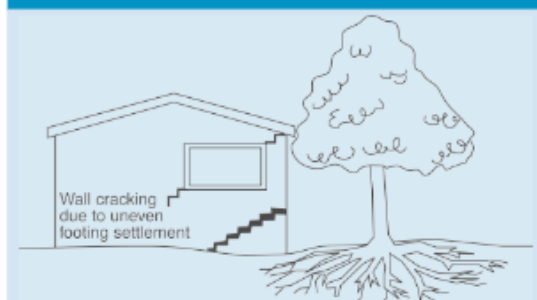
#### Trees can cause shrinkage and damage

As the weather pattern changes and the soil begins to dry out, the external footings will be first affected, beginning with the locations where the sun's effect is strongest. This has the effect of lowering the external footings. The doming is accentuated and cracking reduces or disappears where it occurred because of dishing, but other cracks open up. The roof lines may become convex.
