## **Geotechnical Assessment**

**Project:** New Dwelling

4 Bellara Avenue, North Narrabeen NSW 2101

**Ref:** AG 22455  
20 October 2022

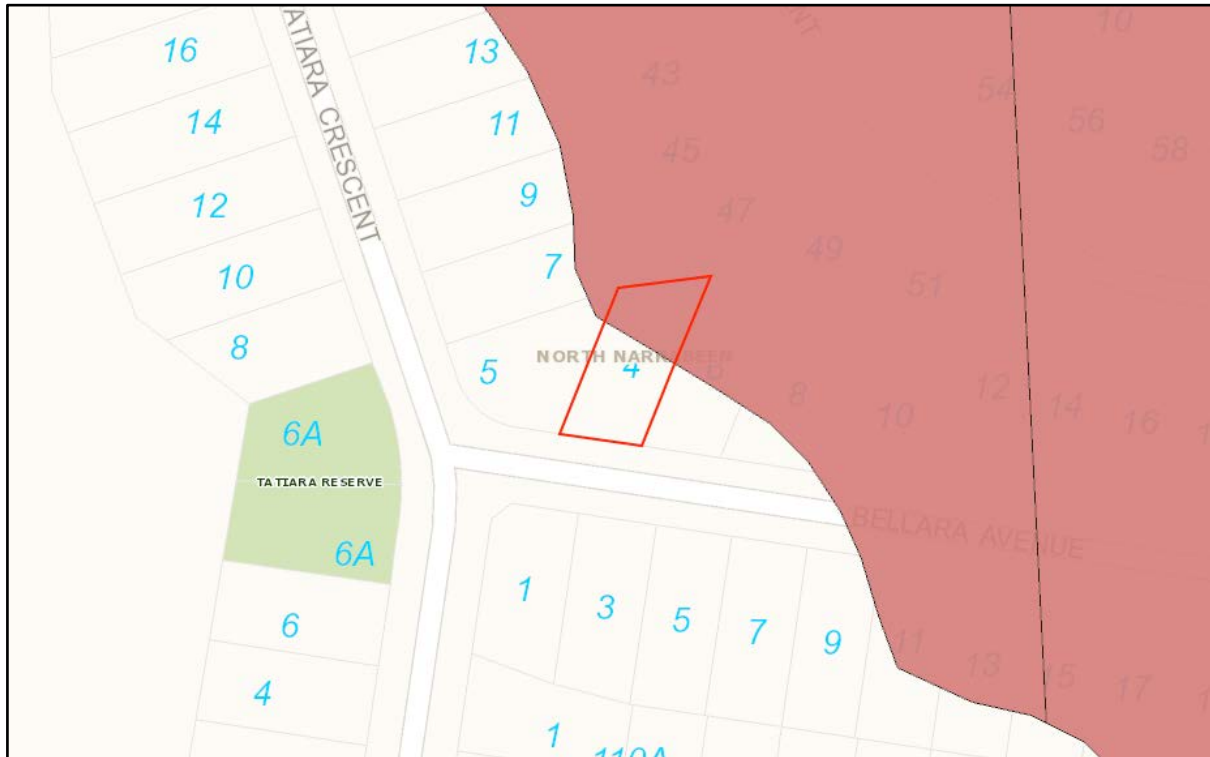
**Image 1.** Pittwater Geotechnical Hazard Risk Map:  
4 Bellara Avenue, North Narrabeen NSW (© NBC Maps)

Based on reference to the plan entitled 'Geotechnical Hazard Mapping' (Ref. P21DCP-BC-MDCP2002, dated 2007) prepared by GHD LONGMAC on behalf of Pittwater Council, the site is located within **Geotechnical Hazard Zone H1**.

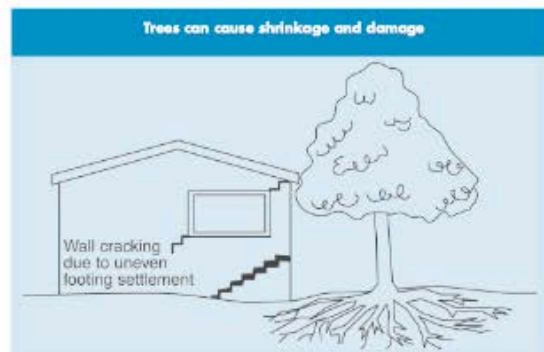
As the moisture absorption process completes its journey to the innermost areas of the building, the internal footings will rise. If the spread of moisture is roughly even, it may be that the symptoms will temporarily disappear, but it is more likely that swelling will be uneven, creating a difference rather than a disappearance in symptoms. In buildings with timber flooring supported by bearers and joists, the isolated piers will rise more easily than the strip footings or piers under walls, creating noticeable doming of flooring.

As the weather pattern changes and the soil begins to dry out, the external footings will be first affected, beginning with the locations where the sun's effect is strongest. This has the effect of lowering the external footings. The doming is accentuated and cracking reduces or disappears where it occurred because of dishing, but other cracks open up. The roof lines may become convex.

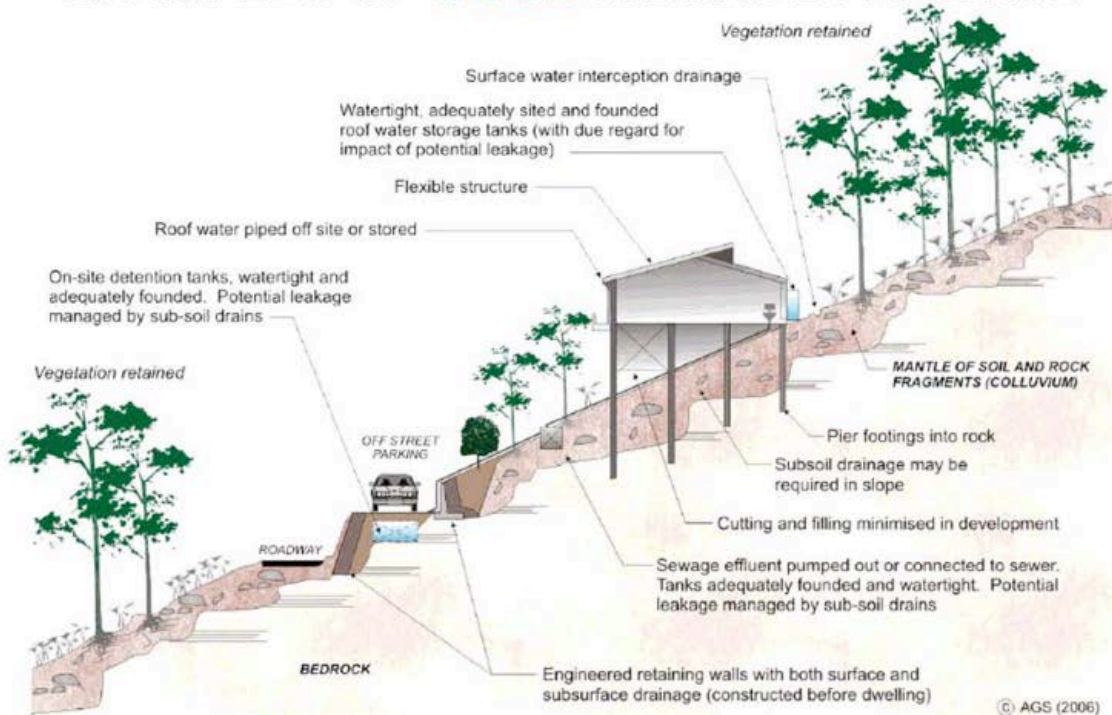
## EXAMPLES OF **GOOD** HILLSIDE PRACTICE

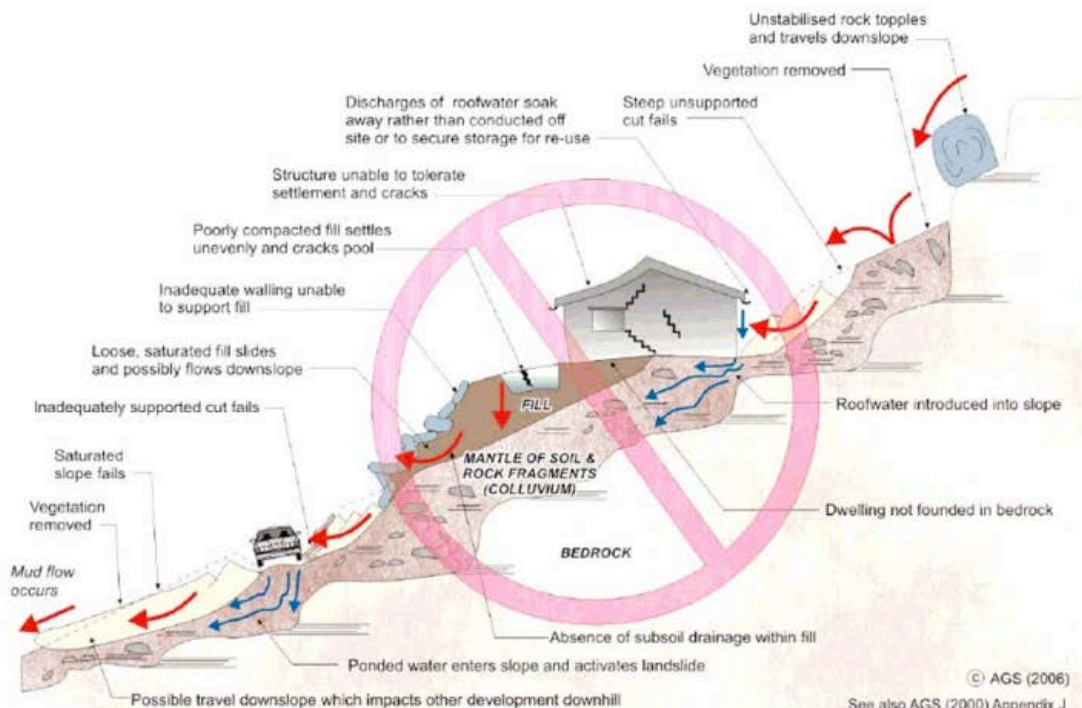
## EXAMPLES OF **POOR** HILLSIDE PRACTICE
